CORRECTIVE ACTION PLAN - PART A REPORT
FOR
FACILITY ID #9-089061
UNDERGROUND STORAGE TANKS 232 & 233
AT
BUILDING 4577
FORT STEWART, GEORGIA

U.S. Army Corps of Engineers - Savannah District
and
Fort Stewart Directorate of Public Works
Under Contract Number DACA21-95-D-0022
Delivery Order 0003

Science Applications International Corporation
800 Oak Ridge Turnpike
Oak Ridge, Tennessee 37831

May 1997

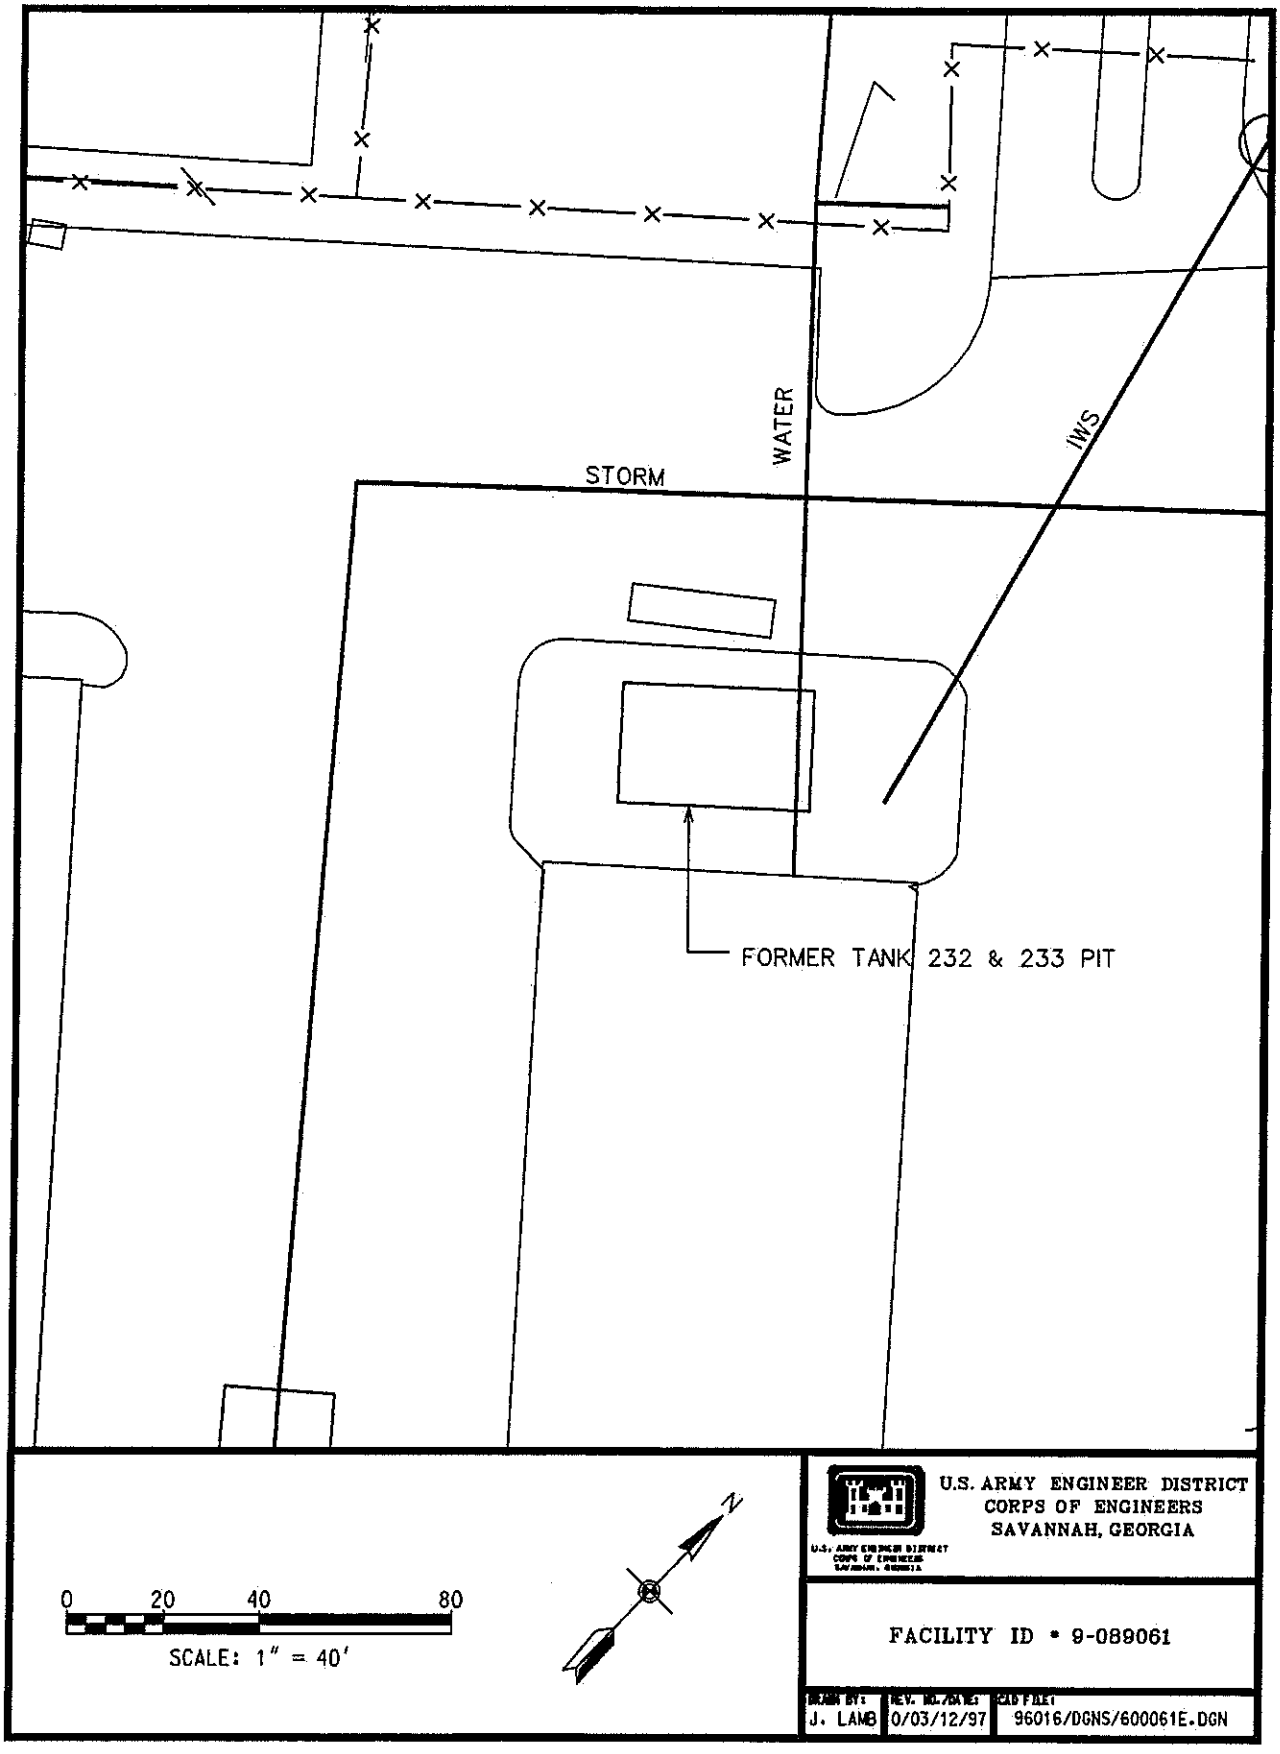
Figure II-1. Facility ID #9-089061, USTs 232 and 233, Site Map

The location of former USTs 232 and 233 are illustrated in Figure II-1. Detailed schematics illustrating the location of the tanks and ancillary piping as configured during operation is not available. During removal activities, Fort Stewart DPW personnel observed no holes in either tank and, therefore, the source of contamination is believed to have been piping leakage and/or tank overflows. At the present time, the only remaining source of contamination at the site is contaminated soil located below the former tank pit.

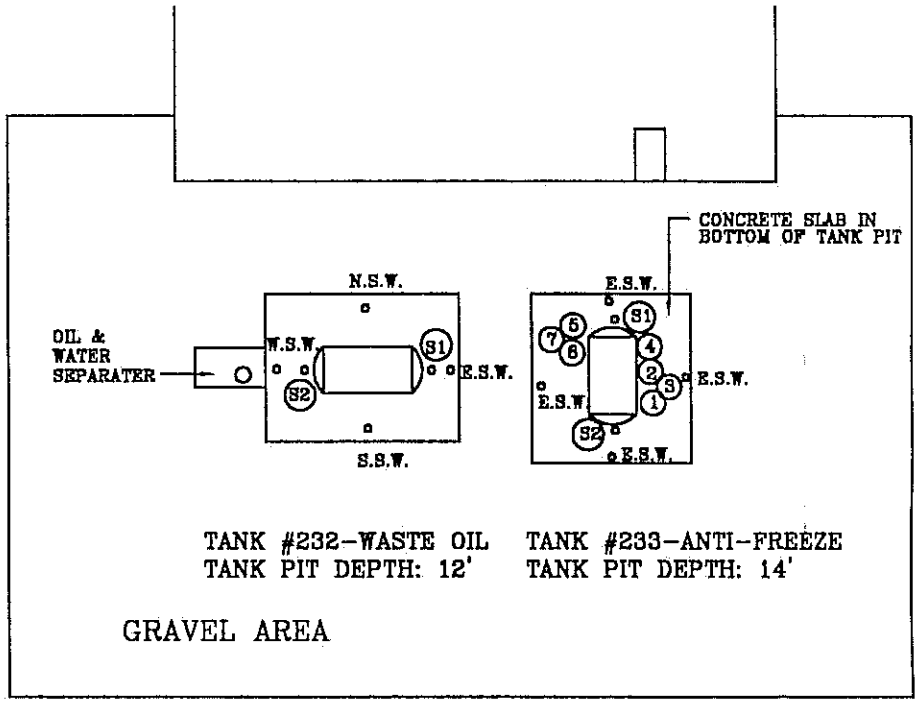
Figure II-2. Site Map of Sampling Lo ns for the USTs 232 and 233 Removal

Sample	Depth	FID	Methane	VOC
1	2'	800		
2	4'	500+		
3	6'	500+		
4	8'	5000+	-0-	
5	2'	3,900		
6	4'	1,200	-0-	
7	8'	900

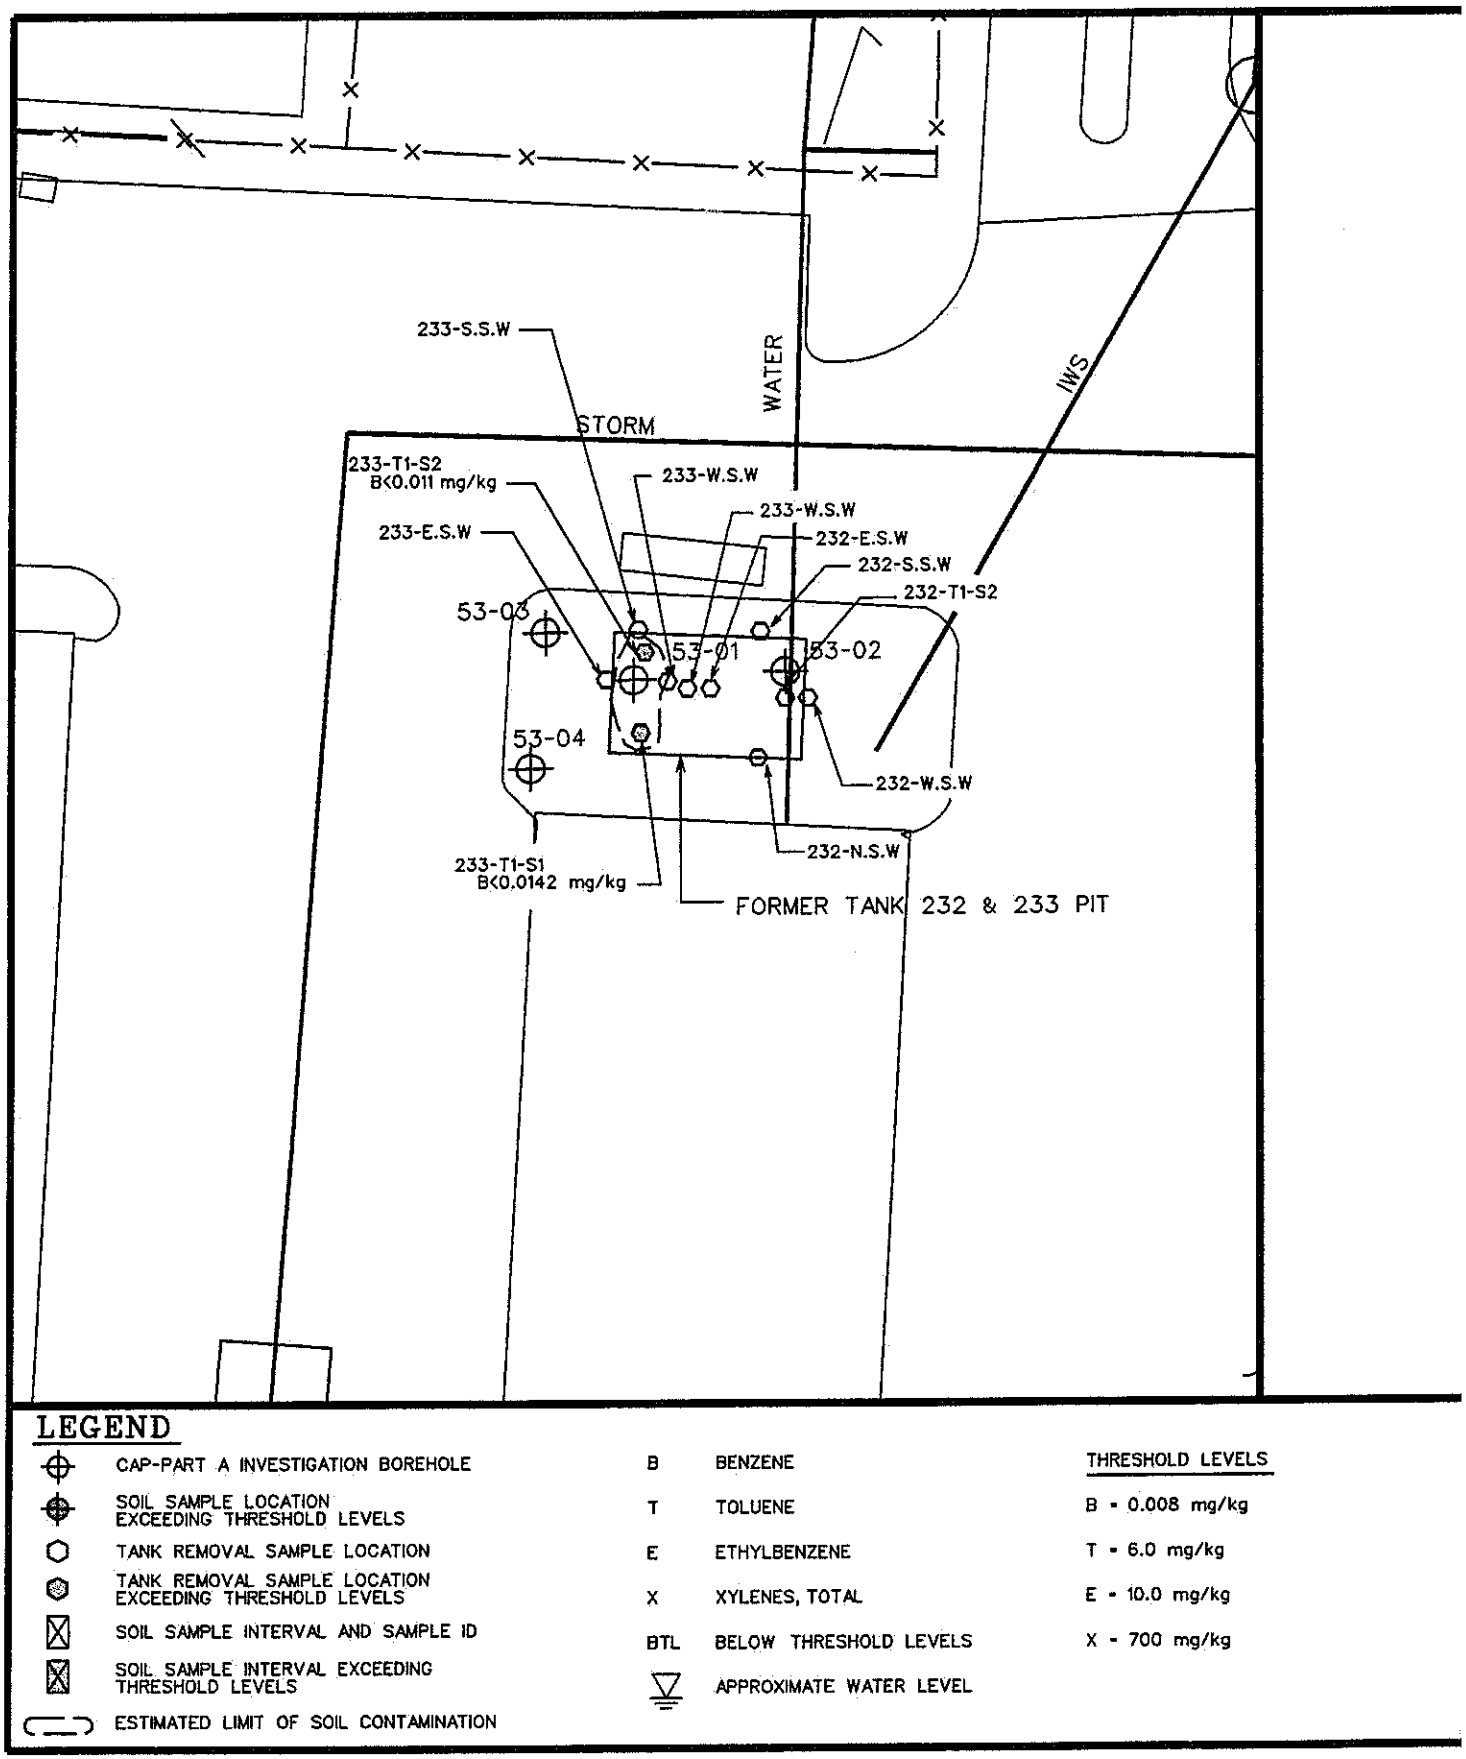
Figure II-3. Site Map of Soil Sampli
for the Facility ID #9-08

Soil analytical data from the tank removal sampling indicated that the soil from the tank pit was contaminated with benzene at concentrations exceeding the applicable soil threshold levels. The soil contamination observed during the CAP-Part A investigation was fully delineated and is limited to an area in the immediate vicinity of the tank pit. No soil contamination above soil threshold levels was found during the CAP-Part A investigation in the soil borings around the perimeter of the tank pit.

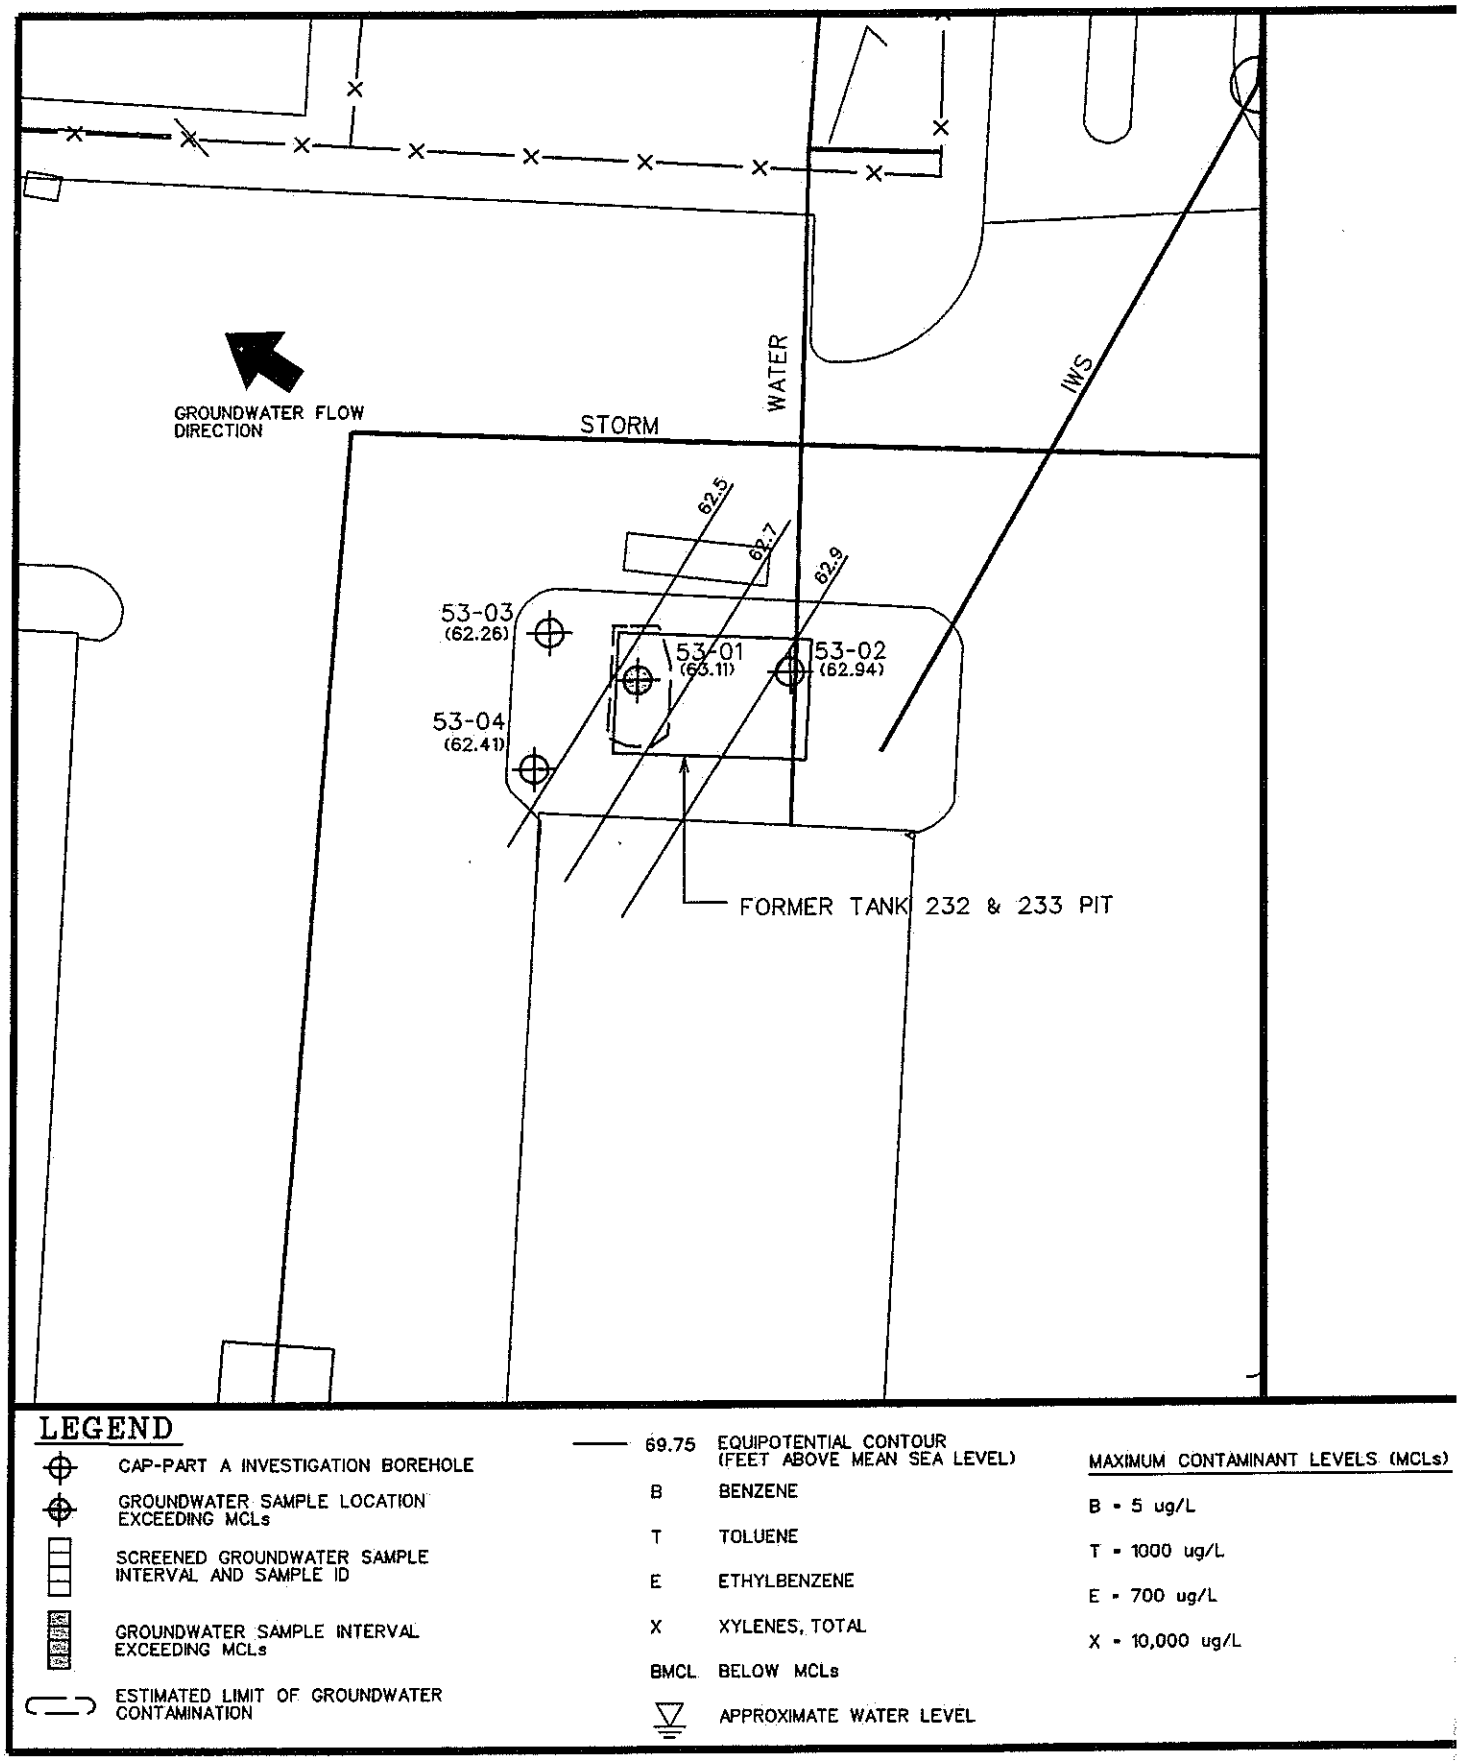
Figure II-4. Site Map of Groundwater Sam
for the Facility ID #9-089

Groundwater analytical data from the initial site characterization of the CAP-Part A investigation indicate that benzene contamination in groundwater exceeds its respective MCLs. However, this contamination was fully delineated and is limited to an area in the immediate vicinity of the tank pit. No groundwater contamination was found in the boreholes around the perimeter of the tank pit.

Analytical results for soil and groundwater samples collected during the site investigation at the site are sufficient to define the nature and extent of petroleum-related contamination at the site. Based on these findings, further investigation of the USTs 232 and 233 site, Facility ID #9-089061, is not required. The rationale for this recommendation is presented in Section III, Site Investigation Plan.
