# 2021 PCB TMDL ACTION PLAN

### U.S. ARMY GARRISON FORT BELVOIR, VIRGINIA

7217 Lockport Place, Suite 201  
Lorton, VA  
January 2018, March 2020, May 2021

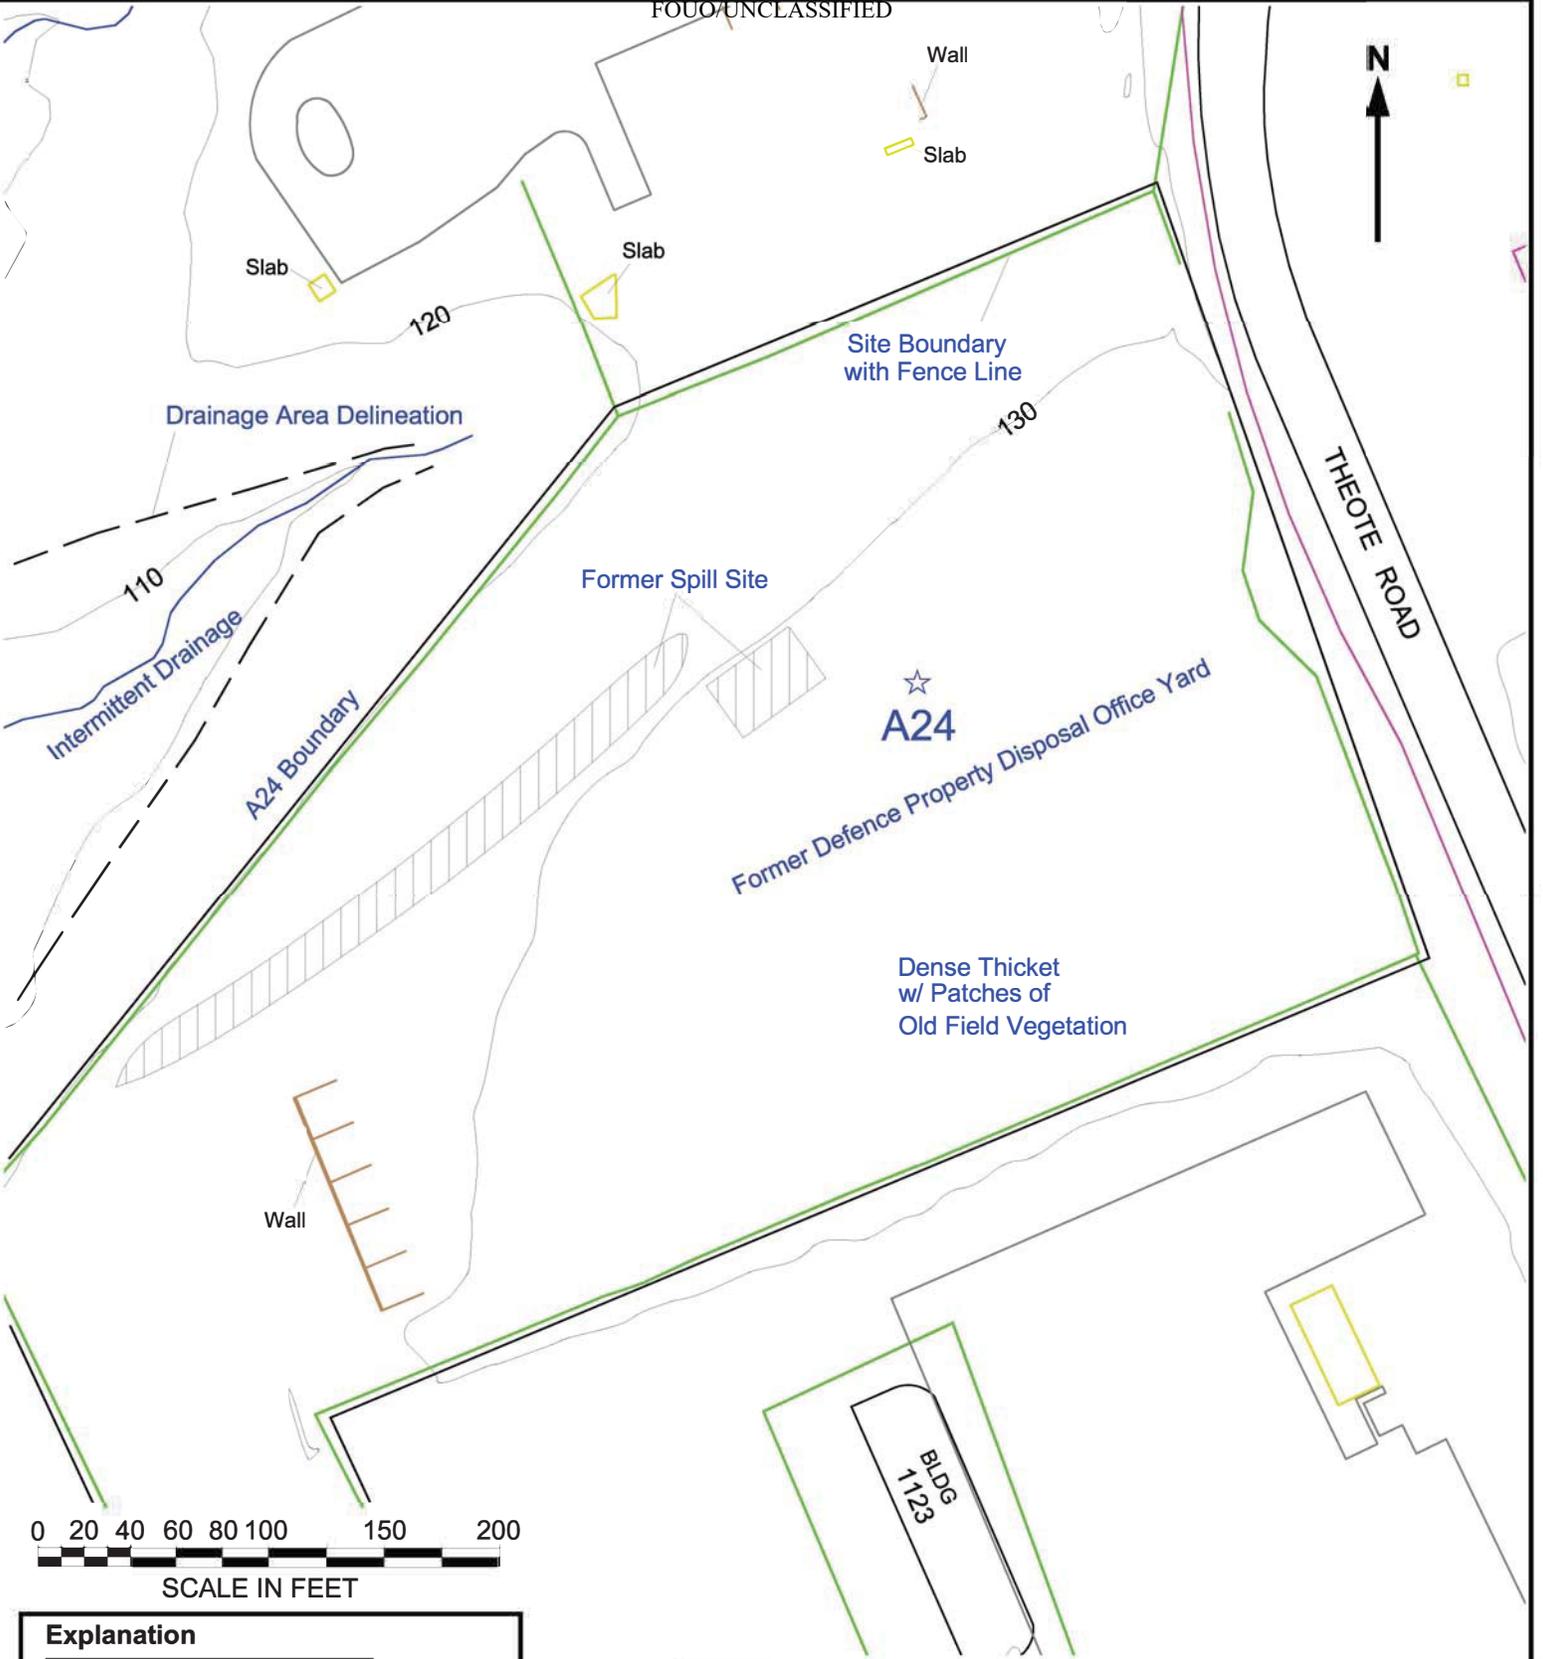
**Site Layout and Proposed Sample Locations for Site A-24**

Explanation	
☆	Site Location
—	Boundary of A24
- - -	Drainage Area Delineation
120	Contour Elevation in ft
1123	Building and Number
—	Road
—	Sidewalk
—	Fence
—	Stream

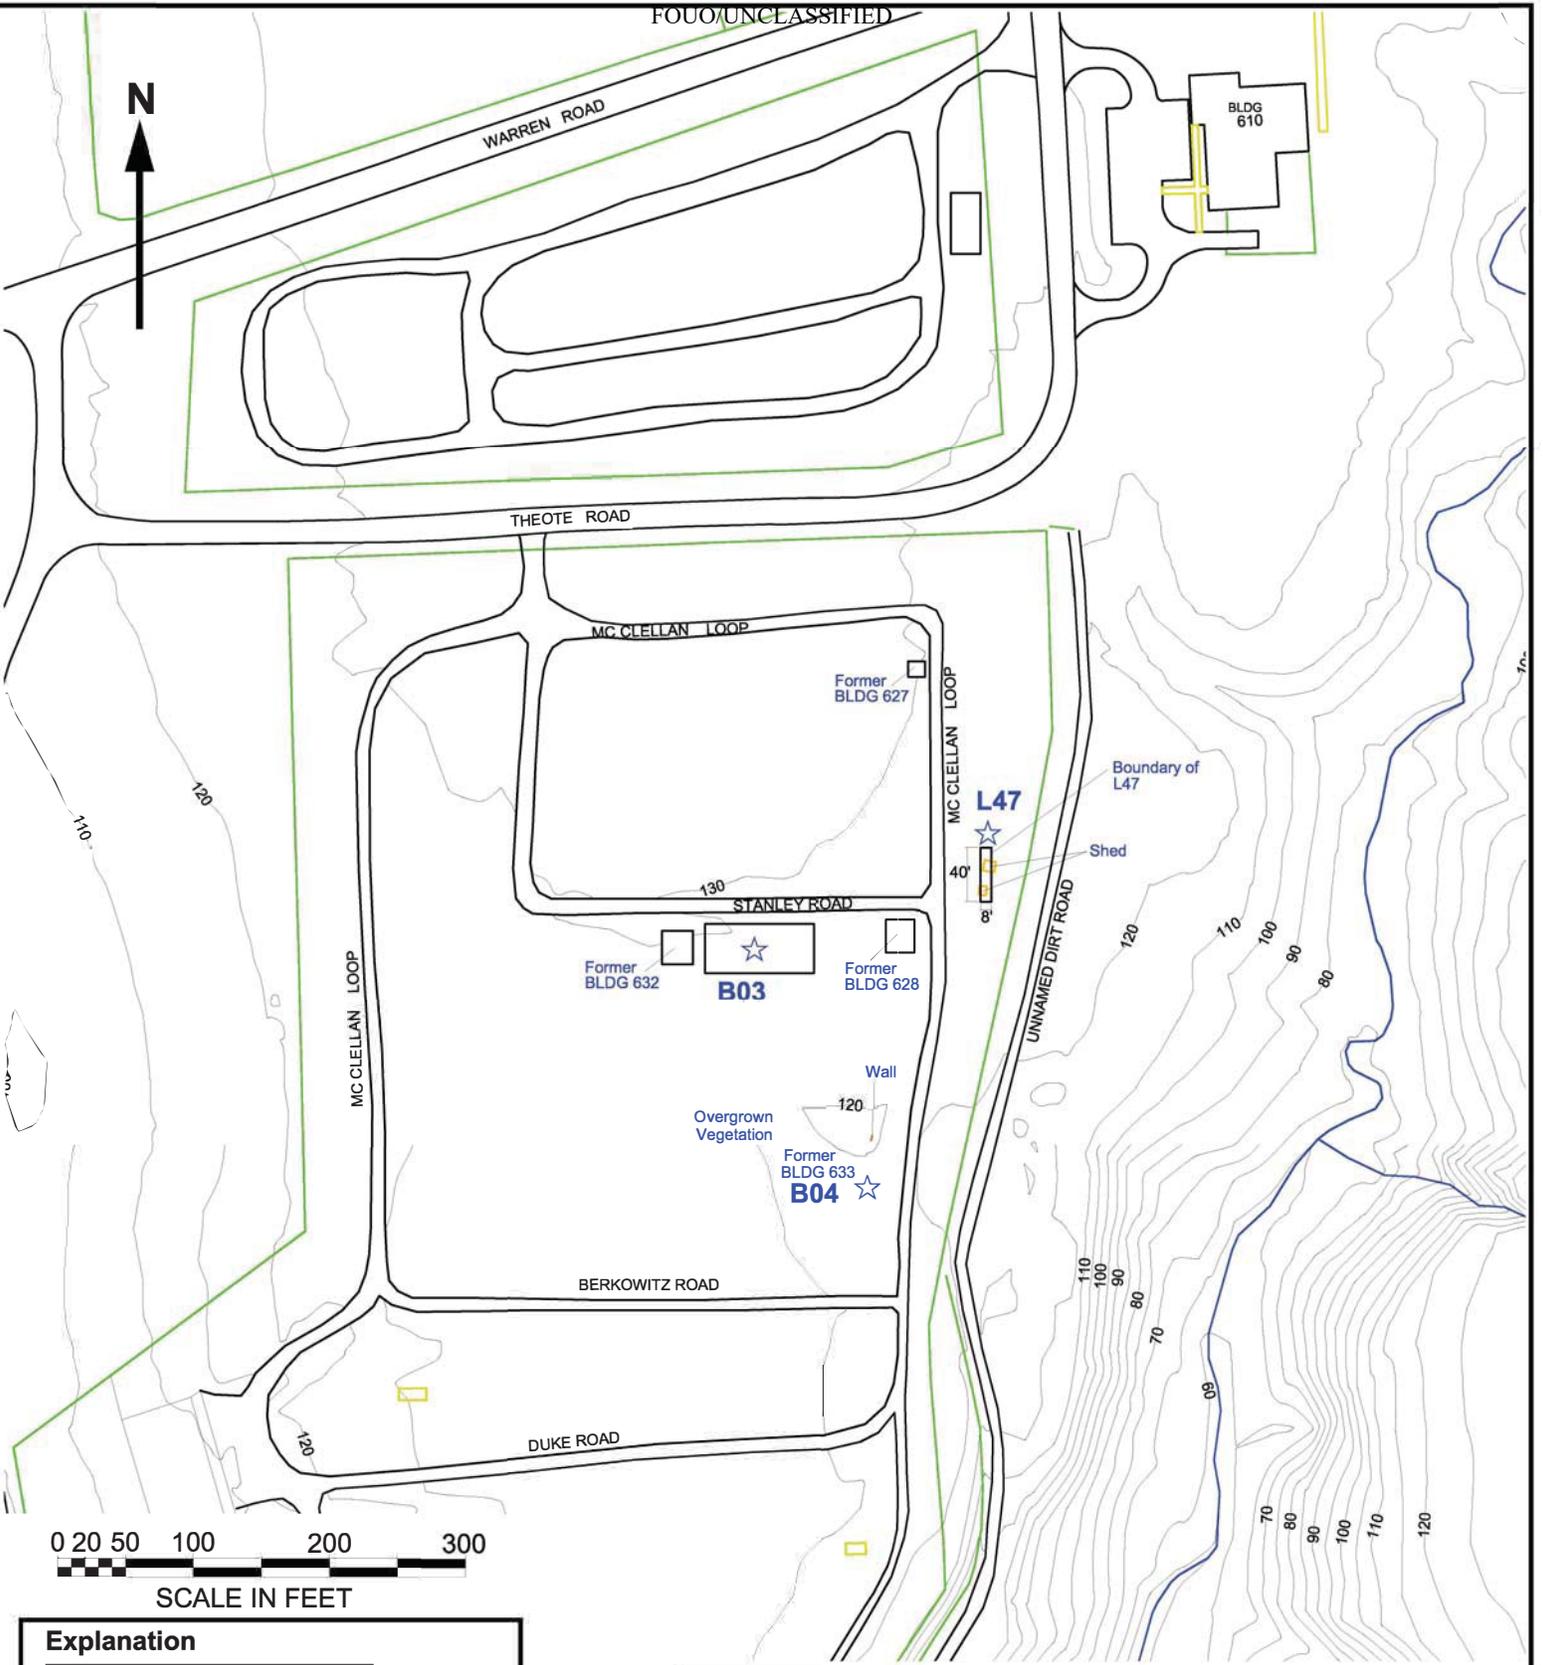
DATE	1/17/2013
DRAWN	HS
APPROVED	WSY
FOUO/UNCLASSIFIED	
PROJECT: 4008-002	DRAWING: Fig5_B03_B04_L47_Map.dwg

Explanation	
	Site Location
	Boundaries of B03, B04, L47
	Drainage Area Delineation
	Contour Elevation in ft
	Building and Number
	Road
	Slab
	Fence
	Stream

Site L47 was a concrete pad that was used to store transformers until they could be tested for PCBs and then disposed of properly or moved to another storage area as shown in Figure 5. The pad was approximately 40 ft by 8 ft and transformers were noted as being stored on wooden pallets over bare ground to the south of the pad (CH2M Hill, 1992). The pad was located outside and transformers were exposed to precipitation. However, there were no reportable releases. Even though stains on the pad were reported it is unknown whether the staining liquid contained PCBs since the transformers at the site were being held for PCB testing. The pad has been removed and the site is now wooded with tall grass, medium brush, and young and mature trees. The location of the former concrete pad is shown in Figure 5. This location is on the top of a hill and drains to stormwater swales, to an unnamed tributary that drains to Gunston Cove. Since PCBs are carried primarily by sediment, the thickly wooded nature of the site would reduce the probability for potentially contaminated sediments to travel.

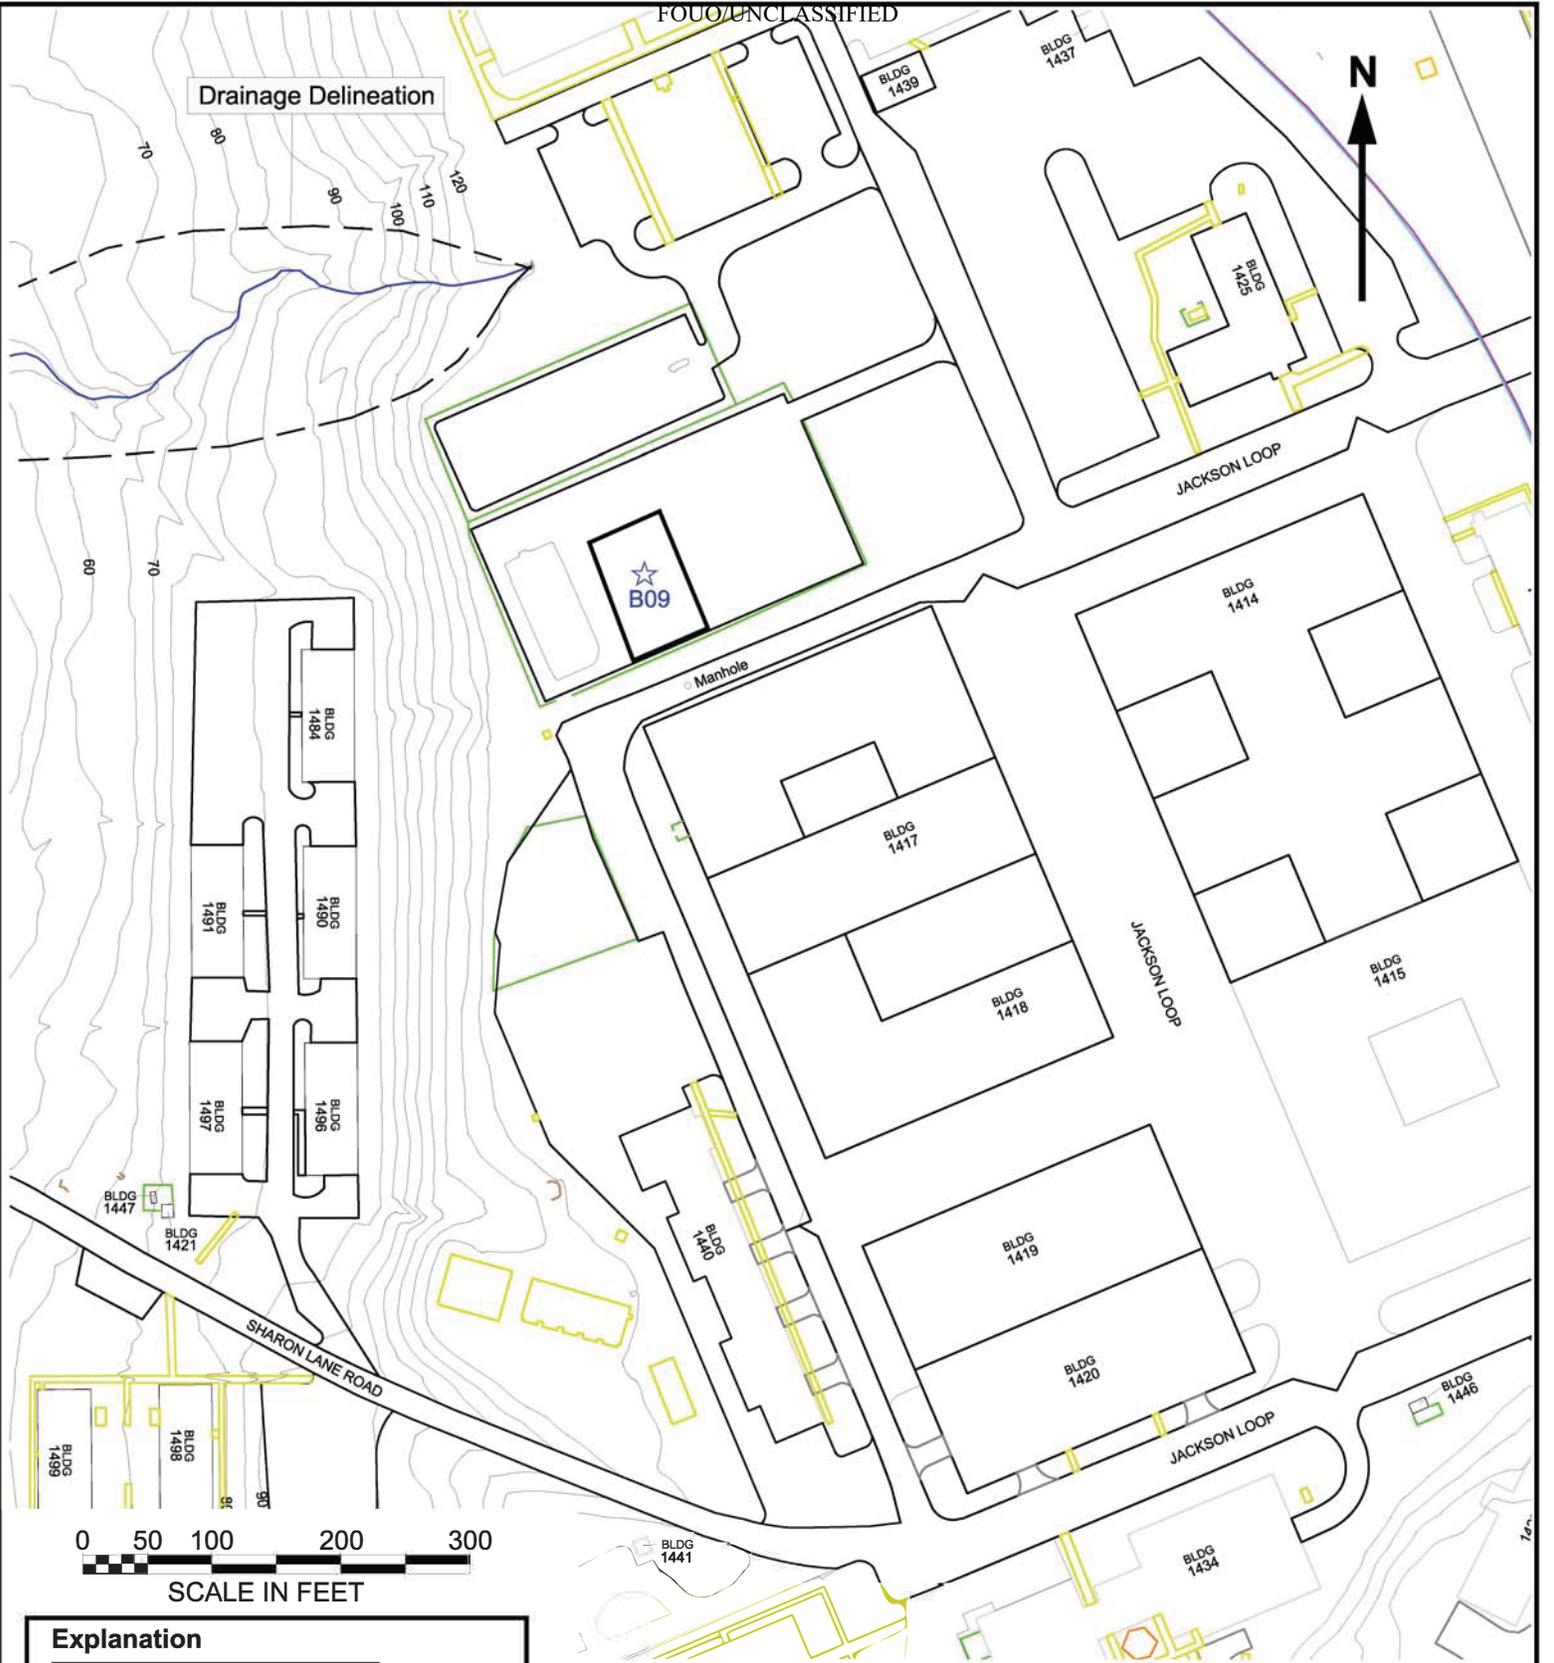
DATE 1/18/2013		
DRAWN HS		
APPROVED WSY	<b>Site Detailed Location Map B09 (Former Bldg. 1430) Fort Belvoir, VA</b>	
FOUO/UNCLASSIFIED		
PROJECT: 4008-002	DRAWING: Fig6_B09_Map.dwg	REV 1.0
SCALE GRAPHIC	SHEET 1/1

Explanation	
	Site Location
	Drainage Area Delineation
	Manhole
	Contour Elevation in ft
	Building Number
	Road
	Sidewalk
	Fence
	Stream

B09 was a former transformer storage area located at Building 1430 as shown in Figure 6. Transformers were stored both indoors and outdoors at this site. Building 1430 no longer exists and the area where the building once stood is now used as a storage area for trailers and large generators. Soil samples and wipe samples were collected in 1997 in accordance with the SWMU corrective action closure plan. The data summary is in Table A-6, Appendix A. All results were non-detect for PCBs, leading to the conclusion that the site had not been impacted and should be recommended for closure (Fort Belvoir DPW ENRD, 2012). Figure 6 shows the location of B09.

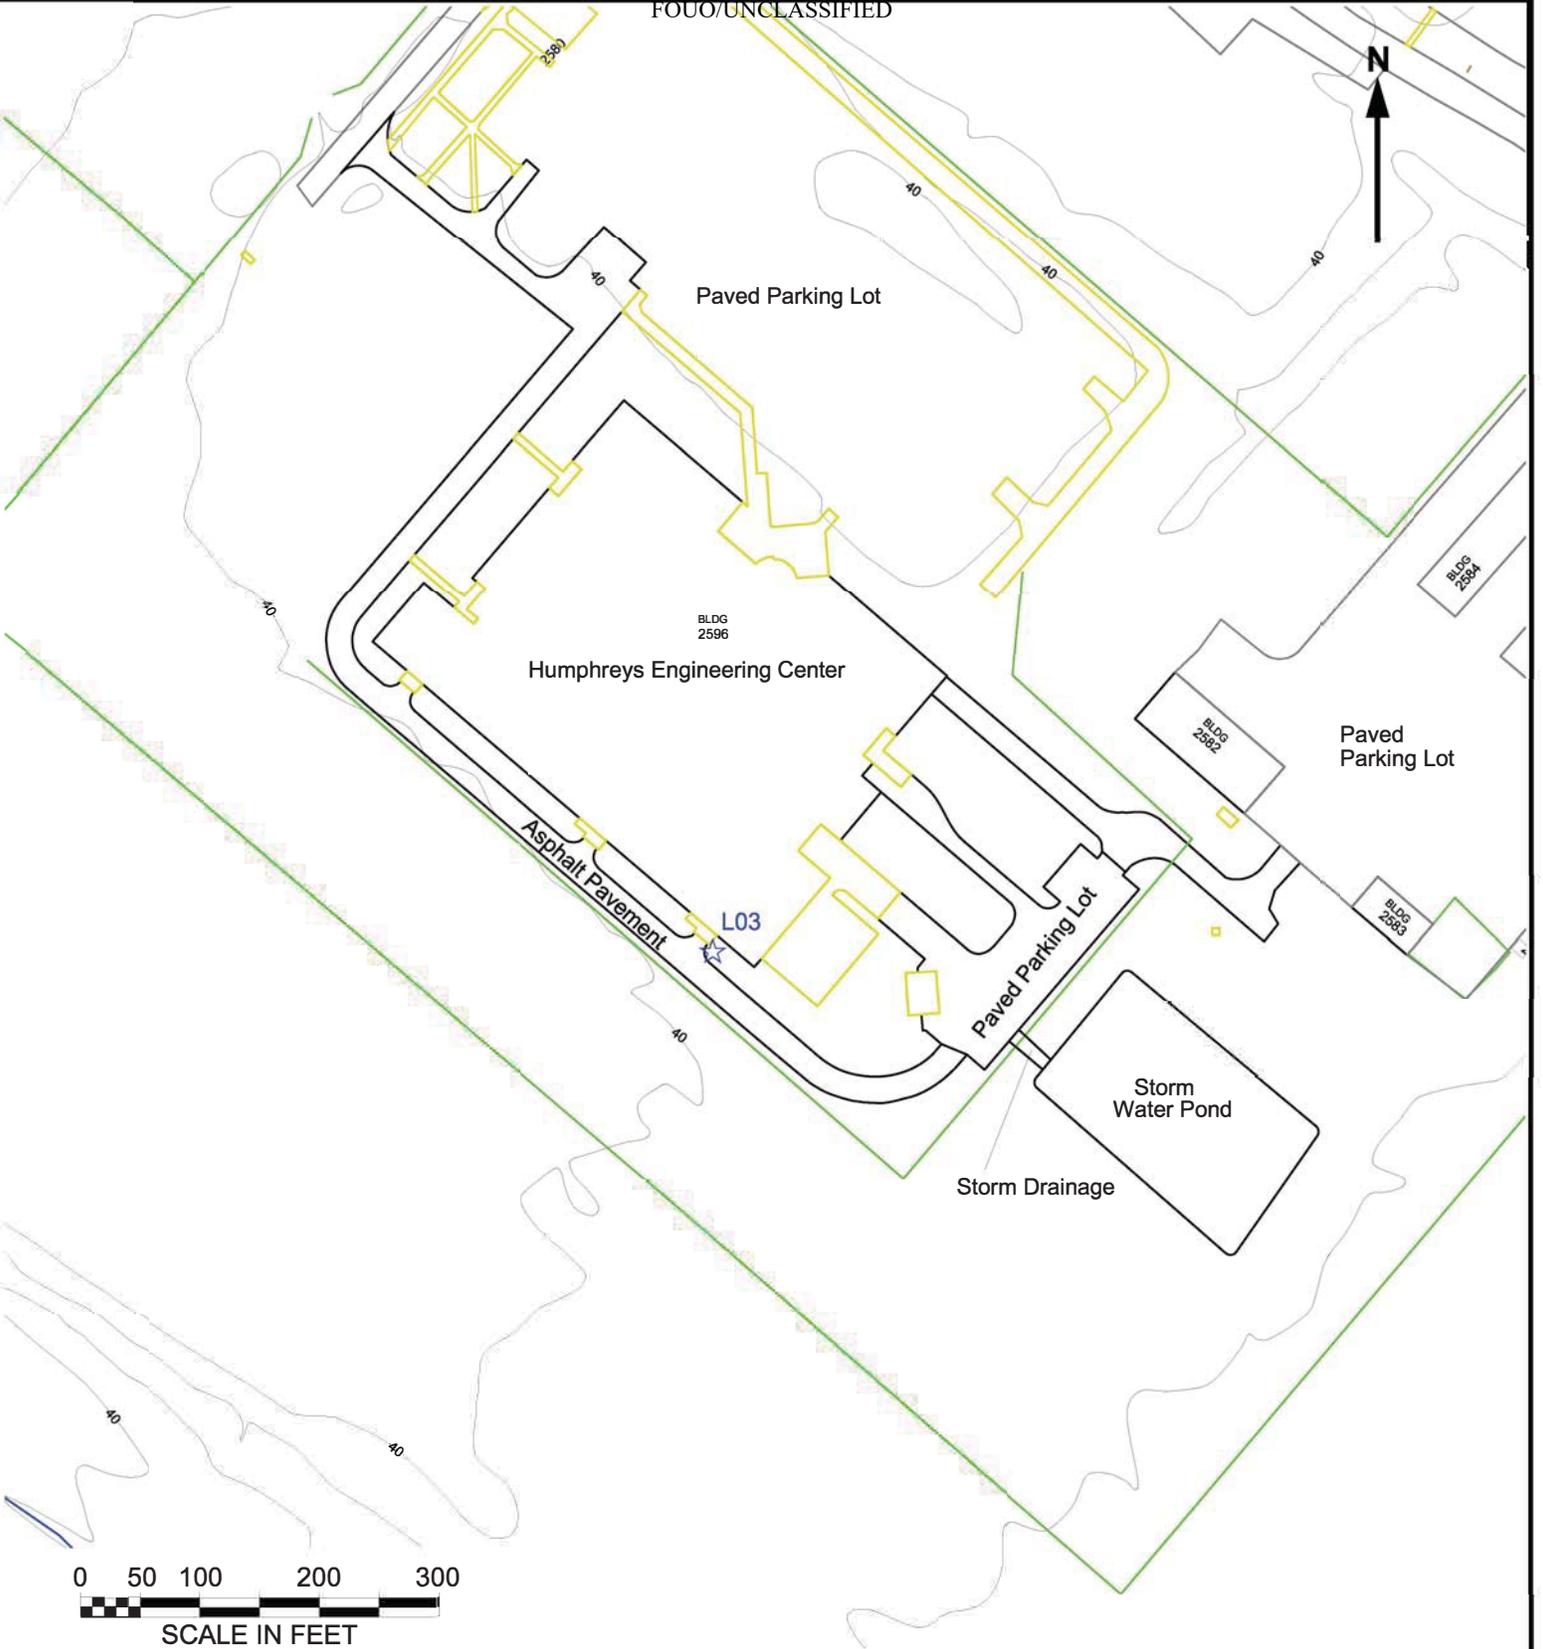
DATE 1/18/2013		
DRAWN HS		
APPROVED WSY	<b>Site Detailed Location Map L03 (Paved Asphalt Parking Lot at Bldg. 2596) Fort Belvoir, VA</b>	
FOUO/UNCLASSIFIED		
PROJECT: 4008-002	DRAWING: Fig8_L03_Map.dwg	REV 1.0
	SCALE GRAPHIC	SHEET 1/1

Explanation	
	Site Location
	Drainage Area Delineation
	Contour Elevation in ft
	Building and Number
	Road
	Sidewalk
	Fence

L03 was not considered as an official PCB storage area. In 1988, transformers were reported as being located at the site and the presence of fluid staining the asphalt was noted (Kearney, 1988). However, no known sampling occurred at the site and there is no documentation of PCB contamination at the site as presented in Figure 8.

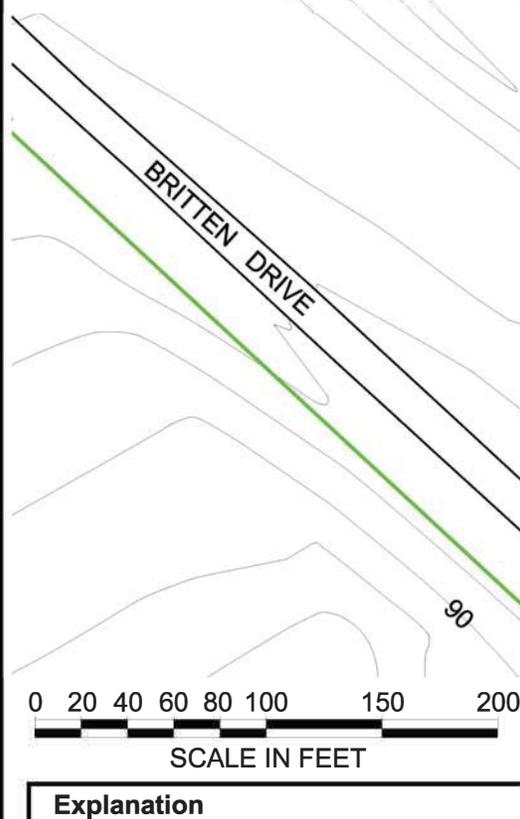
DATE 1/18/2013		
DRAWN HS		
APPROVED WSY	<b>Site Detailed Location Map L04</b> <b>(Hangar 3126 at Davison Army Air Field)</b> <b>Fort Belvoir, VA</b>	
FOUO/UNCLASSIFIED		
PROJECT: 4008-002	DRAWING: Fig9_L04_Map.dwg	REV 1.0
SCALE GRAPHIC	SHEET 1/1

Former PCB Spill Area,  
Currently Concrete Pad

Explanation	
	Site Location
	Drainage Area Delineation
	Future Building
	Contour Elevation in ft
	Building Number
	Road
	Sidewalk
	Fence
	Stream

L04 was an outdoor concrete pad that housed active transformers as shown in Figure 9. Leaking fluid was visible in 1988 (Kearney, 1988) which would have been exposed to precipitation and potentially impacted an open water body. Soil samples collected in 1997 confirmed the absence of PCBs in soils at the site above laboratory detection limits (Fort Belvoir, 1998). The summary of the soil sample data collected is presented in Table A-9, Appendix A.

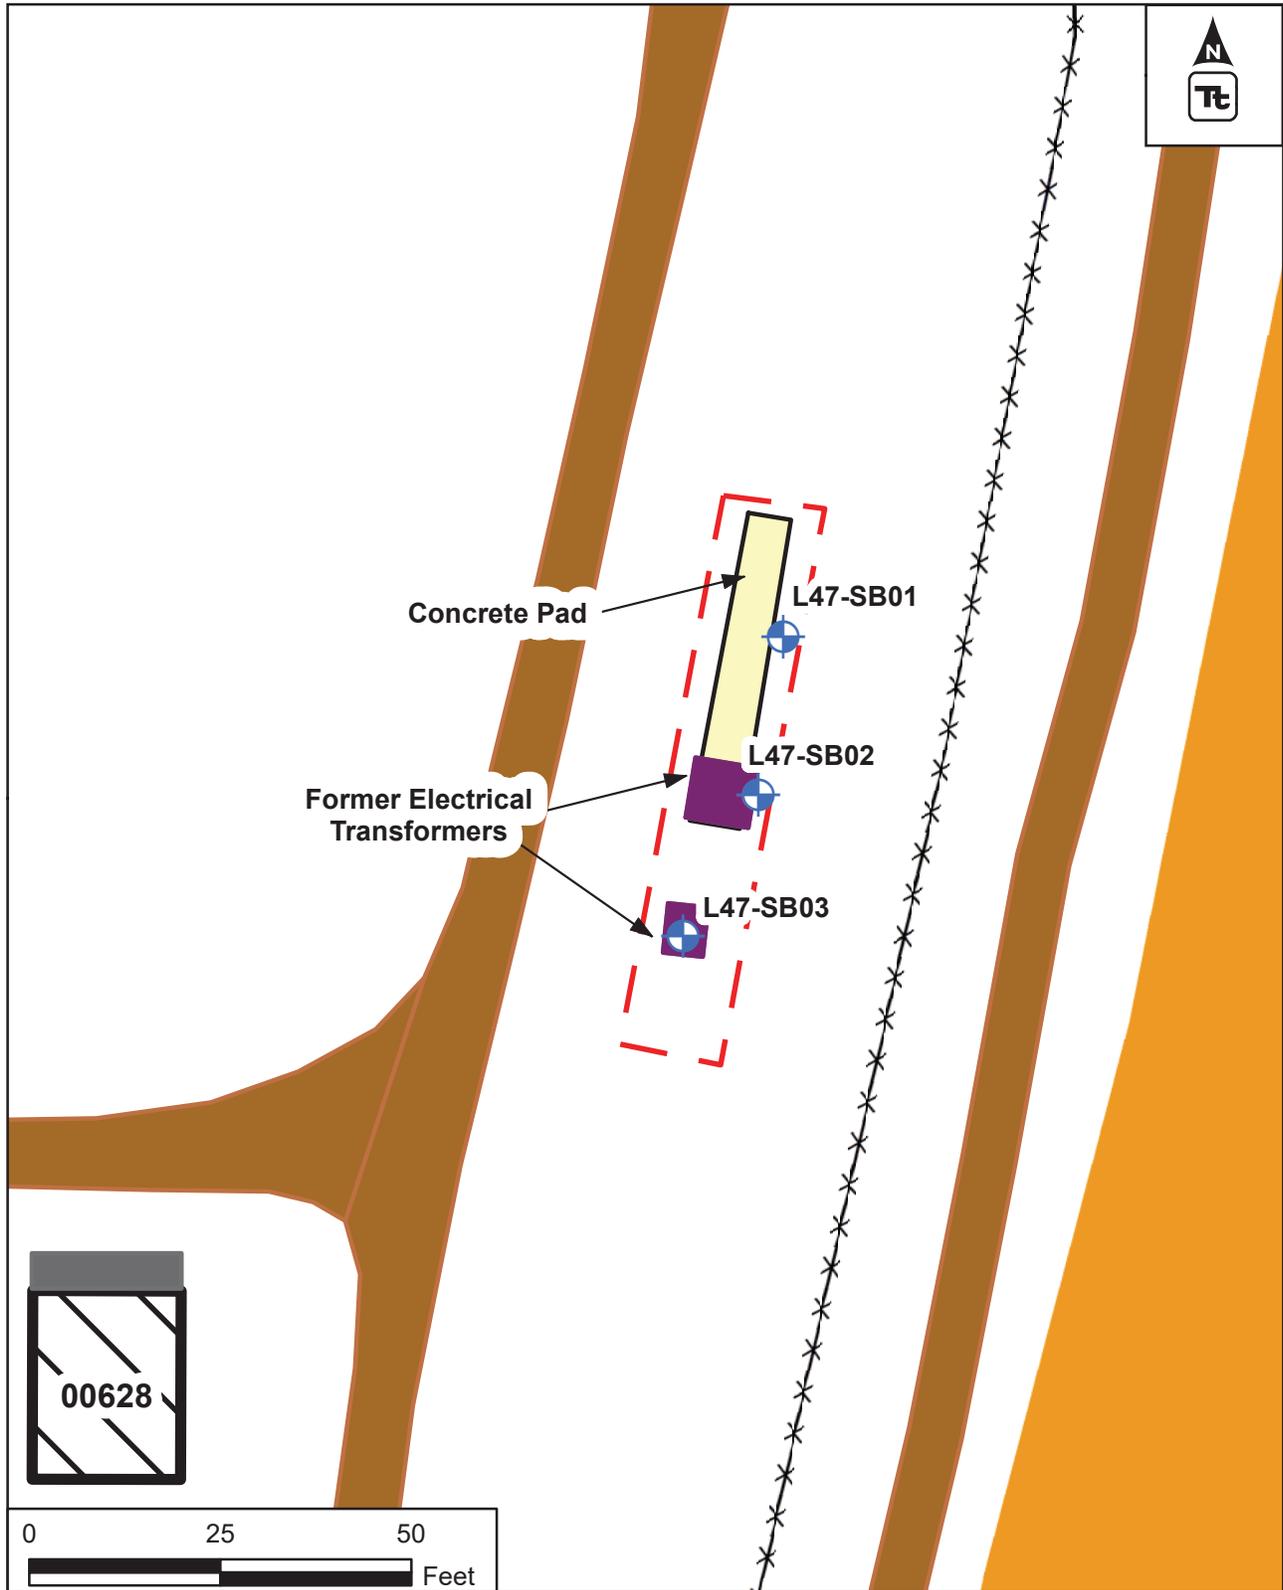
**LEGEND**

- Concrete Slabs
- Unpaved Road
- - - Approximate SWMU L-47 Limits
- ▨ Demolished Buildings
- SWMU L-47 Transformer Pad
- Former Electric Transformers
- SWMU A-28
- ⊕ Soil Boring Locations
- ×-× Fence

- (6) Six samples shall be collected from the soil surrounding the concrete pad at the locations shown in Figure 5. Each sample shall consist of one plug sample taken from the 6-inch to 12-inch interval below the ground surface.

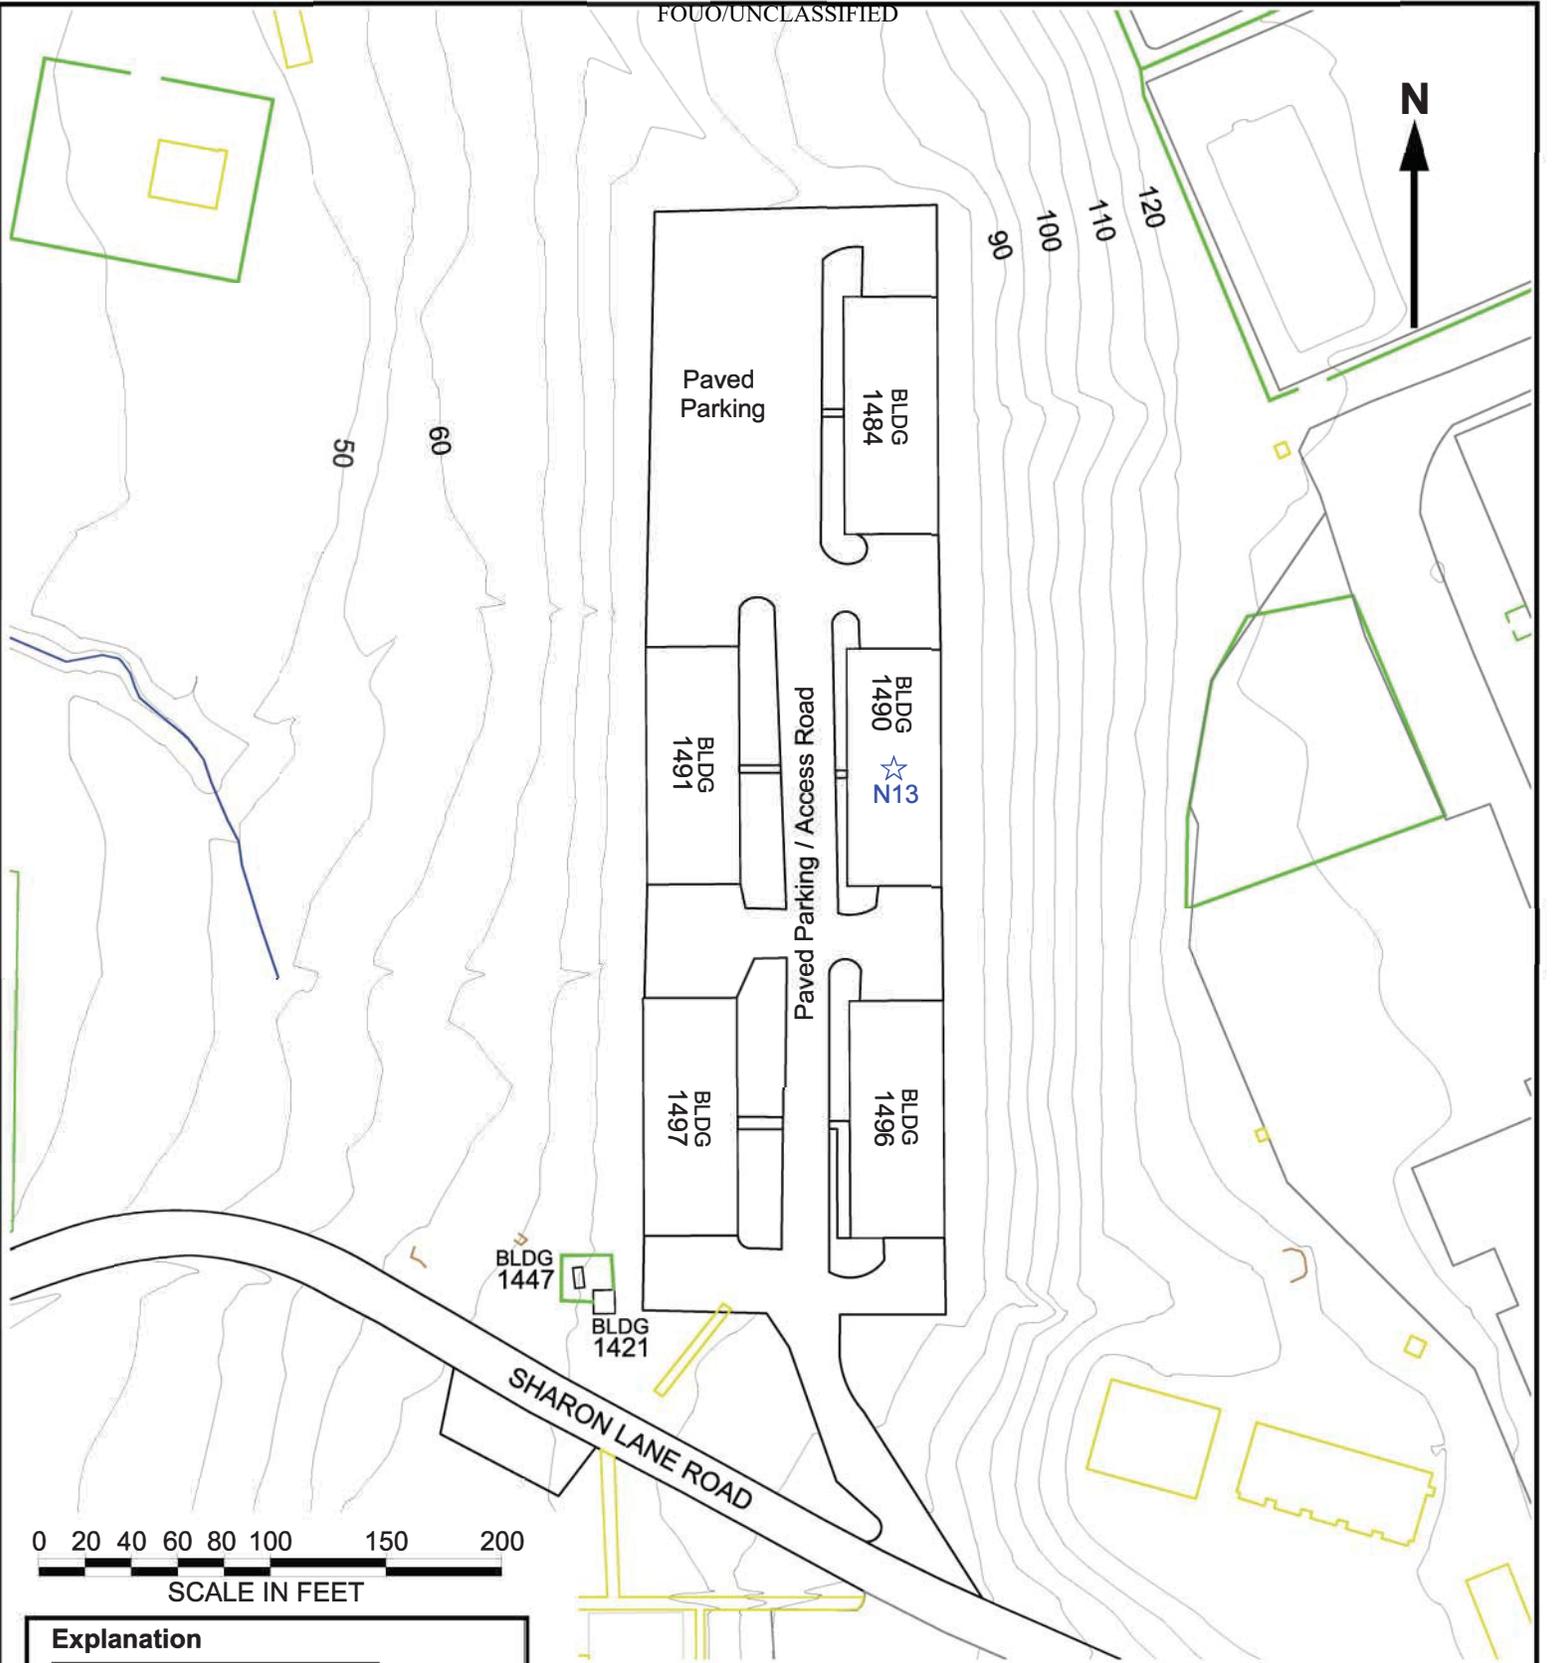
DATE 1/25/2013	
DRAWN HS	
APPROVED WSY	<b>Site Location Map N13</b> <b>(Hazardous Waste Storage Building)</b> <b>Fort Belvoir, VA</b>
FOUO/UNCLASSIFIED	
PROJECT: 4008-002	
DRAWING: Fig11_N13_Map.dwg	REV 1.0
SCALE GRAPHIC	SHEET 1/1

Explanation	
	Site Location
	Drainage Area Delineation
	Proposed Sample Location
	Contour Elevation in ft
	Building Number
	Road
	Sidewalk
	Fence
	Stream

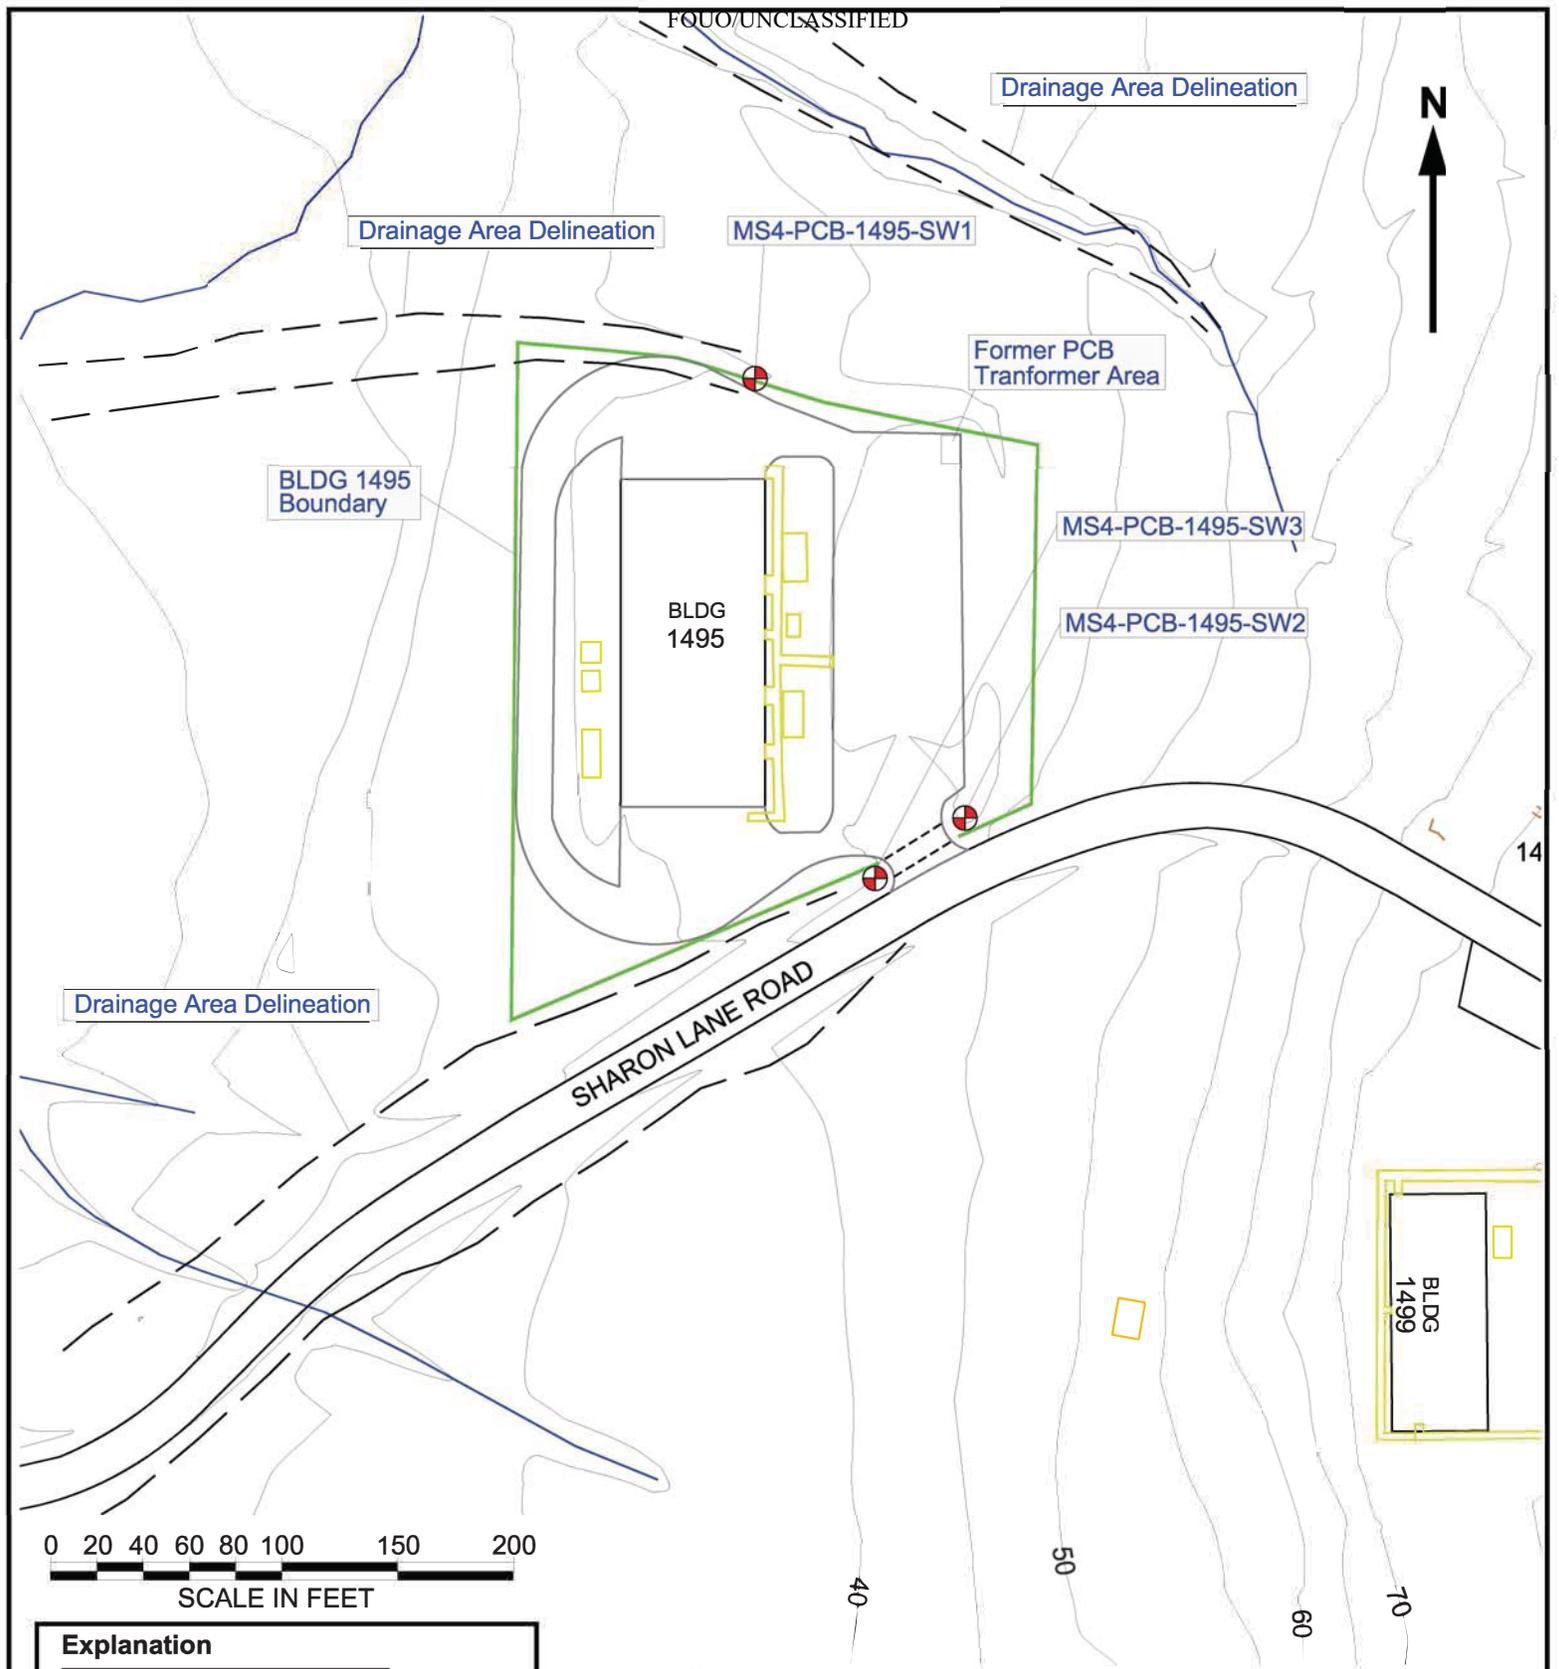
DATE 1/16/2013		
DRAWN HS		
APPROVED WSY	<b>Sampling Location at Bldg 1495 (Hazardous Waste Storage Building) Fort Belvoir, VA</b>	
FOUO/UNCLASSIFIED		
PROJECT: 4008-002	DRAWING: Fig10_1495_Map.dwg	REV 1.0
SCALE GRAPHIC	SHEET 1/1

Explanation	
	Culvert
	Drainage Area Delineation
	Proposed Sample Location
	Contour Elevation in ft
	Building and Number
	Road
	Sidewalk
	Fence
	Stream

The PCB site at Building 1495 consists of the northeast corner of the adjacent parking lot as presented in Figure 10. PCB containing transformers were stored in the area between 2010 and 2012 and were exposed to precipitation. In 2012, ENRD received reports of fluid leaking from the transformers. The transformers were relocated inside Hazardous Waste Disposal Building (Building 1495) and later properly removed and disposed of. Upon the relocation of the transformers to the building, Stains are visible on the asphalt at the site and absorbent and containment materials were placed around the affected areas. Sampling was conducted in April and August of 2012 and Aroclor 1260 was detected in 2 of the 4 soil and asphalt samples as presented in Table A-11, Appendix A.

Recommended Sampling Locations: Two stormwater sampling locations ~~were~~are recommended at the Building 1495 site. The first location (#1) is north of the affected asphalt area at the ~~beginning of the~~ concrete channel that runs along the northern border of the property. Location #1 is located outside of the fenced area. The second location (#2) is south of the affected asphalt area just before the entrance to the culvert running under the access driveway to the parking lot. A backup sampling location at the exit of the culvert ~~was also designated for location #32~~ since the culvert entrance is located behind the access fence and may result in access problem. The exit of the culvert is outside of the fenced area. The recommended sampling locations are shown on the ~~aerial view of the site below~~map below.
