**Fort Belvoir
Spill Prevention, Control,
and Countermeasure Plan**

Fort Belvoir
Directorate of Public Works
Environmental Division

Water Resources Division
Army Public Health Center
ATTN: MCHB-IP-ESW, Building E-1675
5158 Blackhawk Road
Aberdeen Proving Ground, MD 21010-5403

September 2017

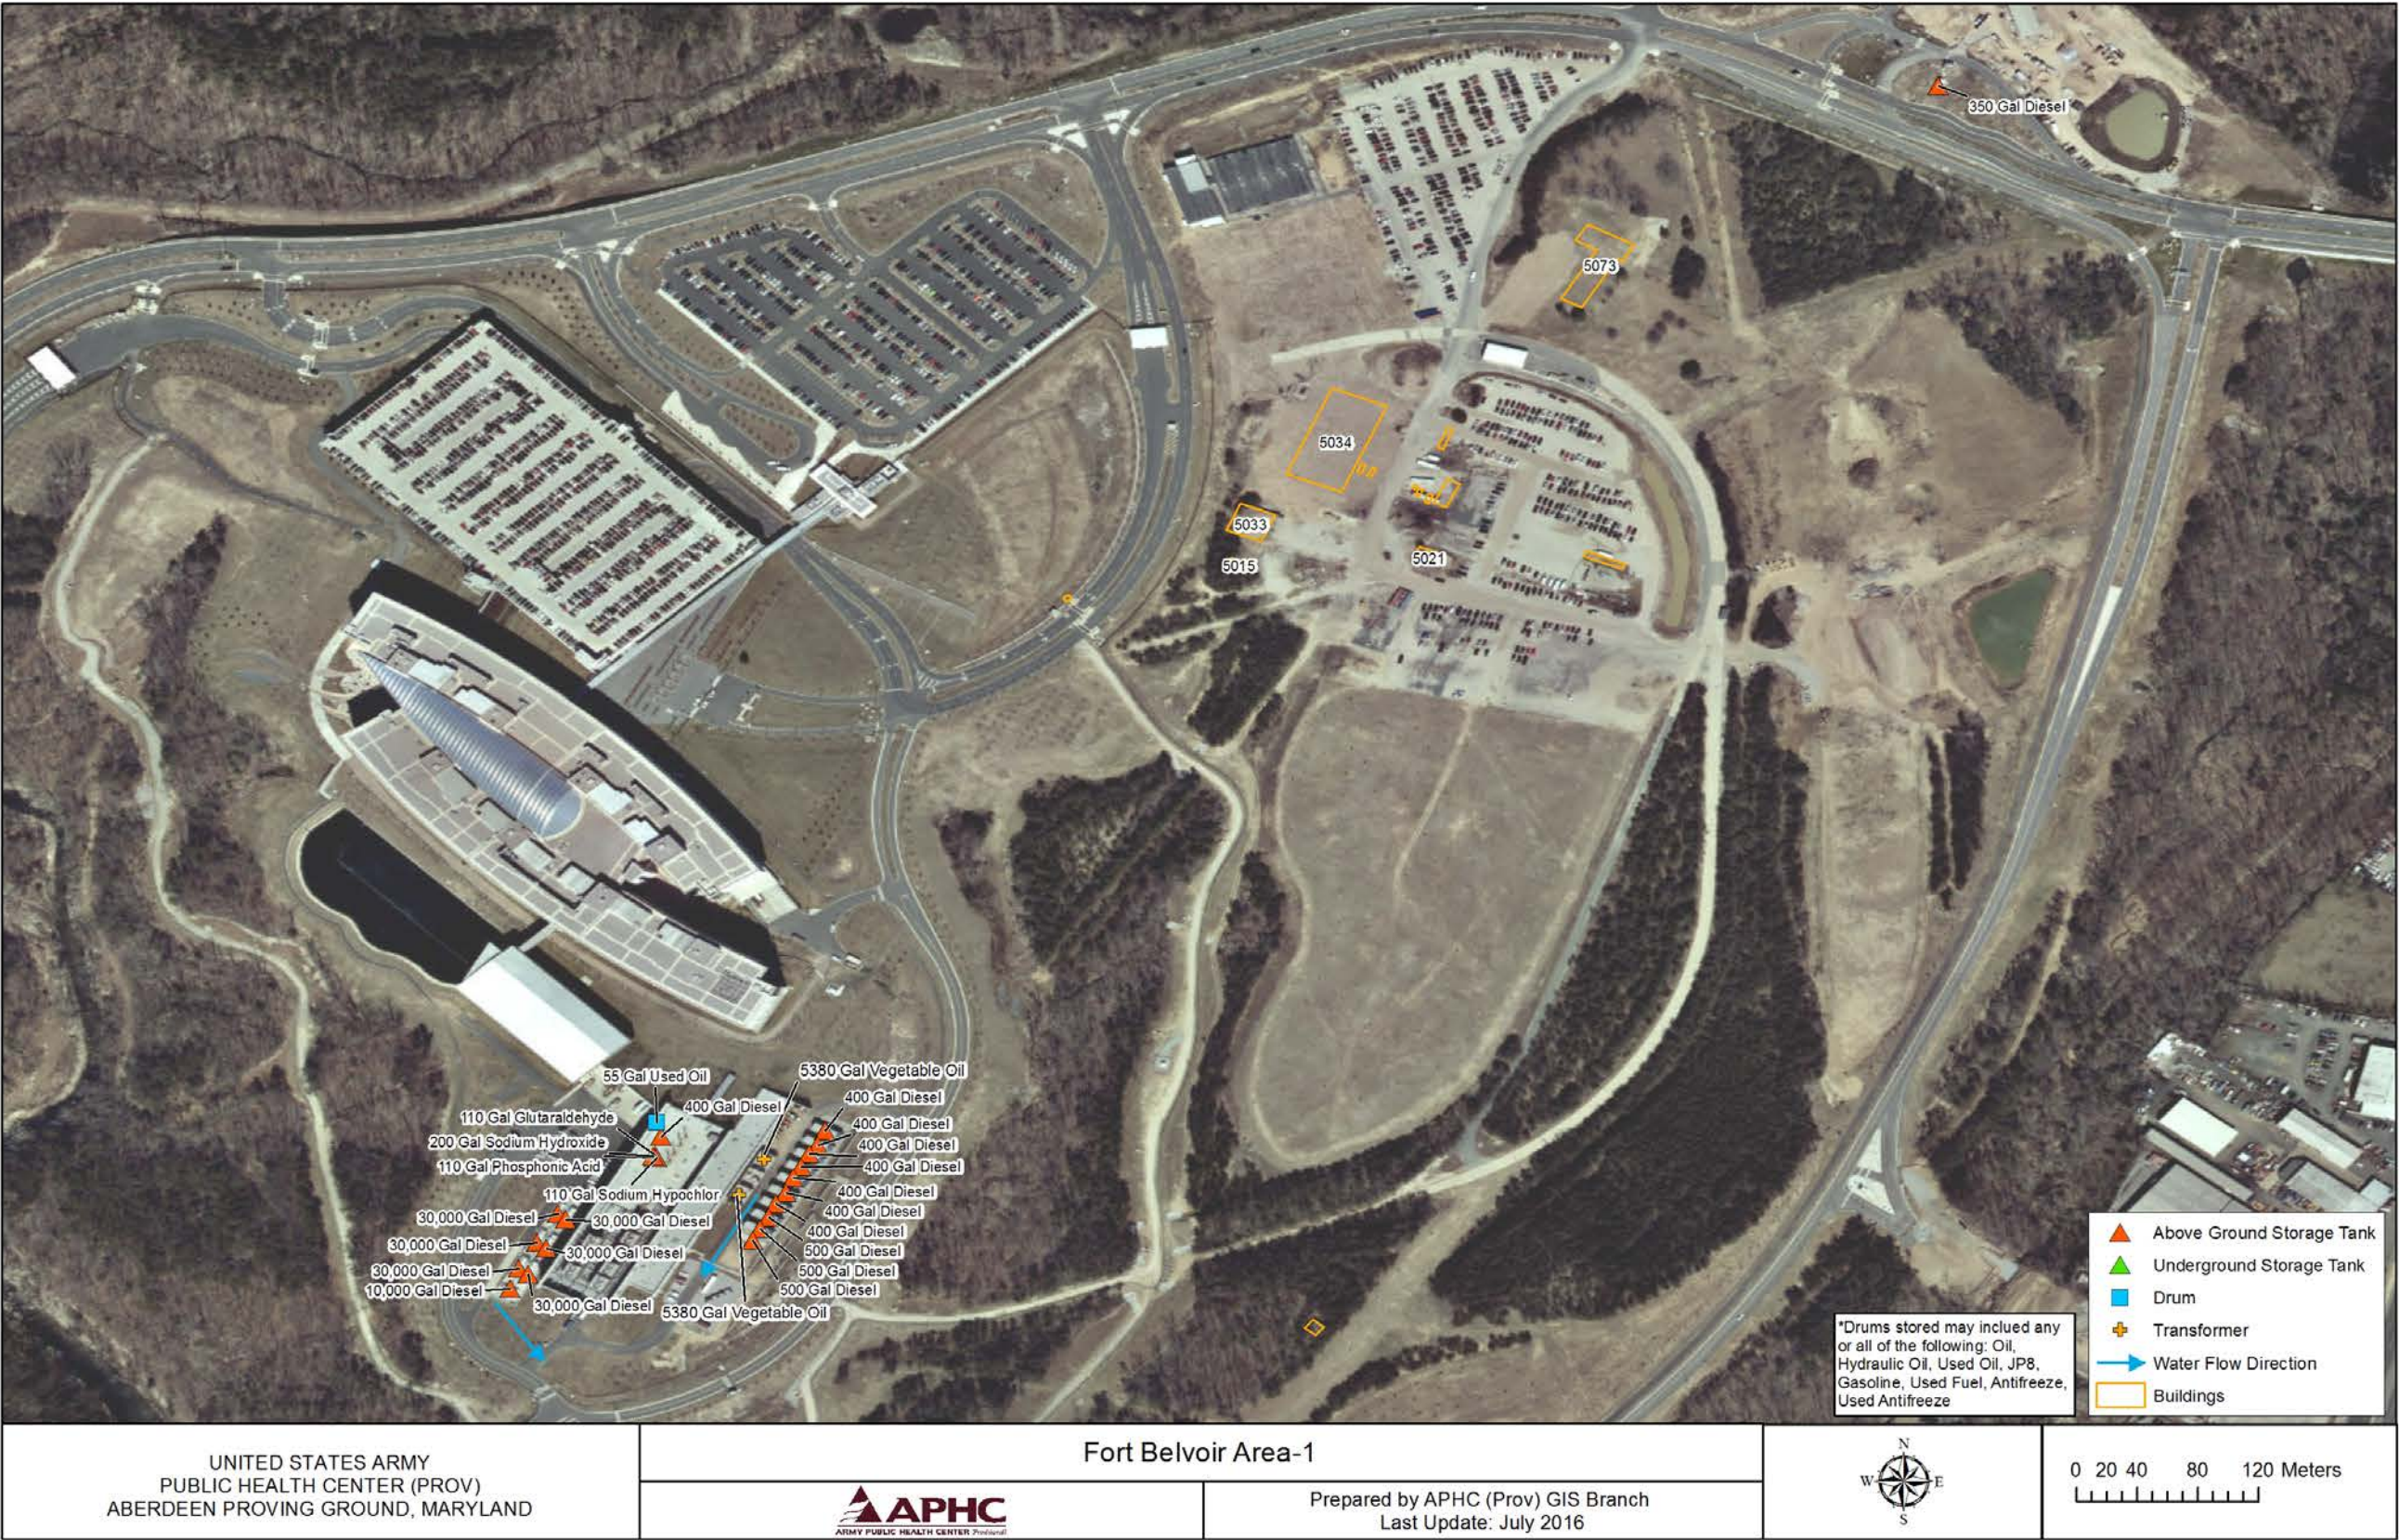
Figure 2.2 Fort Belvoir Containers and Drainage Map (Area 1)

USTs subject to all the technical requirements of 40 CFR 280 (see Appendix A, Table A-2) are exempt from all SPCC requirements. However, they must be shown on the Containers and Drainage Maps (Figures 2.2 to 2.7) and are listed in Table A-2 in Appendix A. There is one UST (2849D) listed in the Appendix that was installed but has never been used and will never be used. However, it was pre-registered as an UST. This tank could be removed from all listings and maps if the registration was nullified.

Spill reporting may include notifications to the National Response Center (NRC), the Virginia Department of Environmental Quality (DEQ), the Virginia Emergency Response Commission, and Installation Management Command (IMCOM). The US EPA does not distinguish between types of oil, and any spill that causes a sheen upon “navigable waters” or that violates applicable water quality standards must be reported to the NRC (40 CFR 110.6). DPW Environmental is responsible for all reporting to external agencies. For Fort Belvoir, this means that the NRC must be called if an oil spill reaches Accotink Creek/Bay, Dogue Creek/Bay, the Potomac River, any associated wetlands, or their tributaries as shown on Figures 2.1 and 2.2.

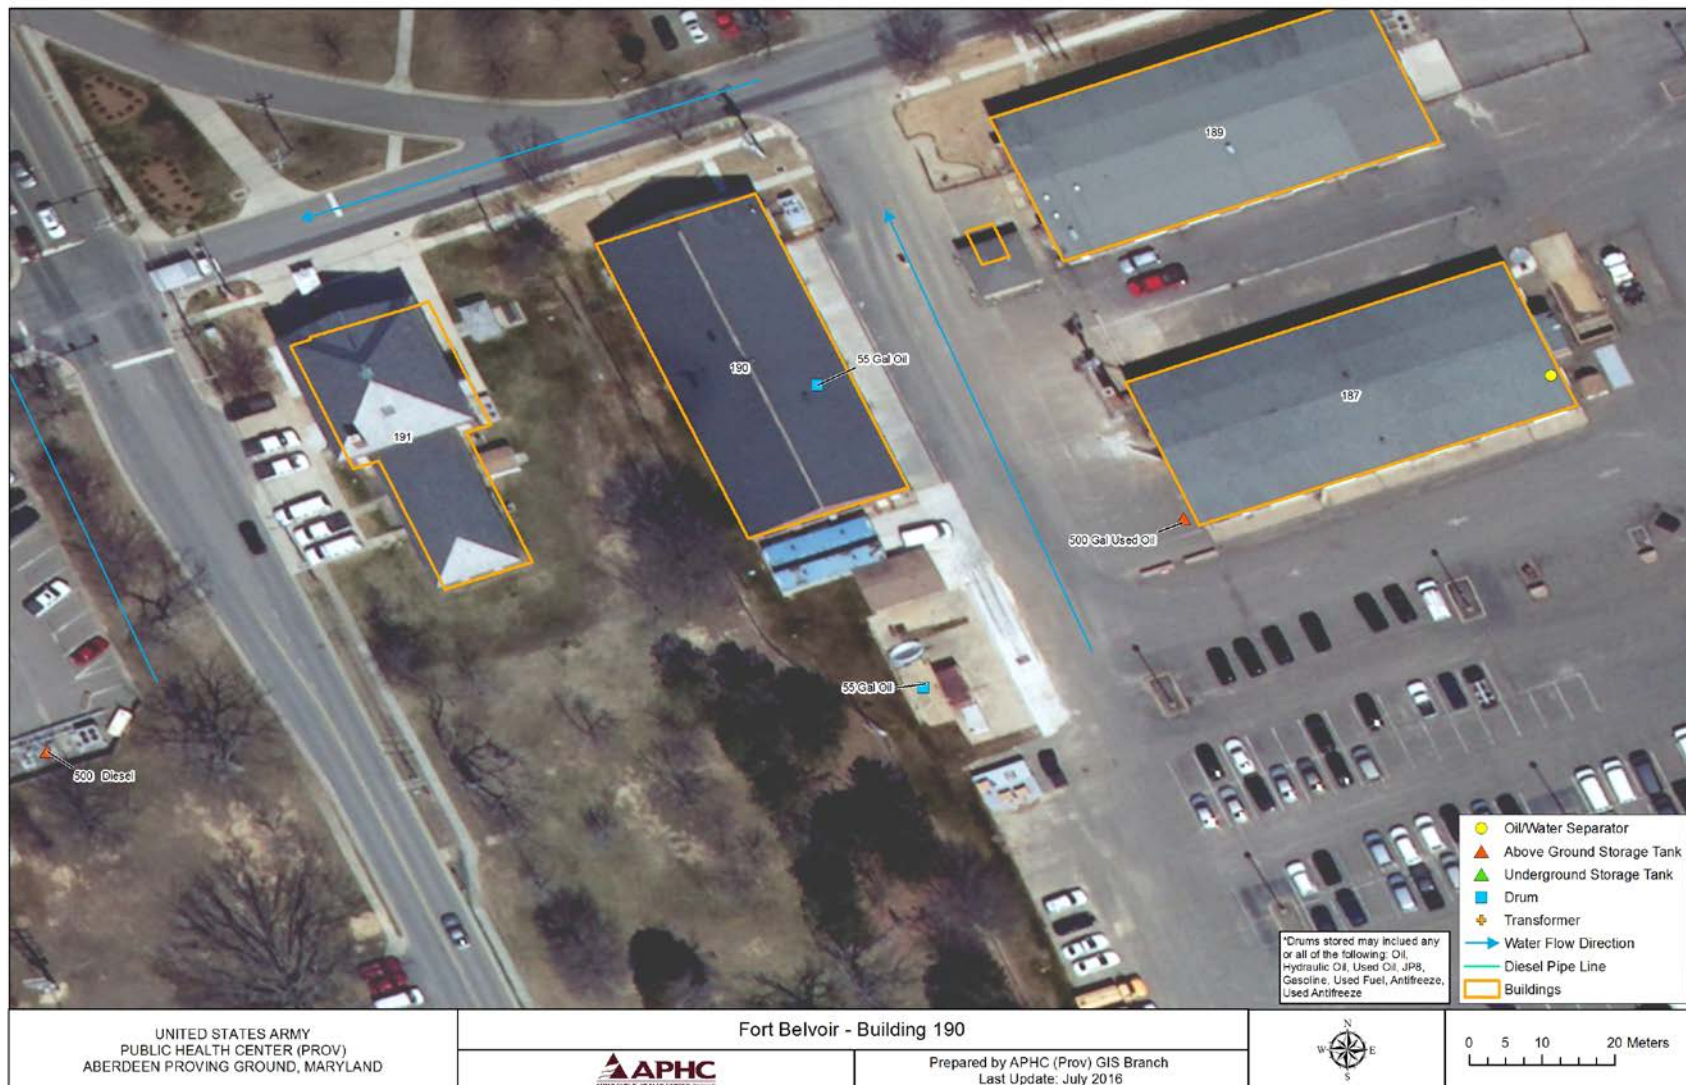
Figure 5.1.1 Transportation Motor Pool (Building 190)

The AST is a double-walled steel tank. The 190DRA drums inside the building are on containment pallets. The 190DRB drums outside the building are in roll top secondary containment pallets.

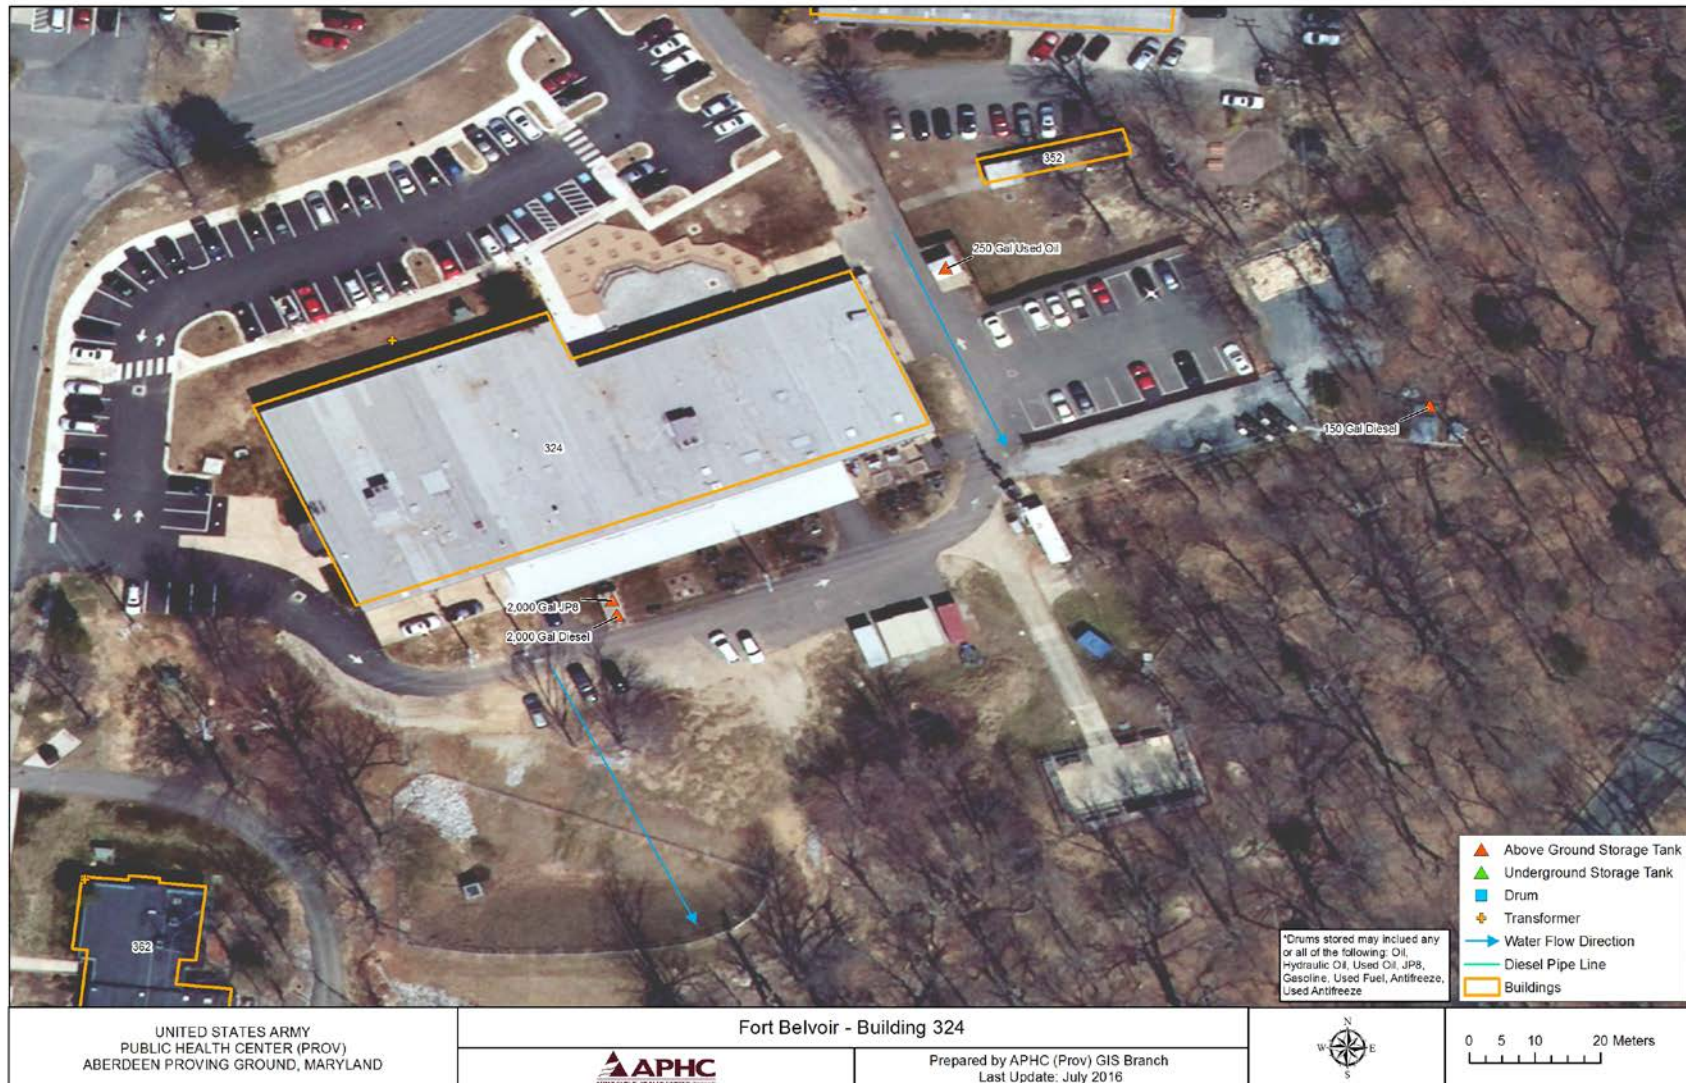
Figure 5.2.1 300-Area Fuel Point (Building 324)

The ASTs are double-walled, except for 324V. AST 324V has a steel dike but it is too small to contain the entire volume of the tank (See Section 6.0, Corrective Actions). Appendix D contains volume calculations for containers within diked areas. Personnel follow the rainwater release procedures found in Section 4.10.

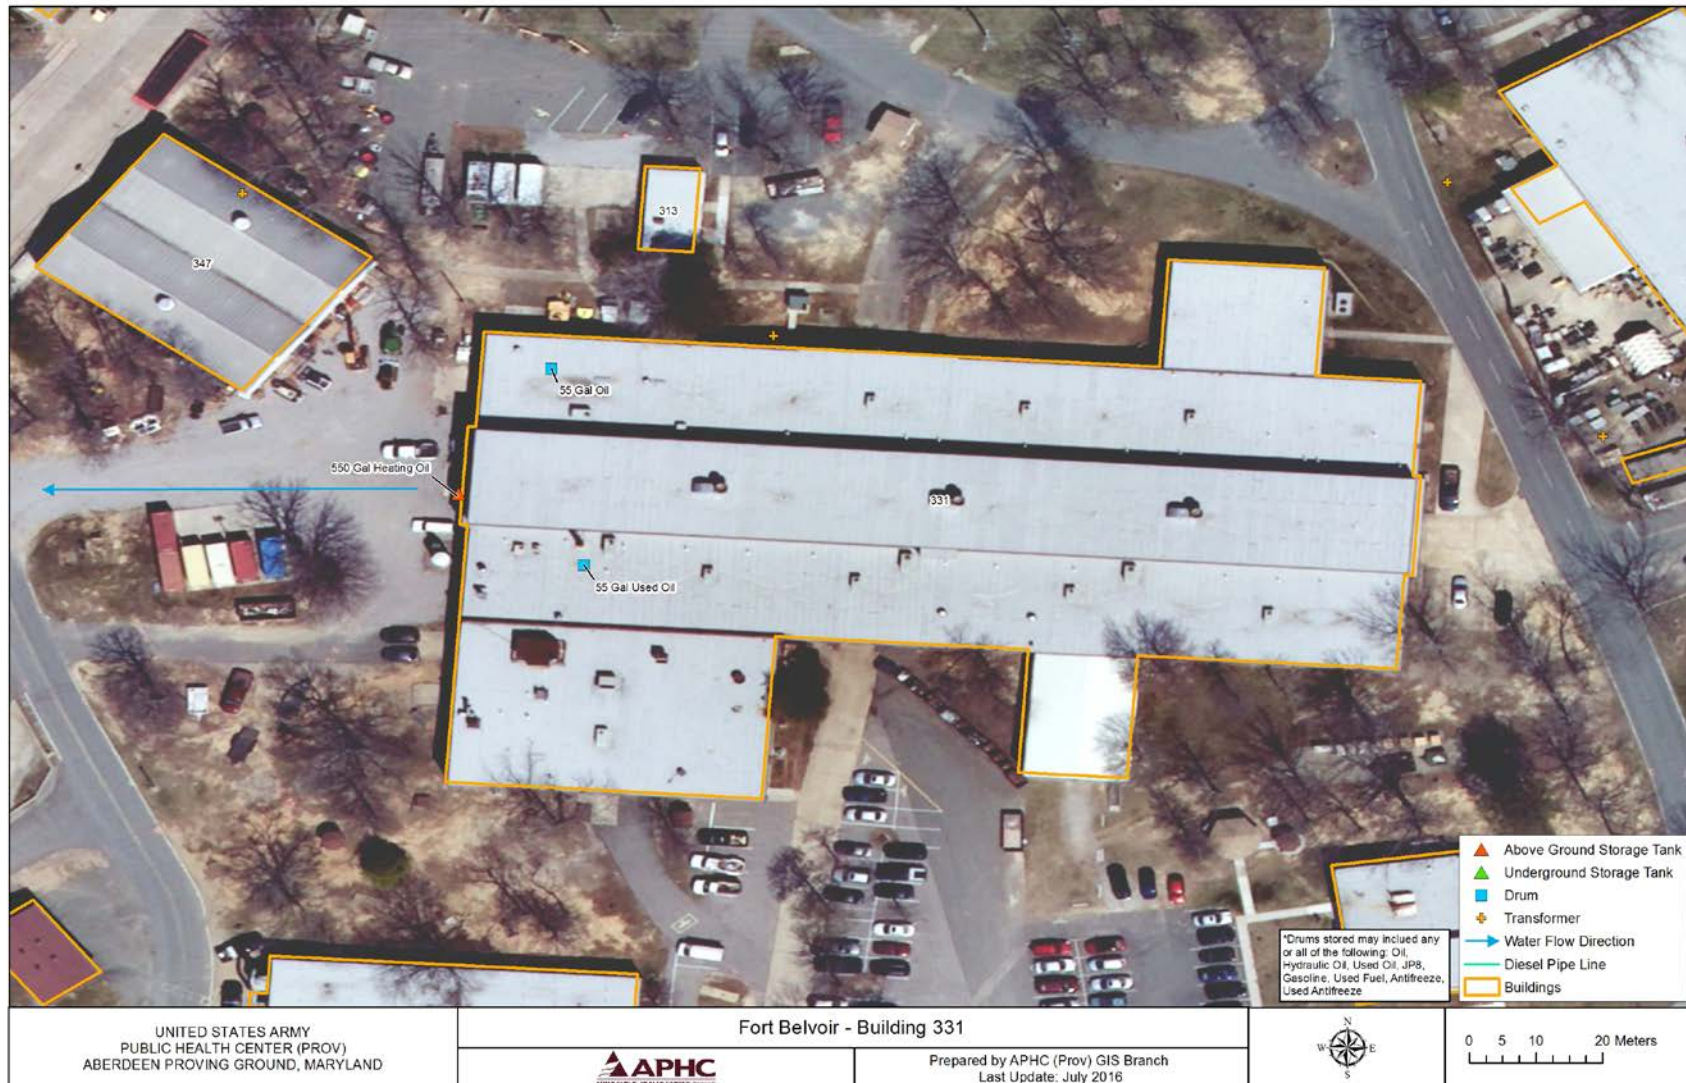
Figure 5.3.1 300-Area Maintenance (Building 331)

The AST is a single-walled steel tank with no secondary containment (see Corrective Actions, Section 6.0). The drums inside the building are on containment pallets or in a shared metal dike area. Appendix D contains volume calculations for containers within diked areas.

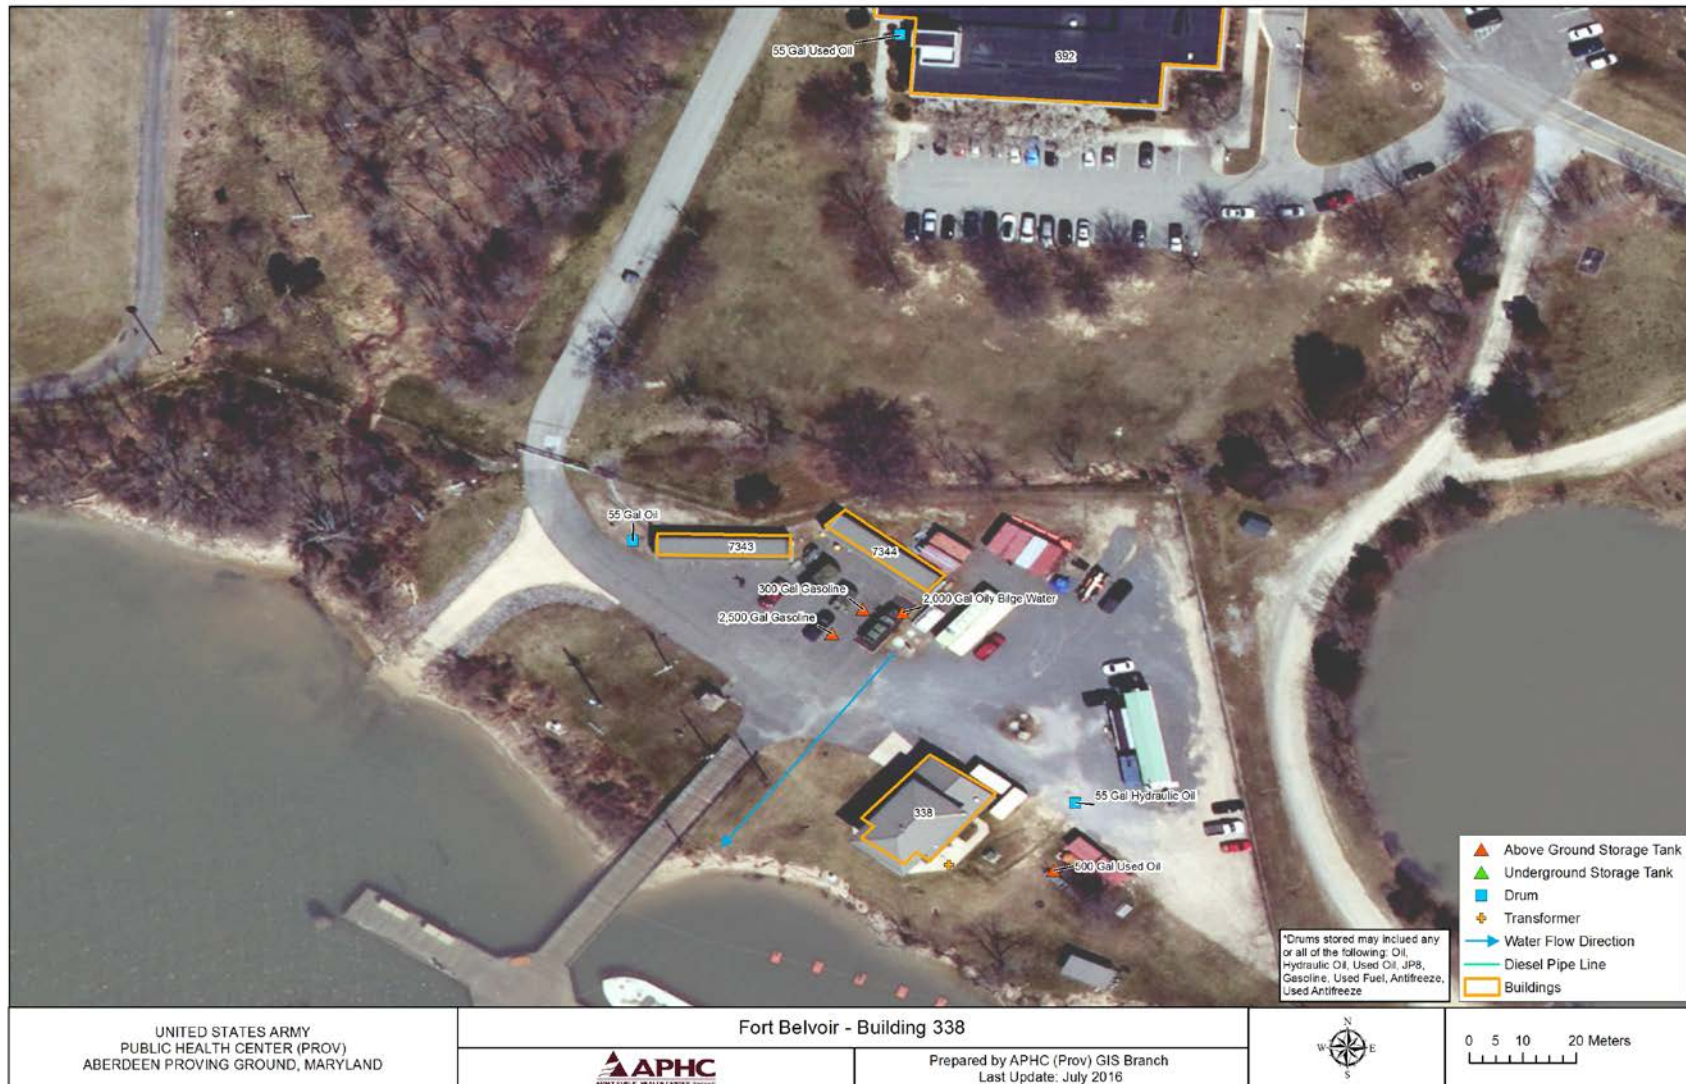
Figure 5.4.1 300-Area Pier (Buildings 338 and 341)

AST 338C is a single-walled steel tank with a steel secondary containment dike but the containment has holes in it that must be repaired prior to using the tank (see Corrective Actions, Section 6.0). The other ASTs are double-walled. The drums are on containment pallets in a shed or in a steel containment conex. The tanker truck is parked in a plastic containment dike with walls that fold down for driving in and out. Appendix D contains volume calculations for containers within diked areas. Personnel follow the rainwater release procedures found in Section 4.10.

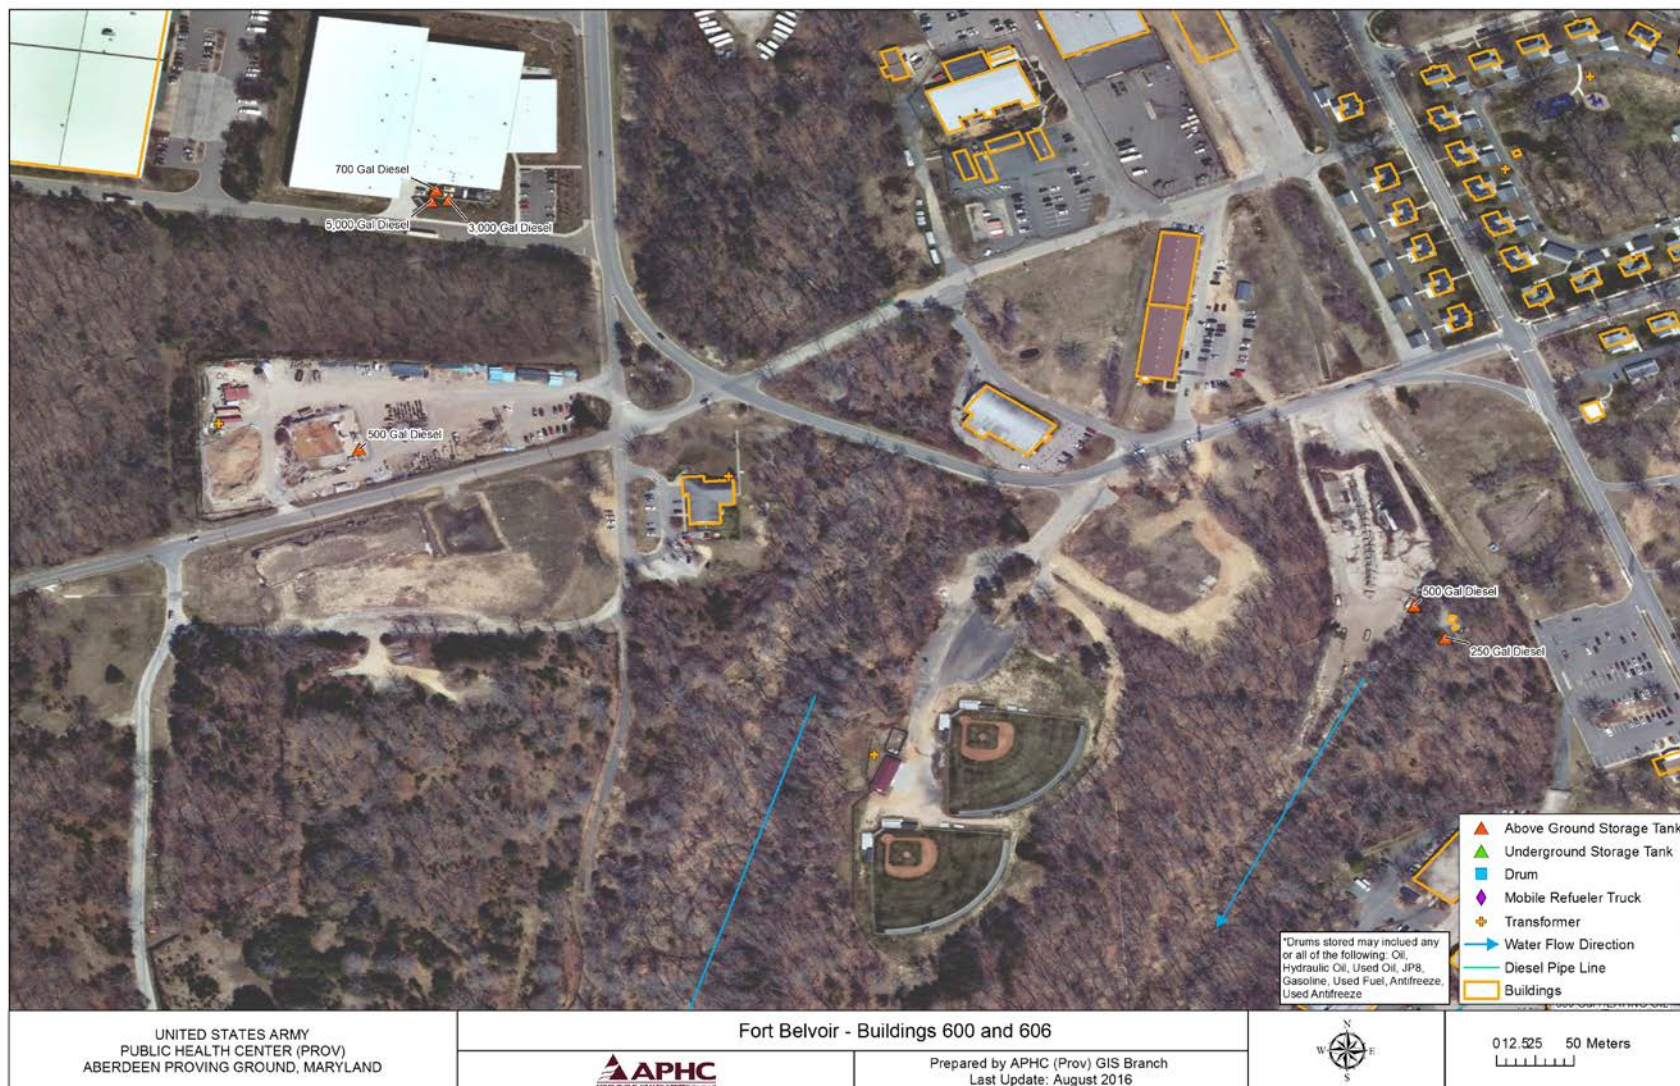
Figure 5.5.1 600-Area (Building 606)

AST 606B is a single-walled steel tank with a plastic secondary containment dike. The other ASTs are double-walled. Appendix D contains volume calculations for containers within diked areas. Personnel follow the rainwater release procedures found in Section 4.10.

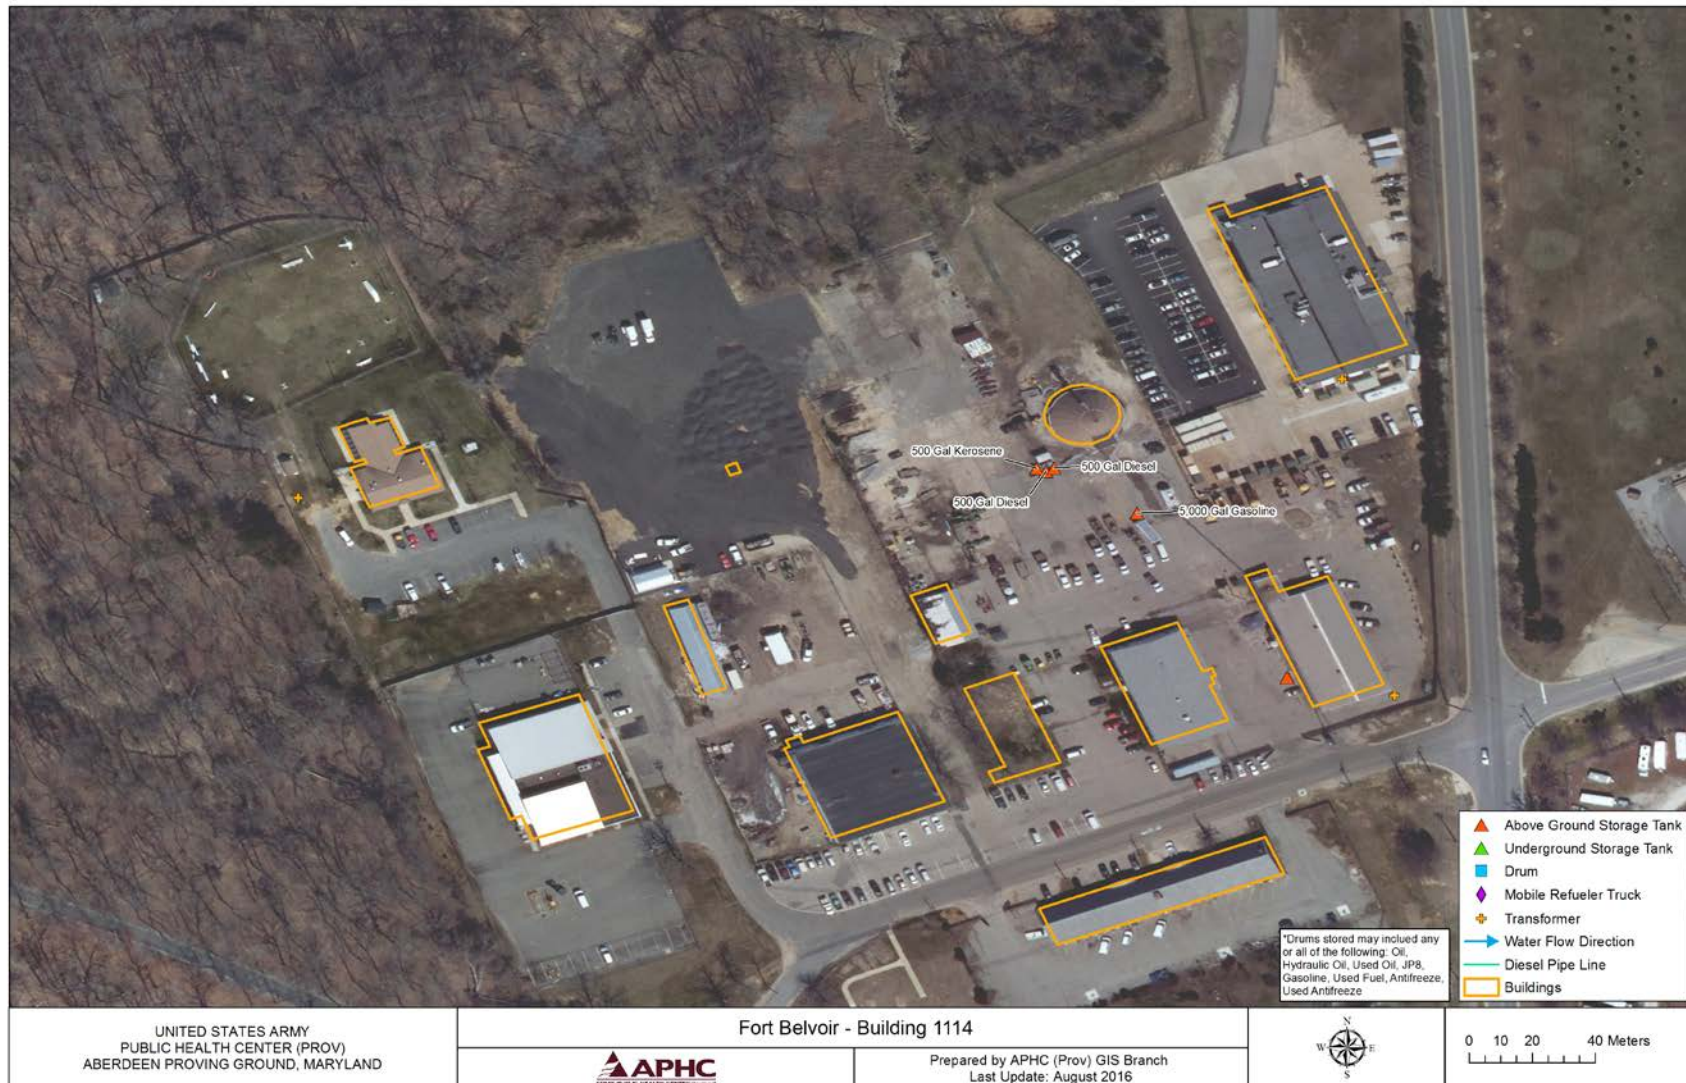
Figure 5.7.1 DPW Roads and Grounds (Building 1114)

Building 1114 is used as the roads and grounds office and fuel point. Table 5.7.1 provides container details, and Figure 5.7.1 shows their locations.

AST 1109D is single-walled with a plastic containment dike. The other ASTs are double-walled. Appendix D contains volume calculations for containers within diked areas. Personnel follow the rainwater release procedures found in Section 4.10.

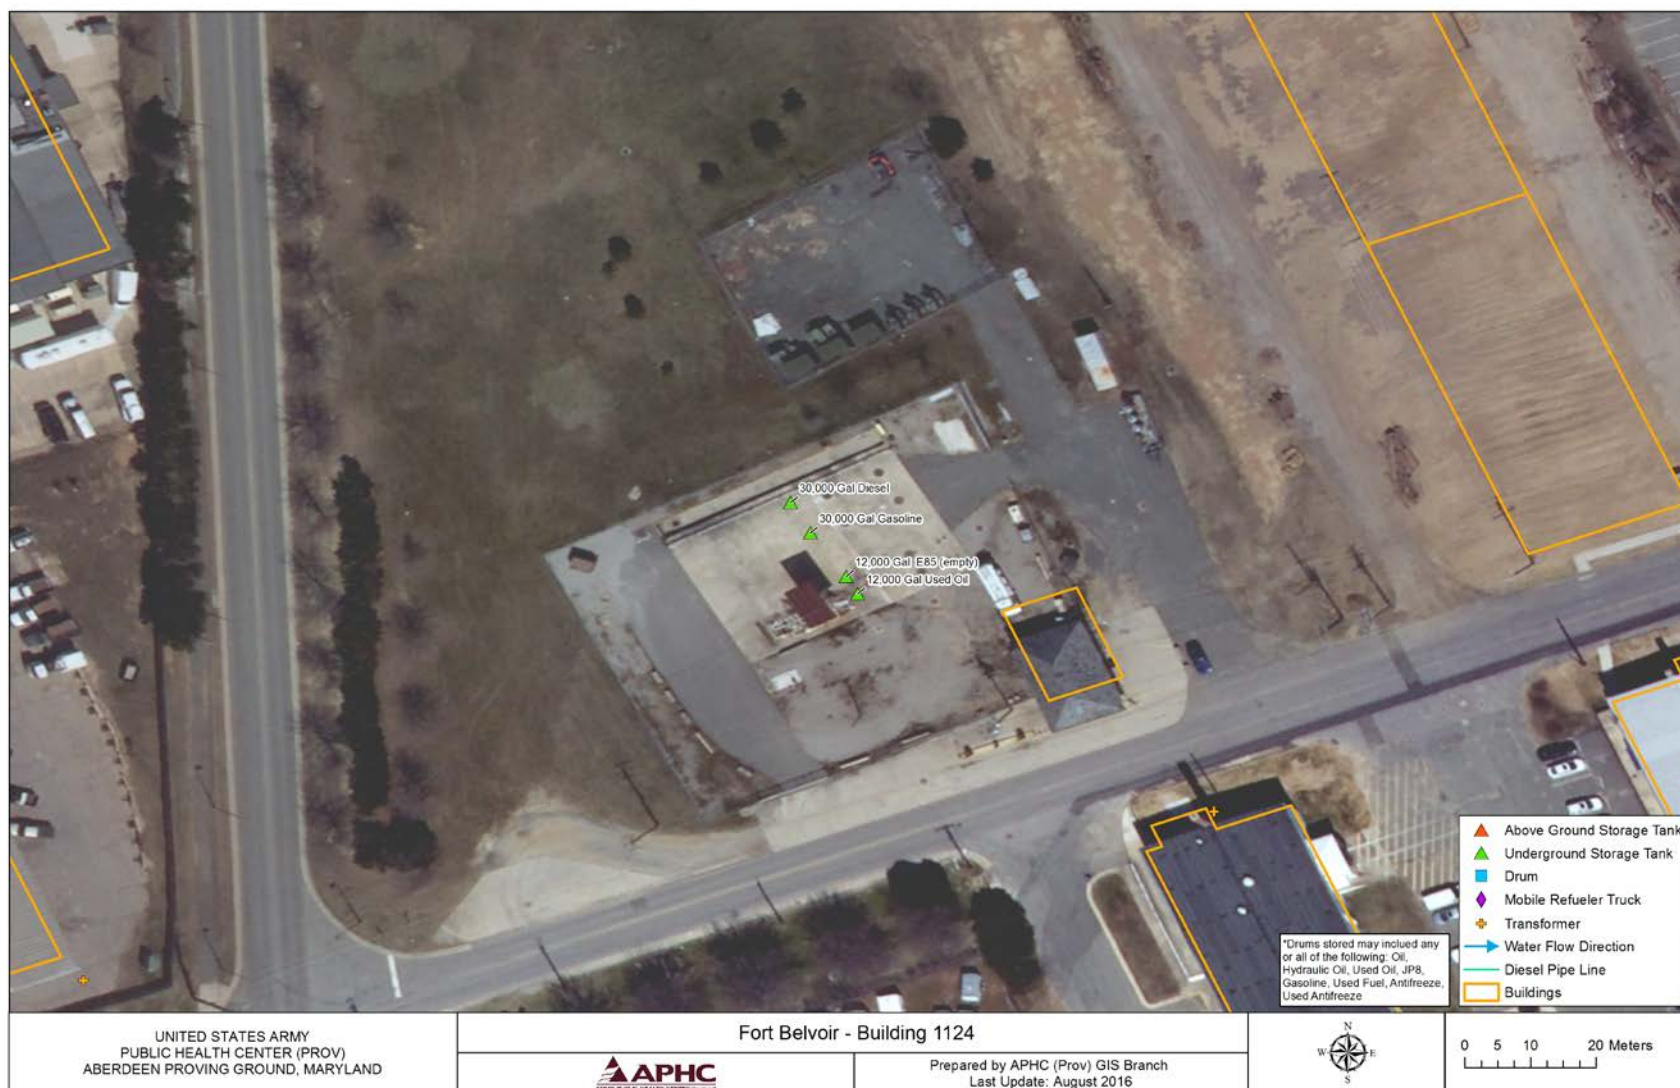
Figure 5.8.1 Capitalized Fuel Station (Building 1124)

The USTs do not have to meet SPCC Plan requirements for secondary containment. The loading/unloading rack has a concrete berm and a concrete holding basin with a valve to release storm water. The loading/unloading rack containment volume calculation is in Appendix D.

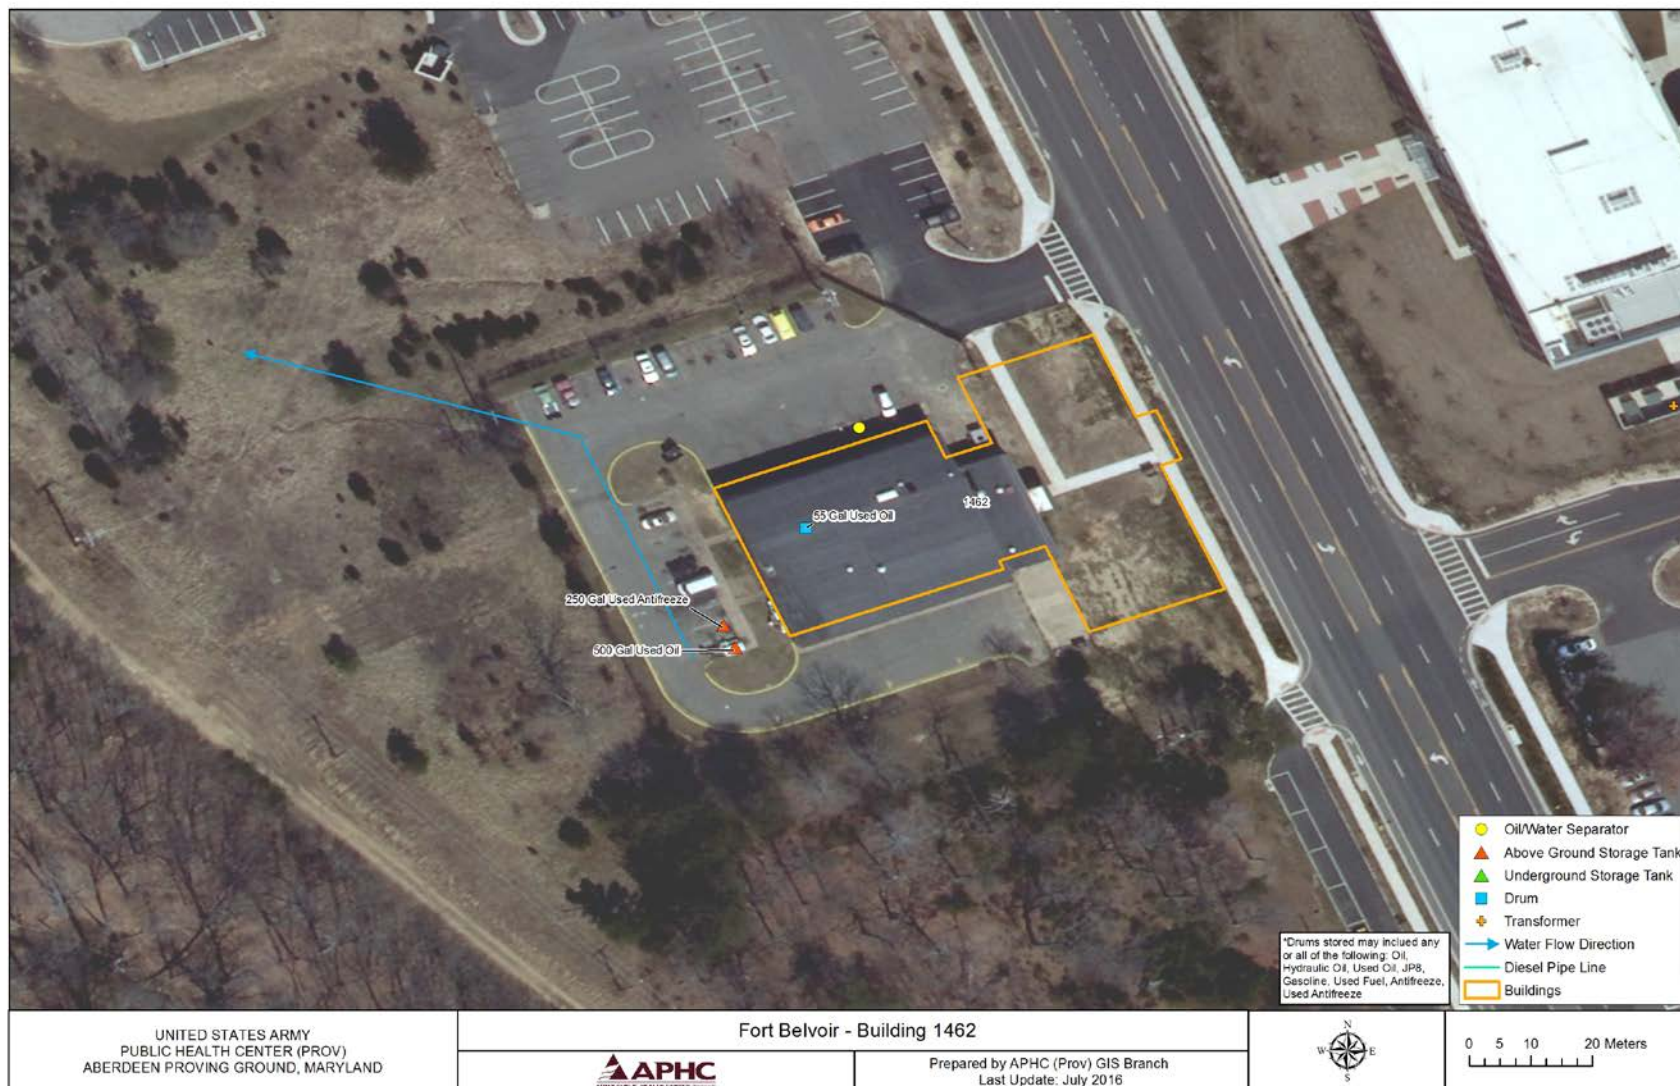
Figure 5.13.1 Autocraft (Building 1462)

The ASTs are double-walled and do not collect storm water. The drums are on a steel containment pallet indoors.

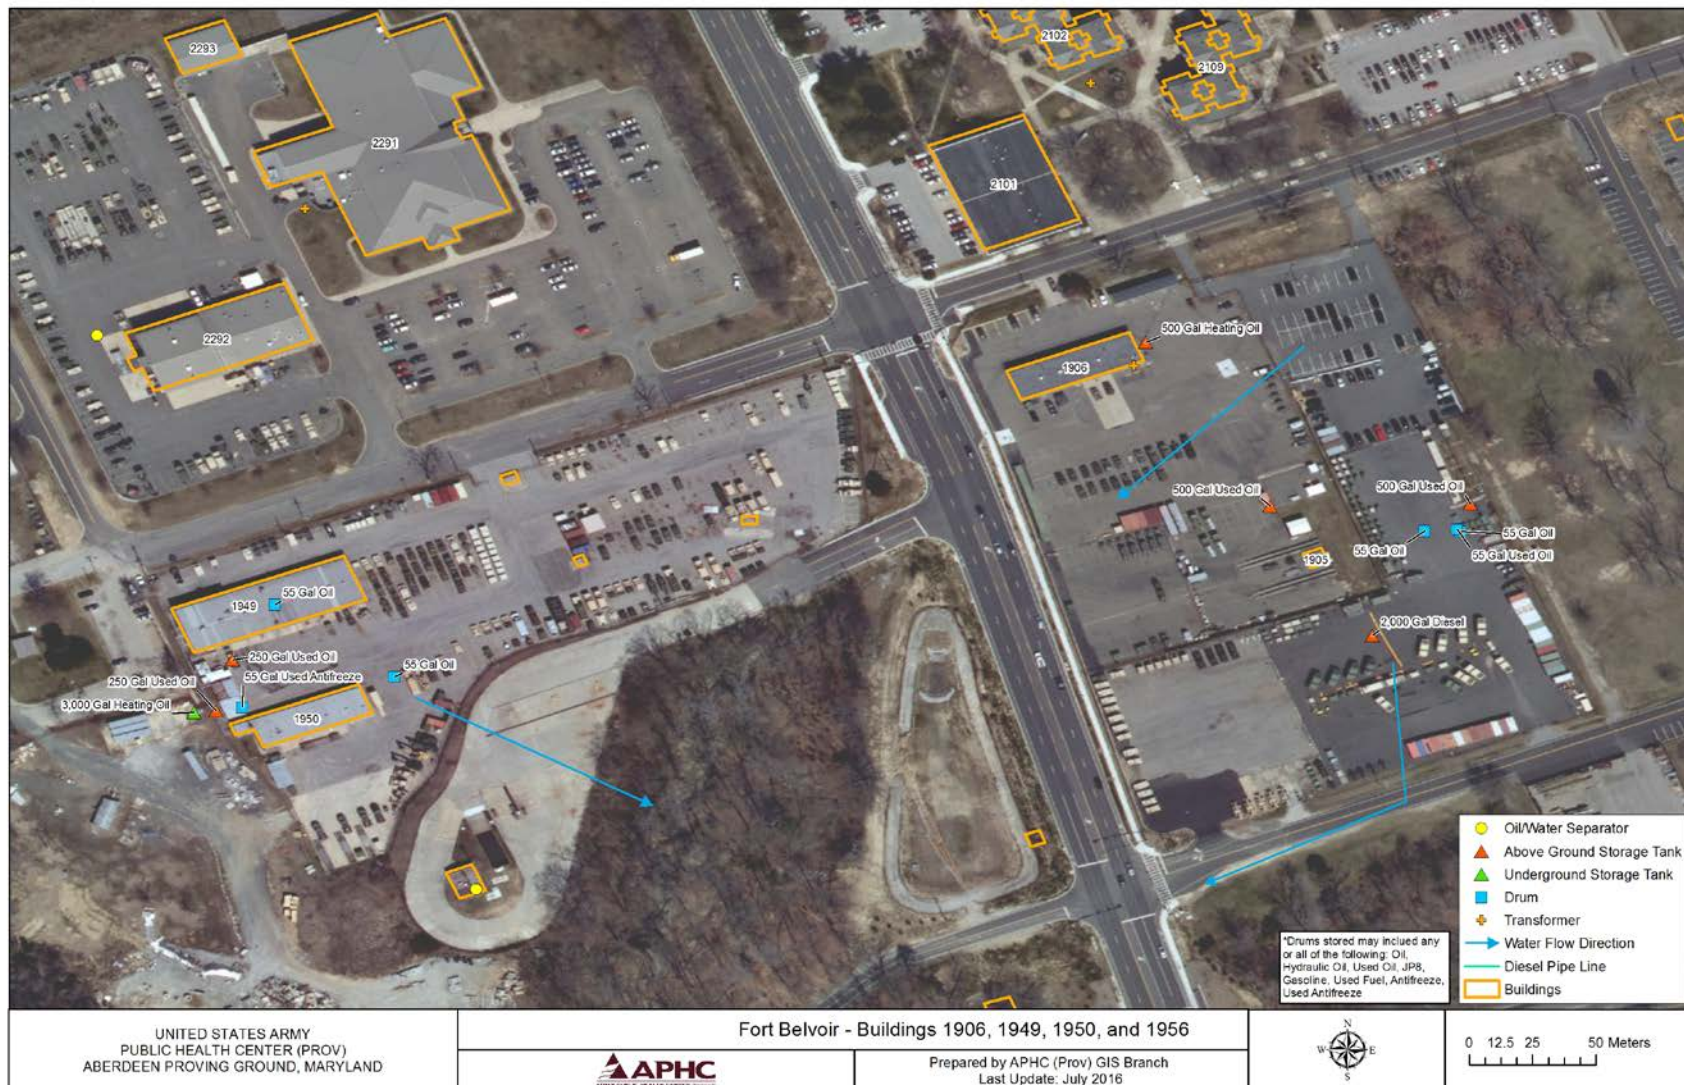
Figure 5.16.1 Motor Pool (Buildings 1949 and 1950)

This area is used for two separate vehicle maintenance organizations (both military). There are two ASTs and two drum storage areas, plus a buried heating oil tank that is shared between the buildings. Table 5.16.1 provides container details, and Figure 5.16.1 shows their locations.
