**Fort Belvoir
Spill Prevention, Control,
and Countermeasure Plan**

Fort Belvoir
Directorate of Public Works
Environmental Division

Water Resources Division
Army Public Health Center
ATTN: MCHB-IP-ESW, Building E-1675
5158 Blackhawk Road
Aberdeen Proving Ground, MD 21010-5403

September 2017

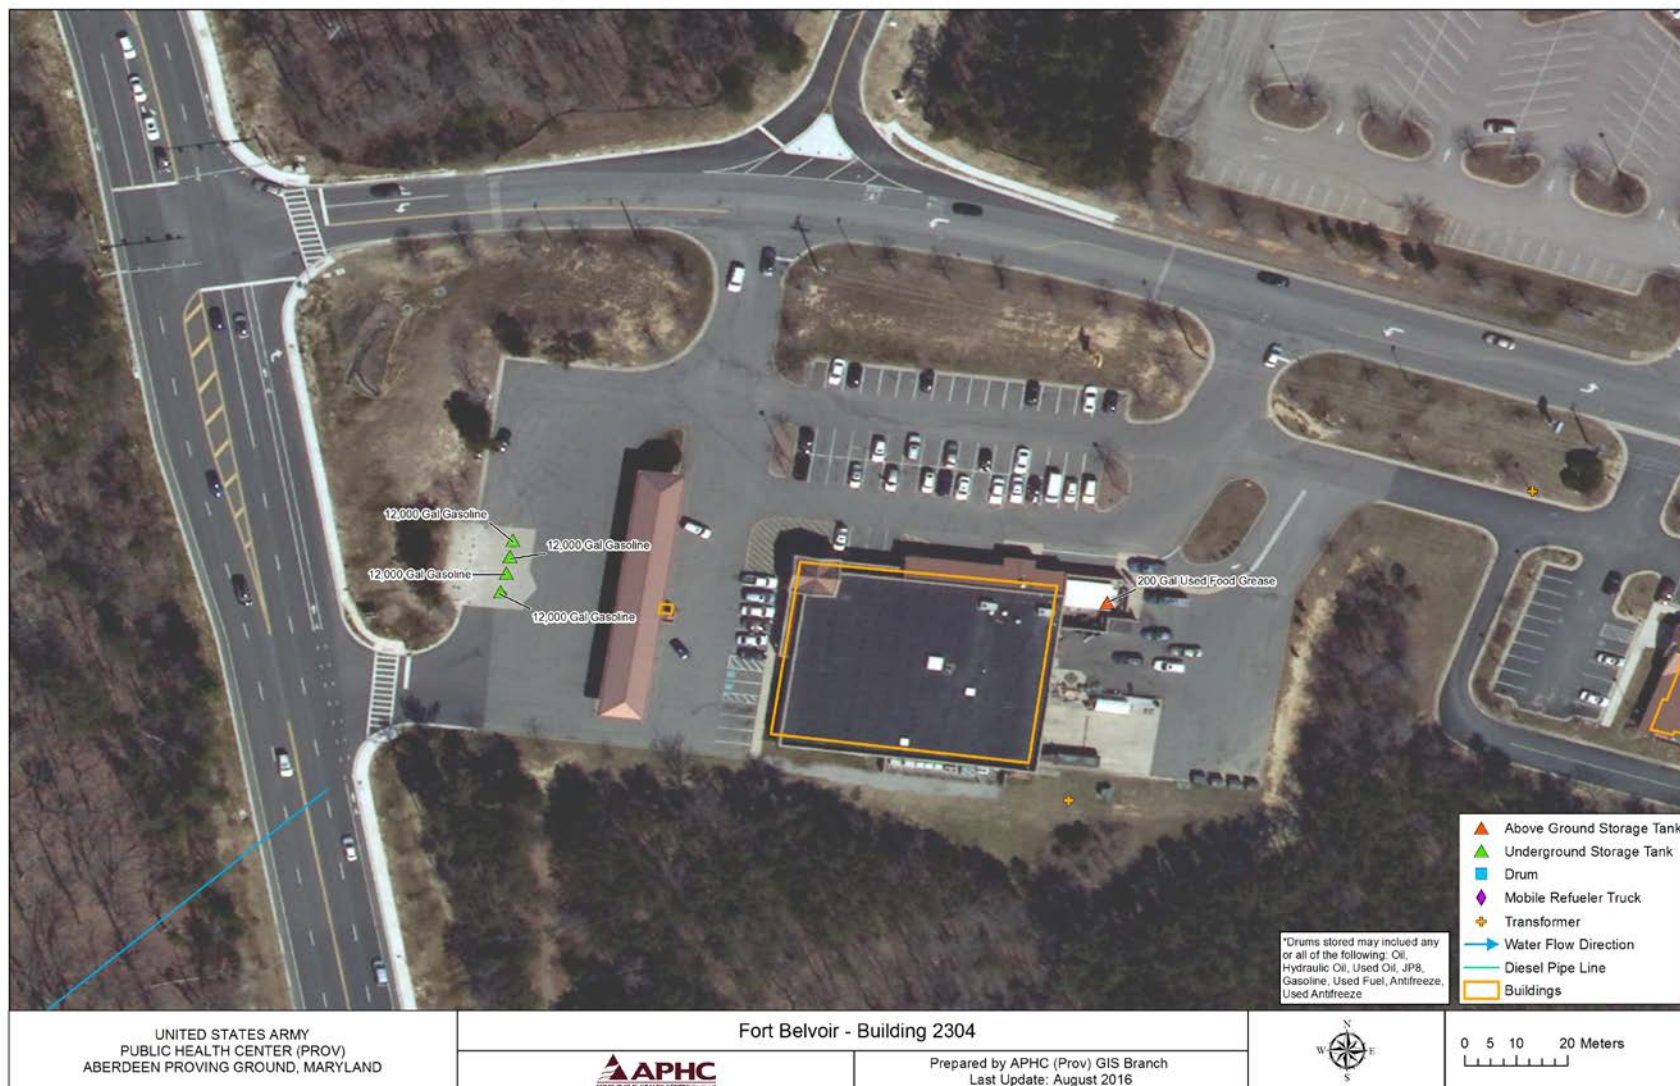
Figure 5.17.1 AAFES Gas Station (Building 2304)

Building 2304 is a gas station for privately owned vehicles. Four USTs hold fuel for vehicles. There is also a food grease container at the site (see Section 5.35). Table 5.17.1 provides container details, and Figure 5.17.1 shows their locations.

An error dispensing fuel could spill 25 gallons. The loss of the entire contents of a larger fuel delivery tanker truck could spill 5,000 gallons. Any spill from this area would flow north across the parking lot to a storm water inlet to an unnamed creek and then southwest to Accotink Creek (see Figures 5.17.1, 2.1, and 2.5). A spill in this area would trigger the spill response procedures listed in Section 4.7.

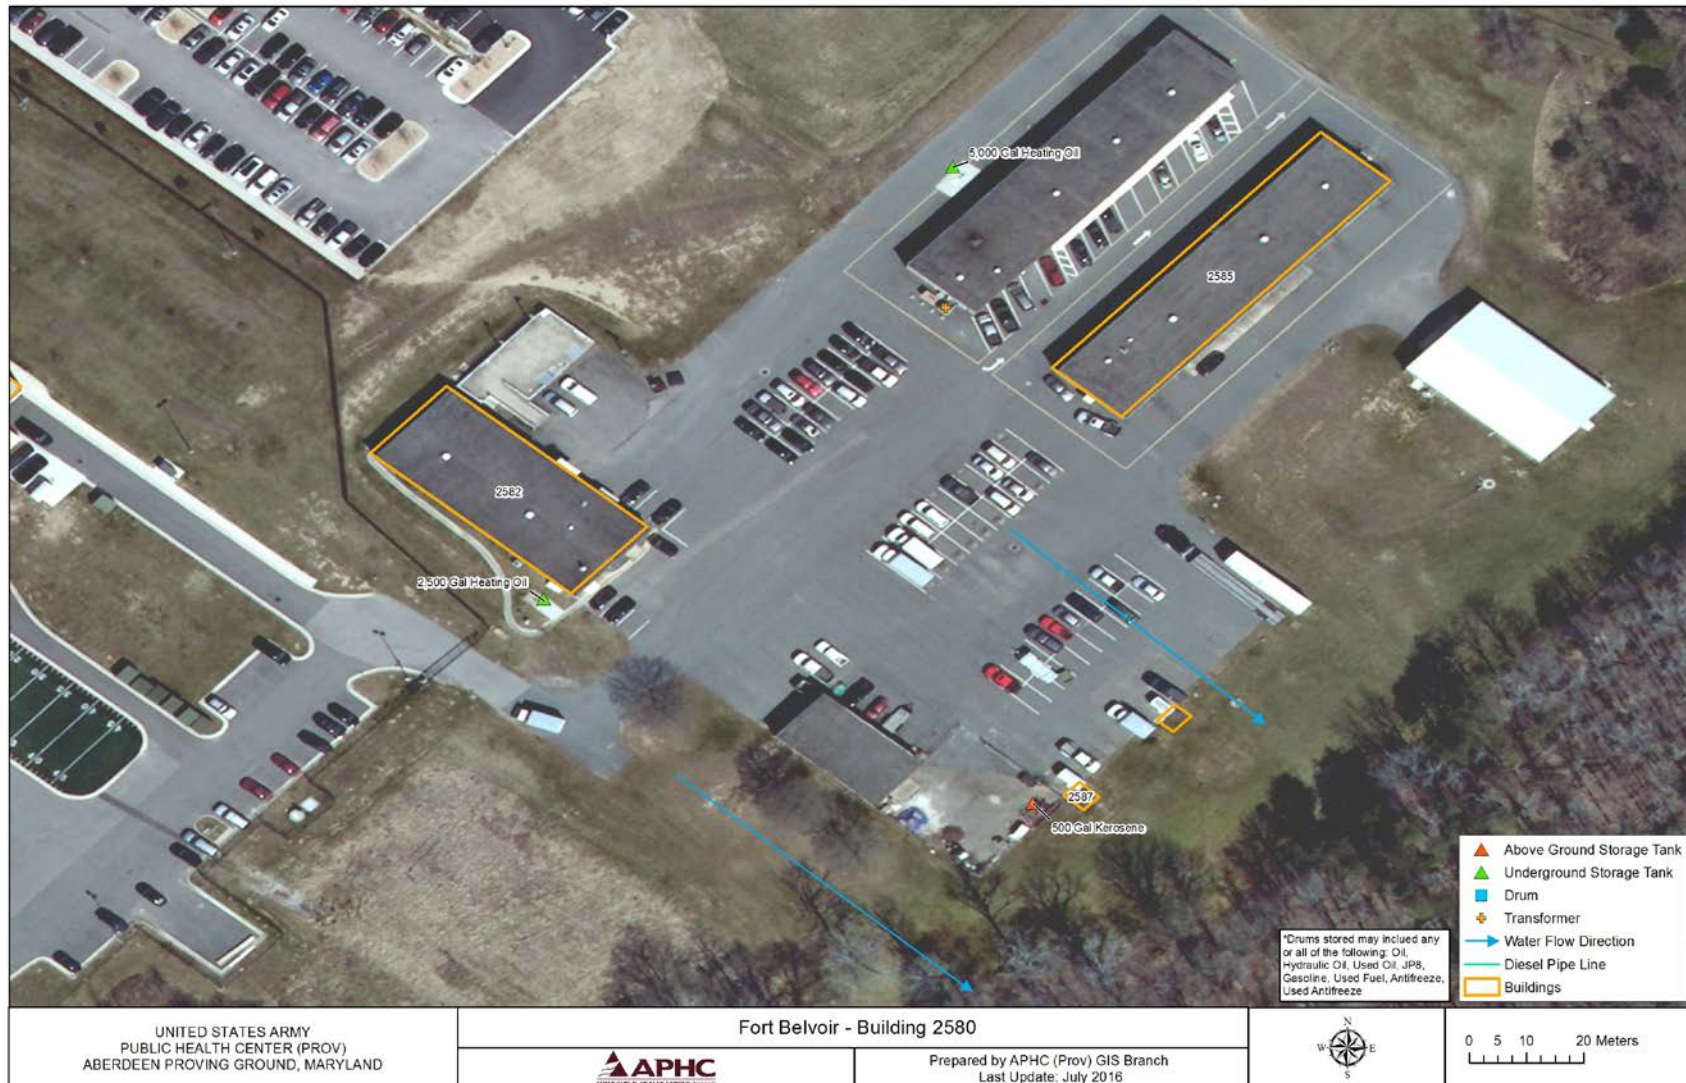
Figure 5.21.1 HECSA (Building 2580)

This area is operated by HECSA. There is an AST that dispenses kerosene for small heaters. Table 5.21.1 provides container details, and Figure 5.21.1 shows their locations.

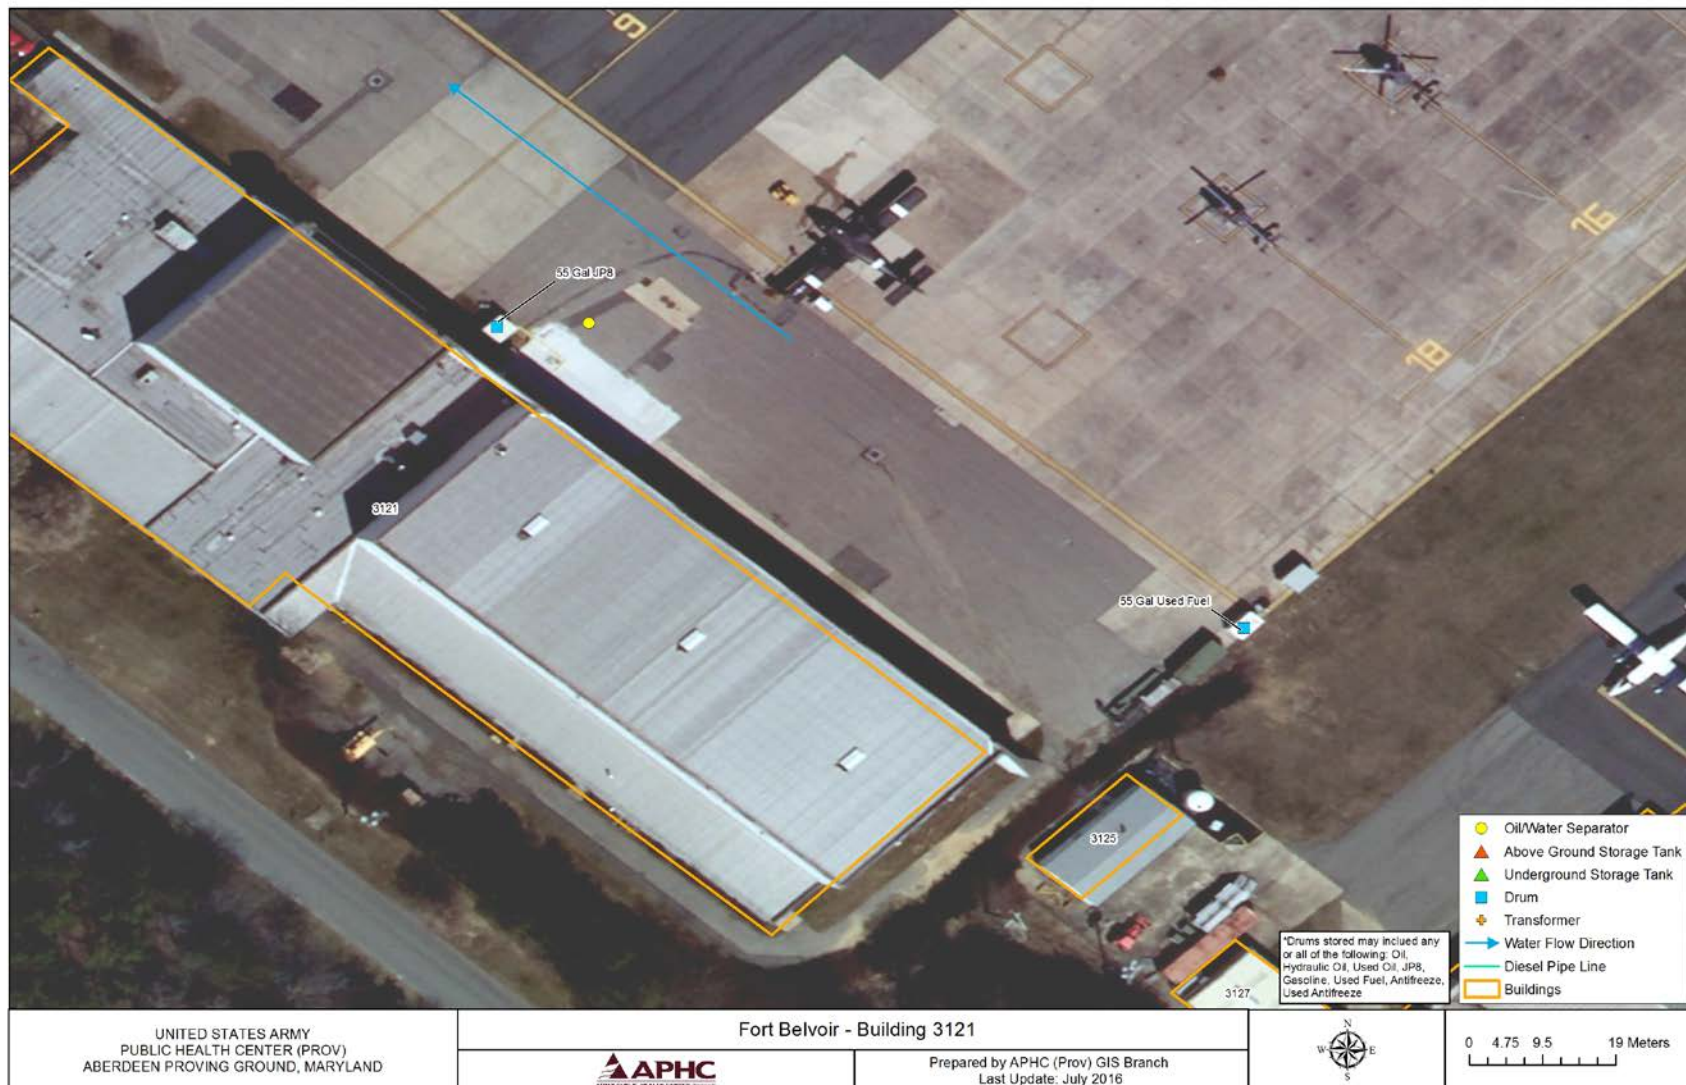
Figure 5.25.1 Hangar (Building 3121)

The hangar area includes aircraft maintenance facilities with drum storage areas. Table 5.25.1 provides container details, and Figure 5.25.1 shows their locations.

The loss of the entire contents of the vacuum tanker truck could spill 2,000 gallons. It is assumed only one drum would spill in a given event. Any spill from this area would flow northwest across concrete to a storm water inlet and then northeast before turning south to Accotink Creek (see Figures 5.25.1, 2.1, and 2.4). A spill in this area would trigger the spill response procedures listed in Section 4.7.

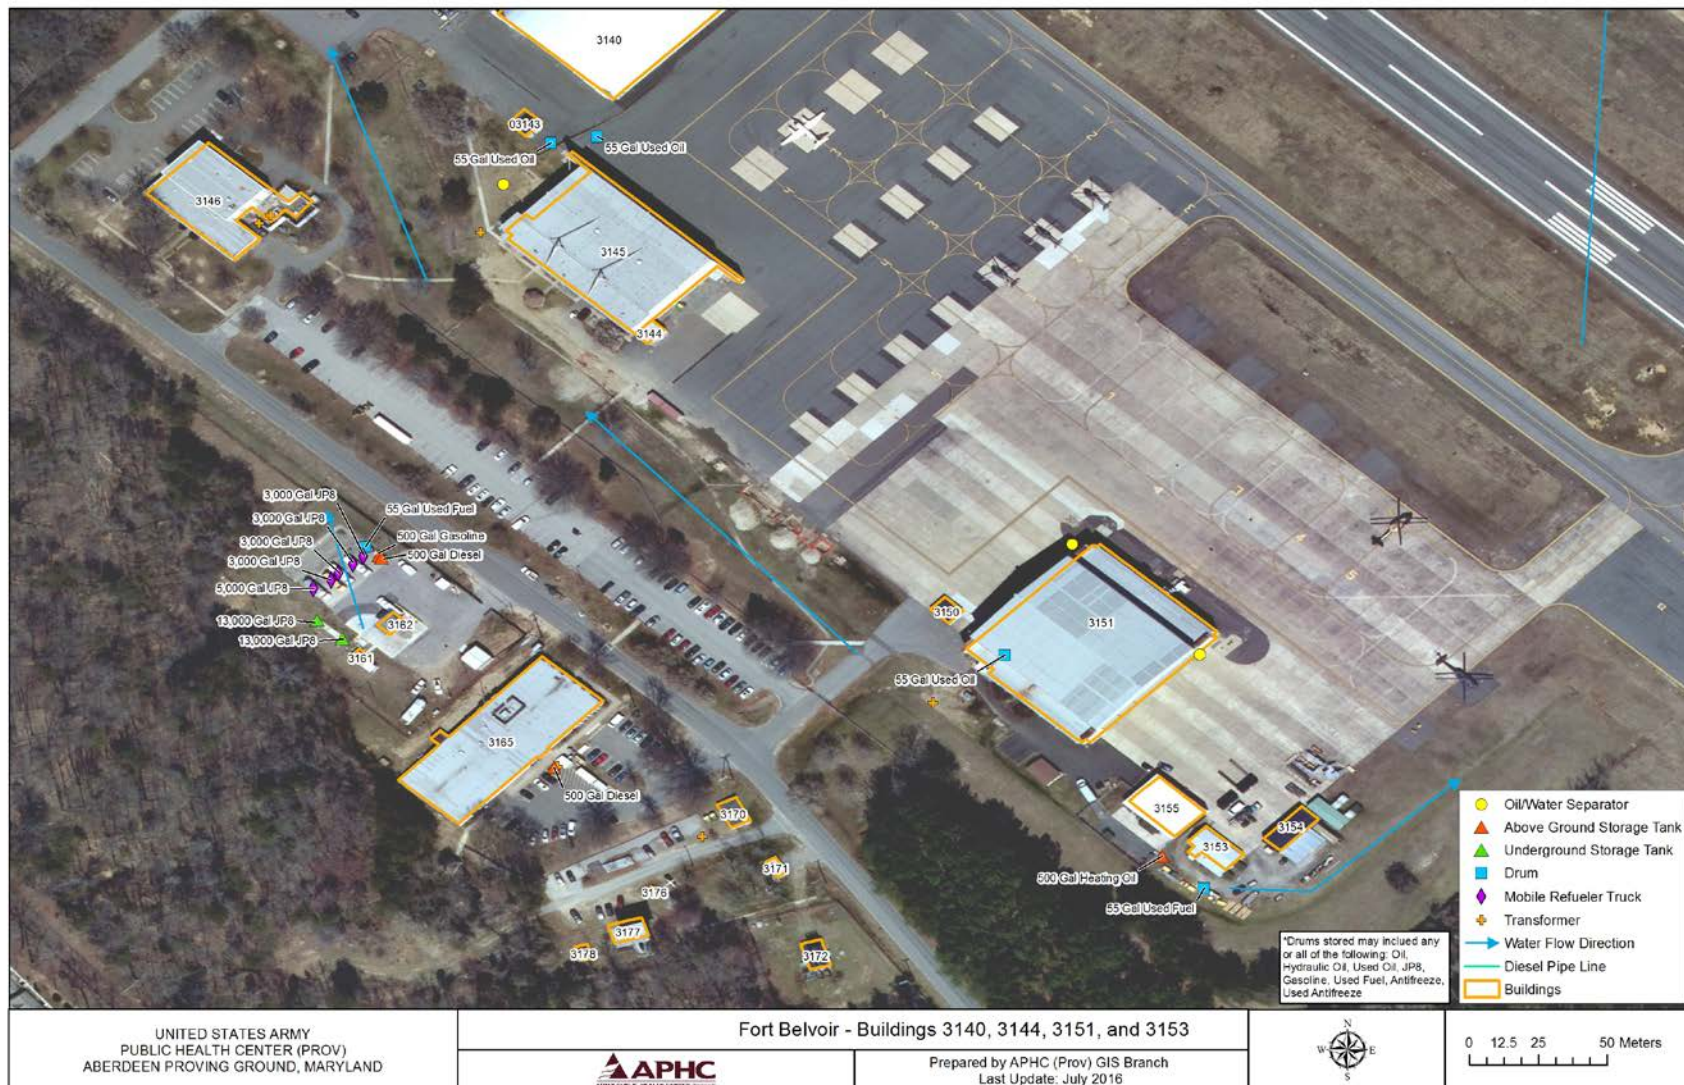
Figure 5.27.1 Hangars (Buildings 3151 and 3153)

The hangar area includes aircraft maintenance facilities with drum storage areas and an office building with a heating oil tank. Table 5.27.1 provides container details, and Figure 5.27.1 shows their locations.

Complete failure of the AST could spill 550 gallons. The loss of the entire contents of the fuel delivery truck could spill 3,000 gallons. The loss of the entire contents of the vacuum tanker truck could spill 2,000 gallons. It is assumed only one drum would spill in a given event. Any spill from this area would flow northwest across concrete to a storm water inlet and then northeast before turning south to Accotink Creek (see Figures 5.27.1, 2.1, and 2.4). A spill in this area would trigger the spill response procedures listed in Section 4.7.

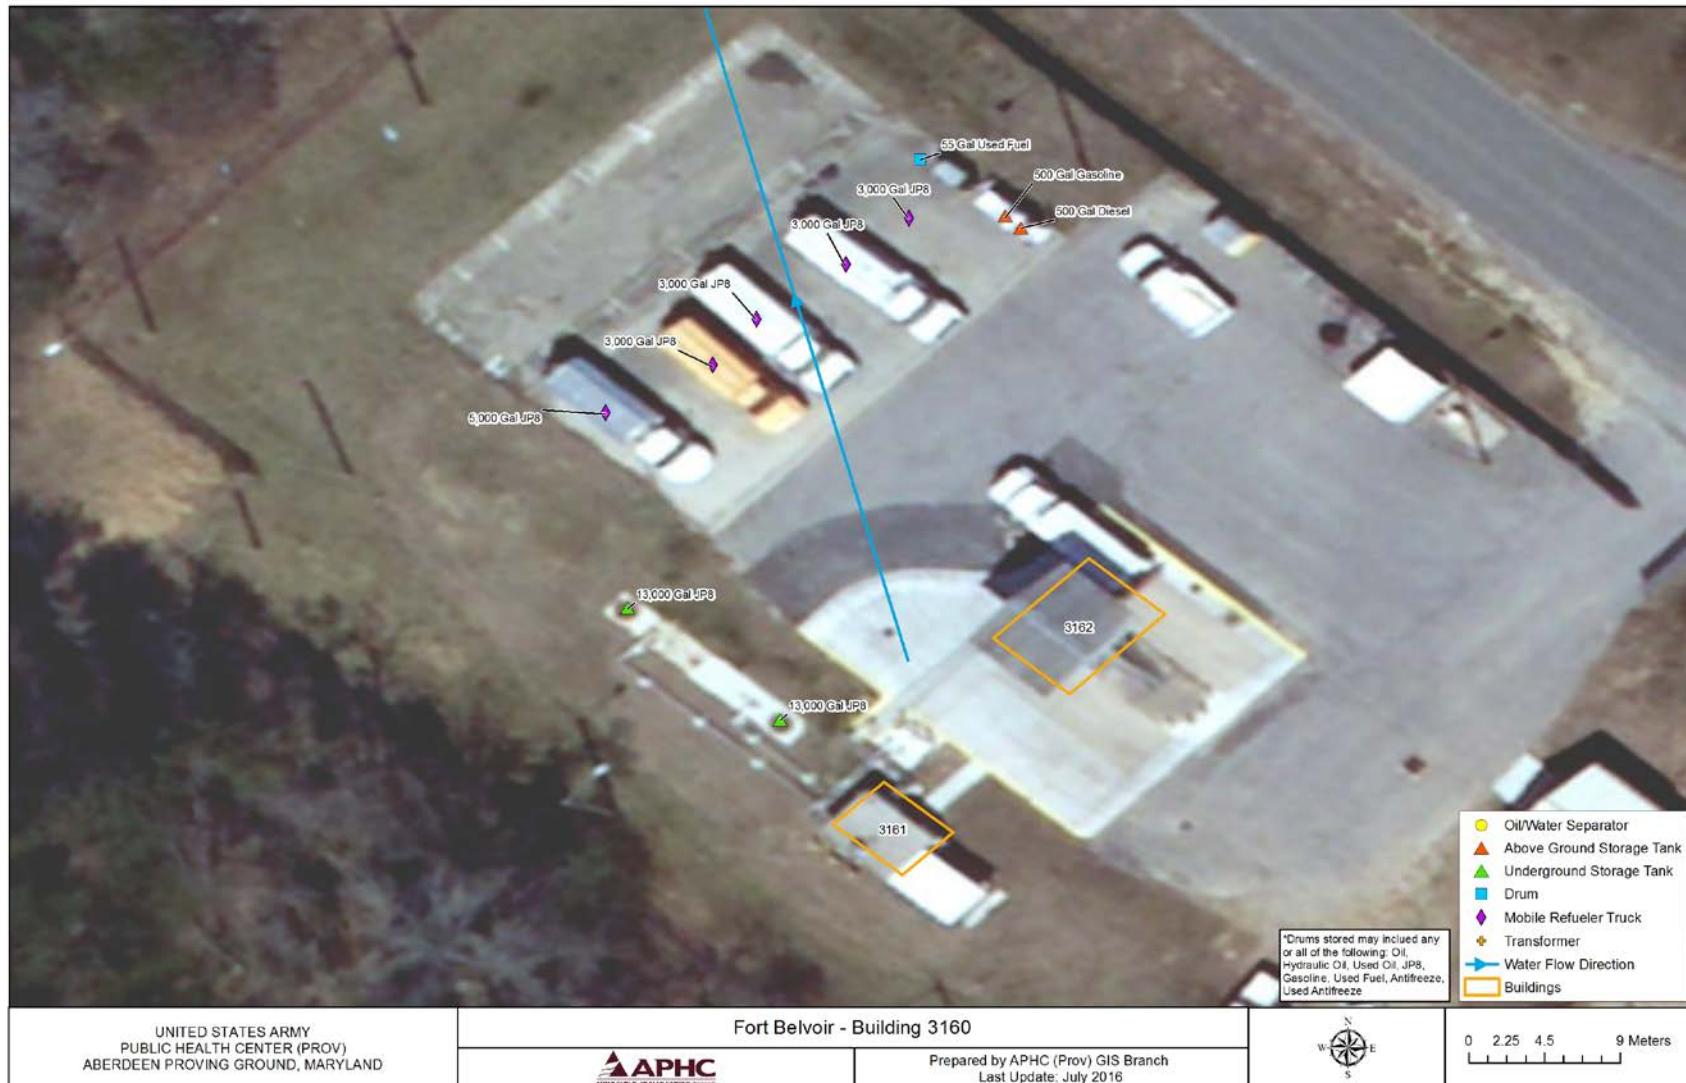
Figure 5.28.1 DAAF Fuel Point (Building 3161)

The fuel point supplies fuel for all of the aircraft at DAAF. There are two USTs as the main fuel storage, five mobile refueler trucks that deliver fuel directly to aircraft on the flight line, two ASTs for fueling ground vehicles, and drums for collecting used fuel. Used food grease is also onsite (see Section 5.35). Table 5.28.1 provides container details, and Figure 5.28.1 shows their locations.

Complete container failure of an AST could result in a spill of up to 500 gallons. The loss of the entire contents of the larger fuel delivery tanker truck could spill 5,000 gallons. The loss of the entire contents of the vacuum truck could spill 2,000 gallons. It is assumed only one drum would spill in a given event. Any spill from this area would flow northwest across concrete to a storm water inlet and then northeast before turning south to Accotink Creek (see Figures 5.28.1, 2.1, and 2.4). A spill in this area would trigger the spill response procedures listed in Section 4.7.

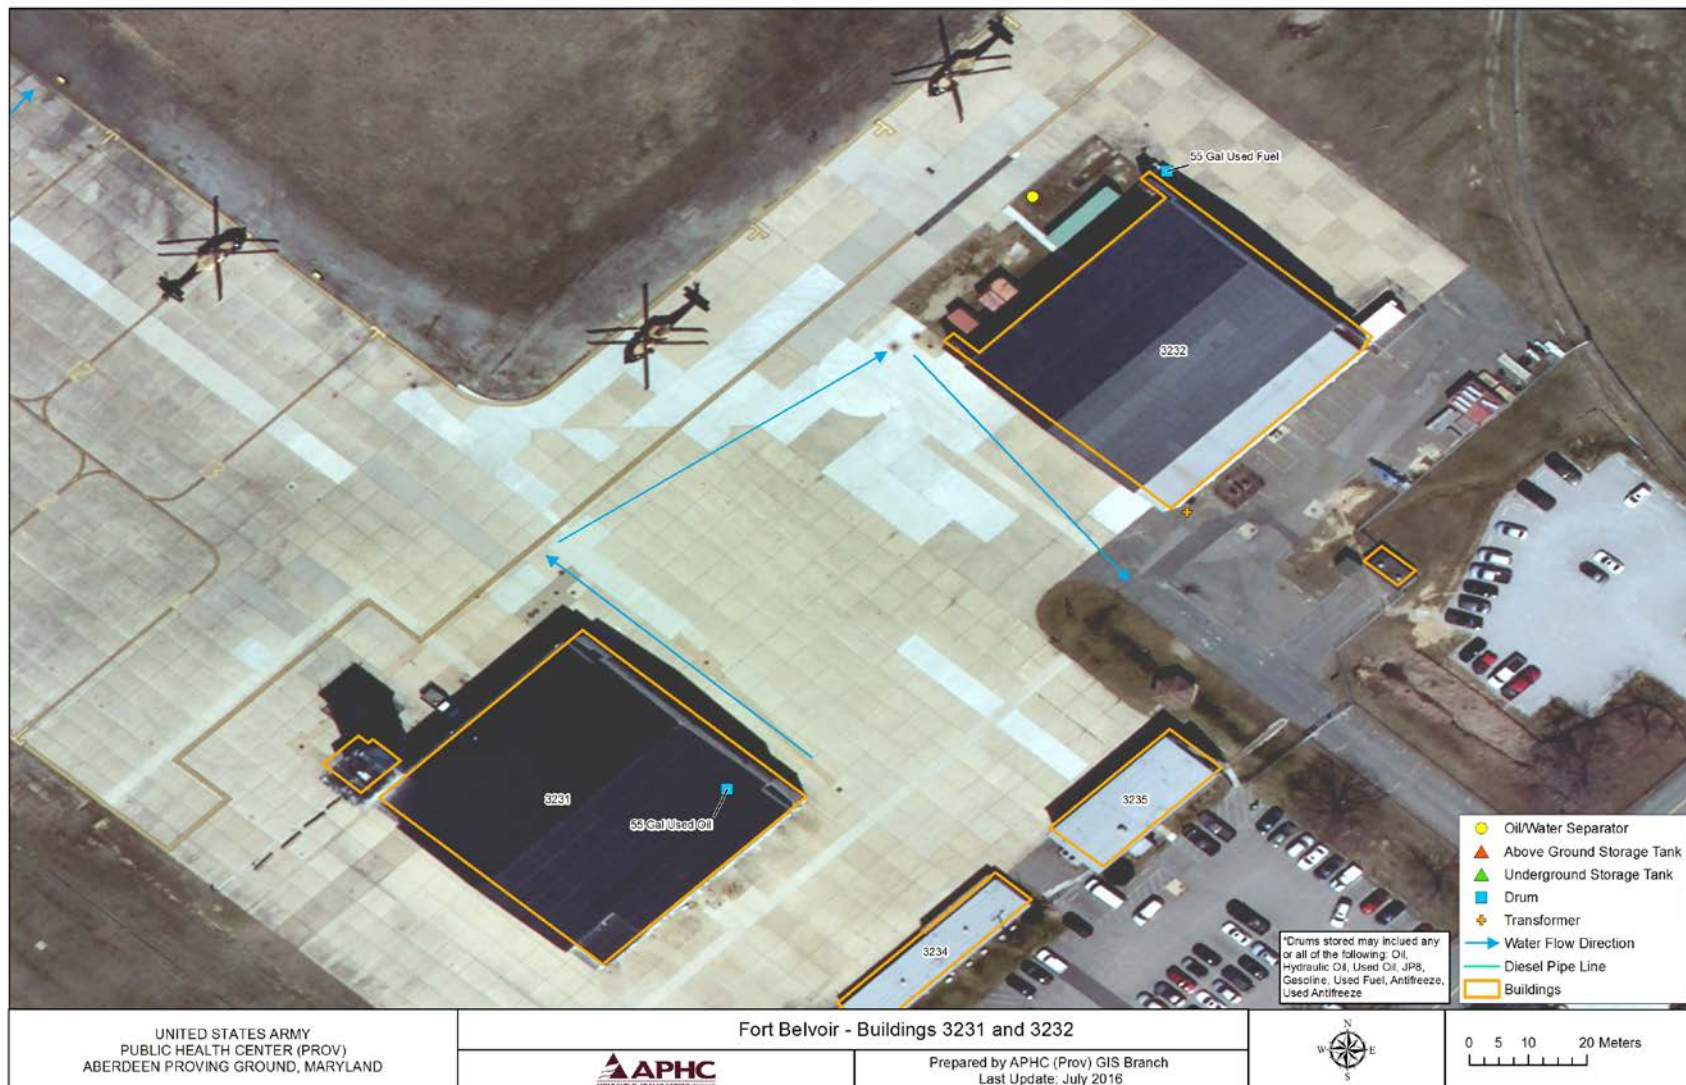
Figure 5.29.1 Hangars (Buildings 3231 and 3232)

The hangar area includes aircraft maintenance facilities with drum storage areas. Table 5.29.1 provides container details, and Figure 5.29.1 shows their locations.

The loss of the entire contents of the vacuum tanker truck could spill 2,000 gallons. It is assumed only one drum would spill in a given event. Any spill from this area would flow northwest across concrete to a storm water inlet and then northeast before turning south to Accotink Creek (see Figures 5.29.1, 2.1, and 2.4). A spill in this area would trigger the spill response procedures listed in Section 4.7.

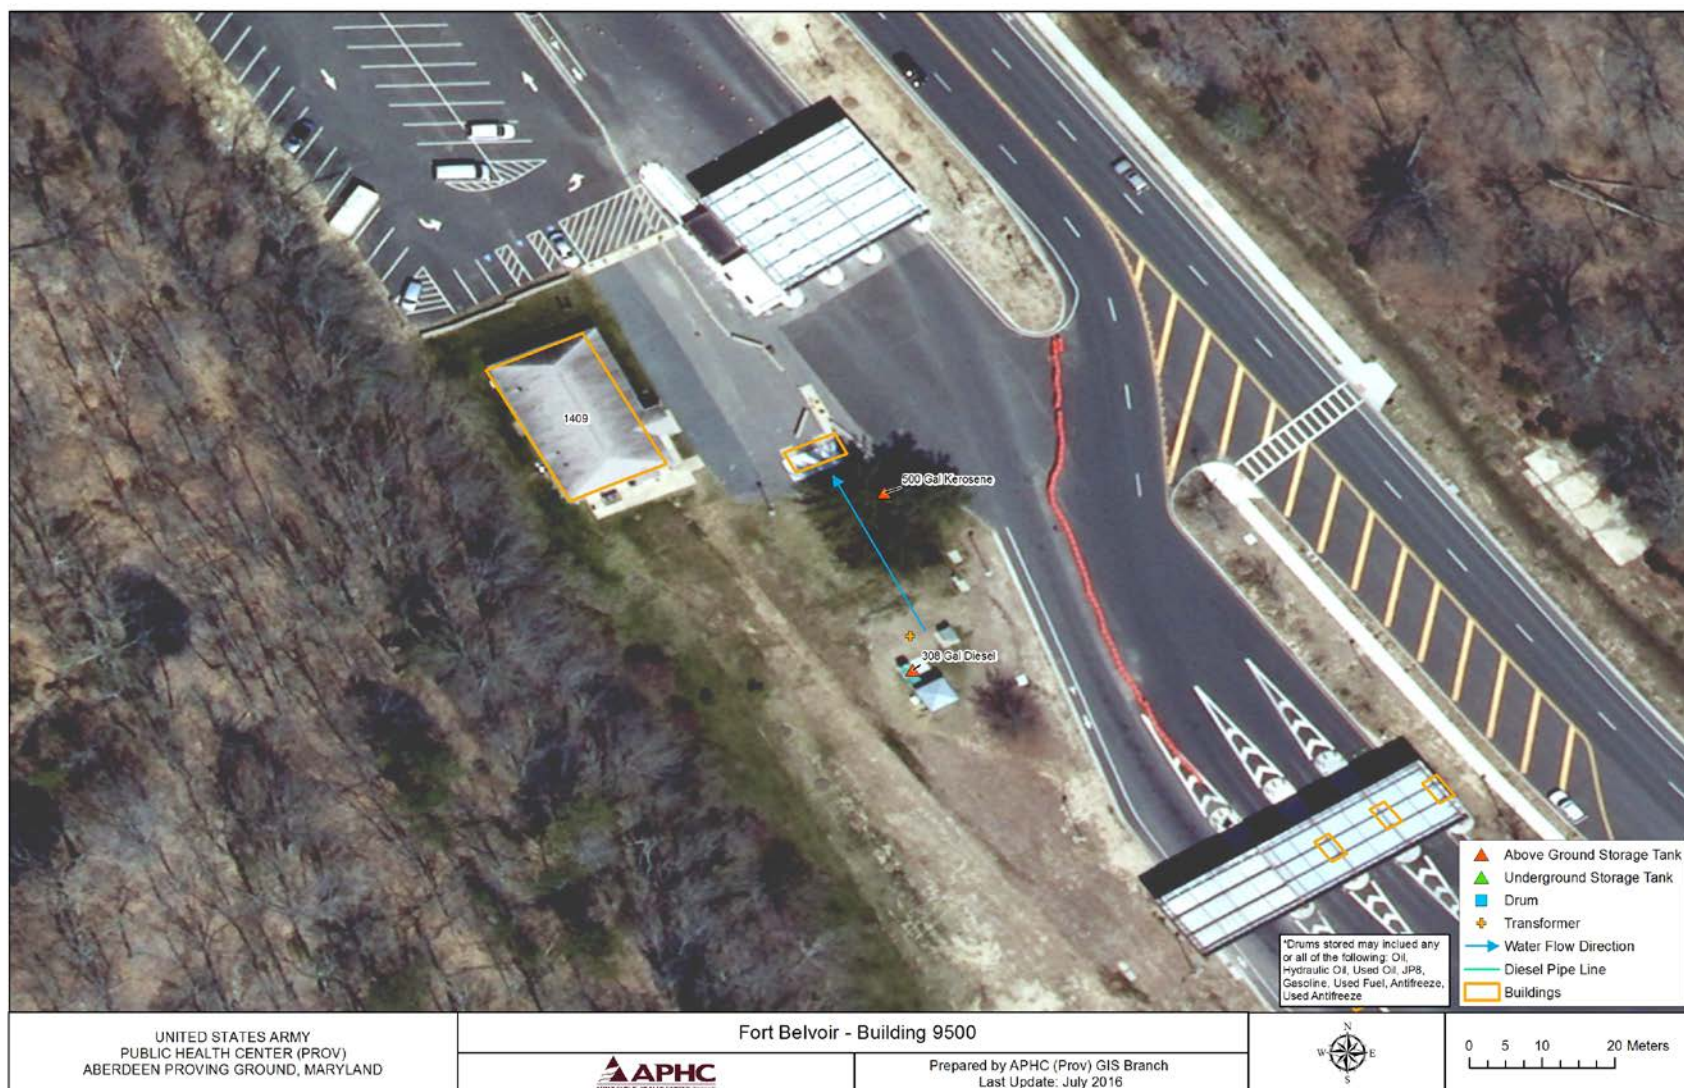
Figure 5.31.1 Tulley Gate (Building 9500)

The Tulley Gate has a visitor center with an emergency generator and a fuel tank for filling space heaters used by guards. Table 5.31.1 provides container details, and Figure 5.31.1 shows their locations.
