2020 PCB TMDL ACTION PLAN

U.S. ARMY GARRISON FORT BELVOIR, VIRGINIA

Department of the Army
U.S. Army Garrison, Fort Belvoir
Directorate of Public Works
Environmental and Natural Resources Division

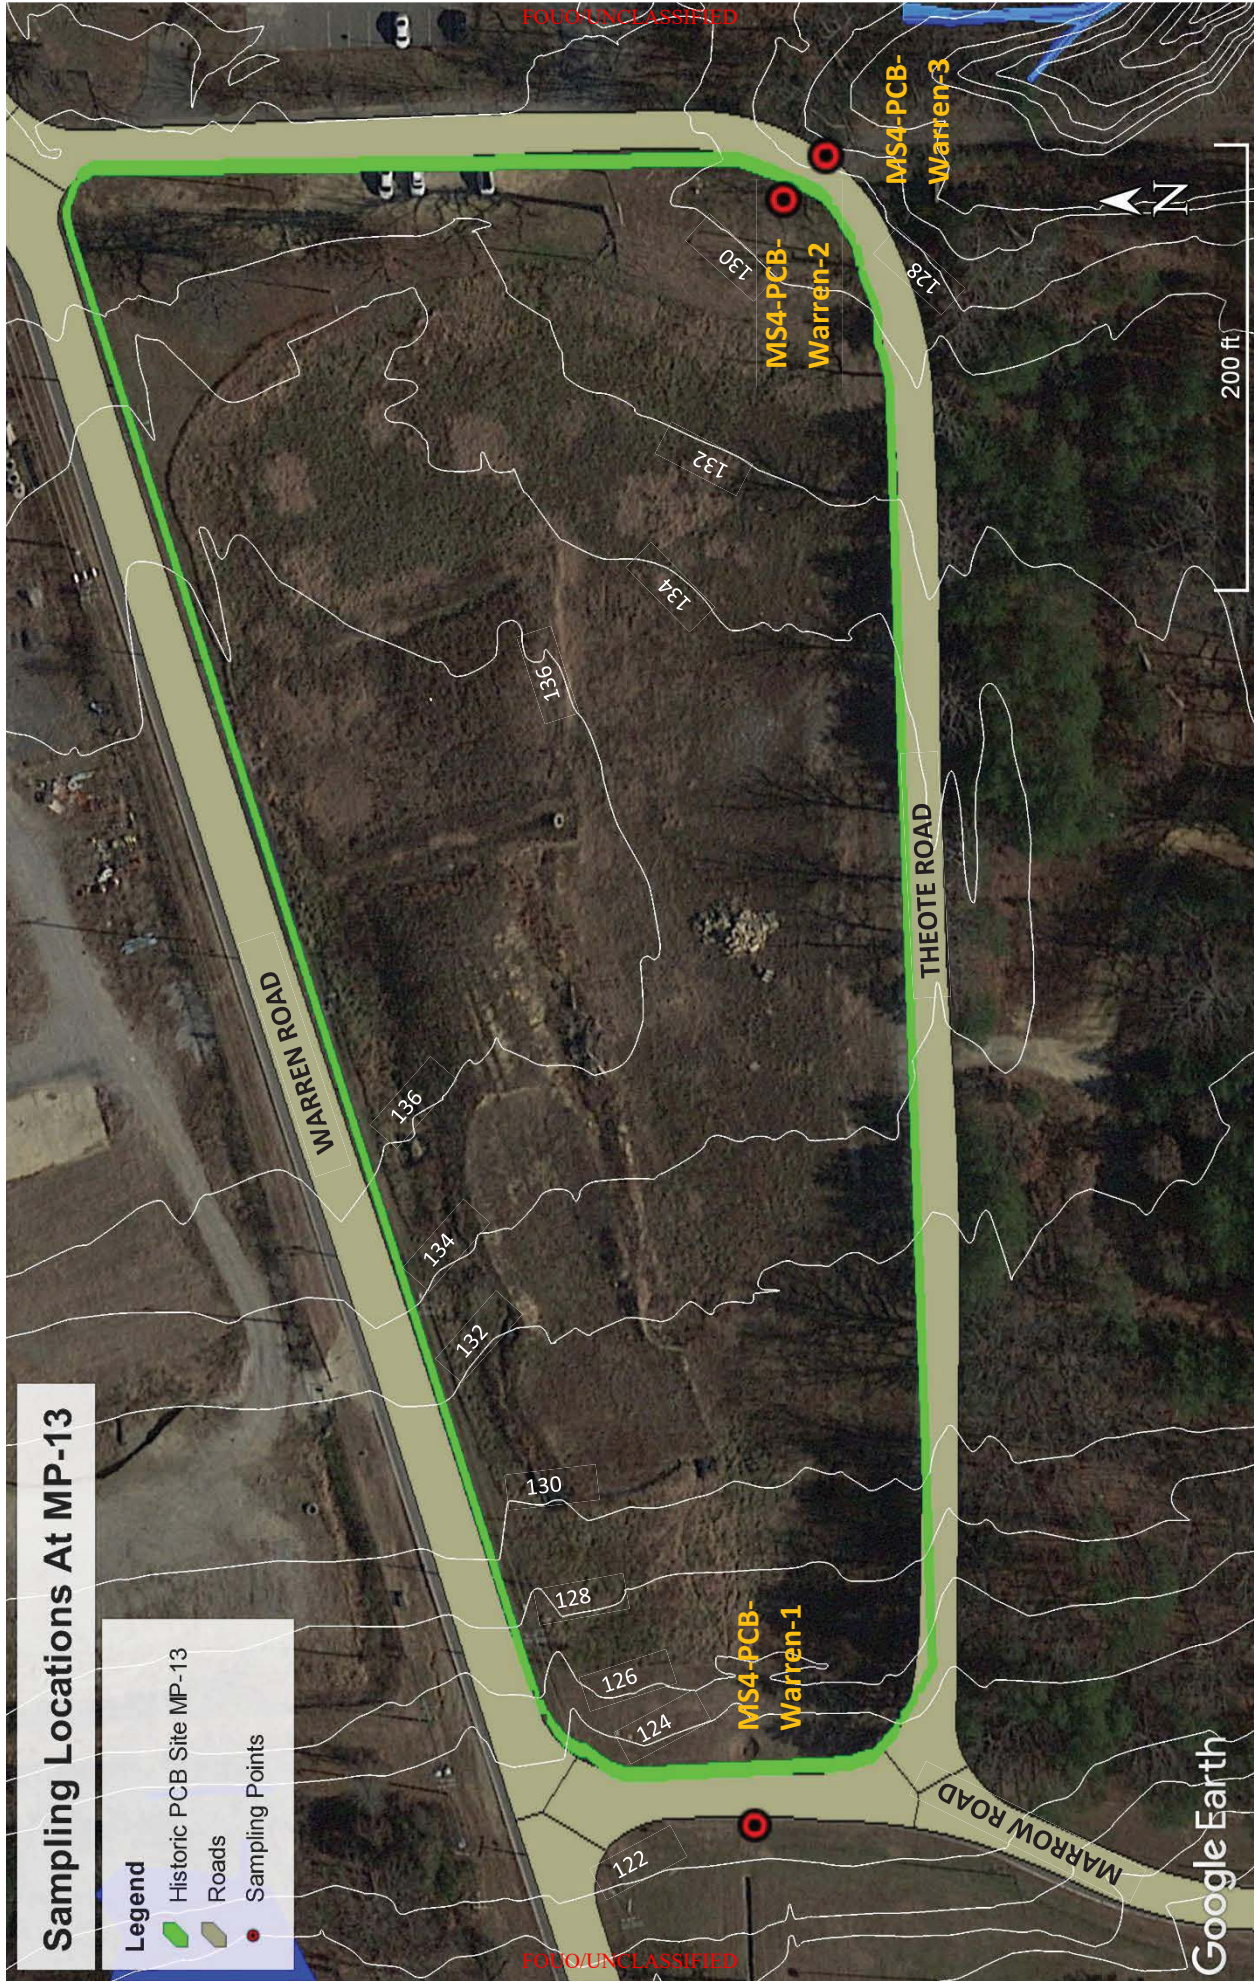
Sampling Locations At MP-13

- Legend**
- Historic PCB Site MP-13
 - Roads
 - Sampling Points

Site Layout and Proposed Sample Locations for Site MP-13 RFI

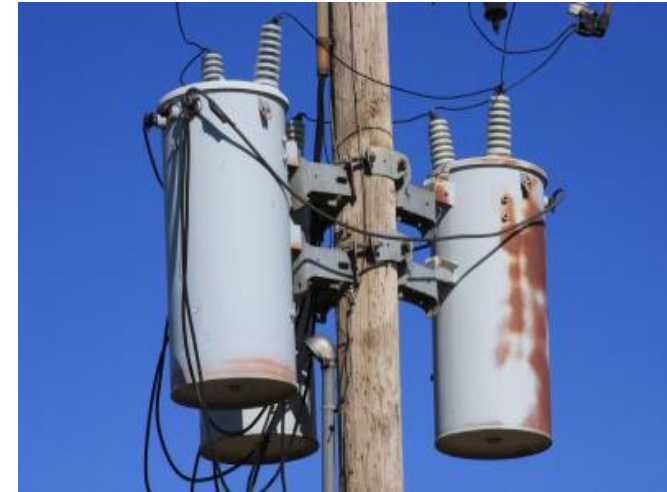
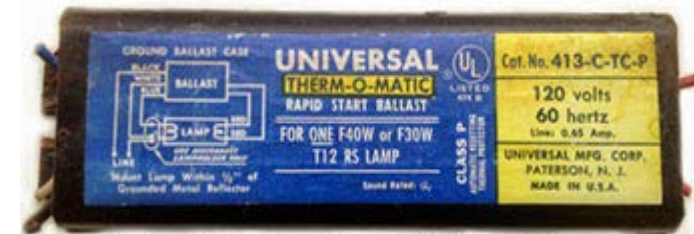
A typical pre-1979 PCB-containing fluorescent light ballast (FLB)

- Yellow, oily liquid or tar-like potting material that leaks from the FLB or transformers.
- Older, derelict transformers around the Installation

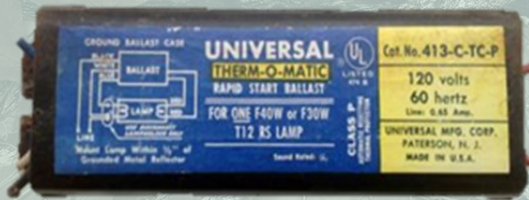
A typical pre-1979 PCB-containing fluorescent light ballast

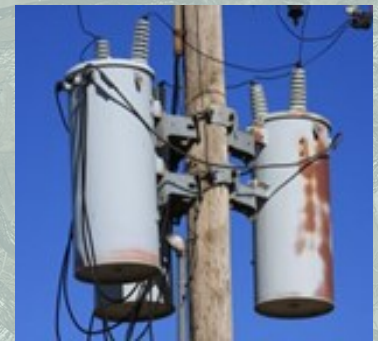
Typical PCB-containing Transformer

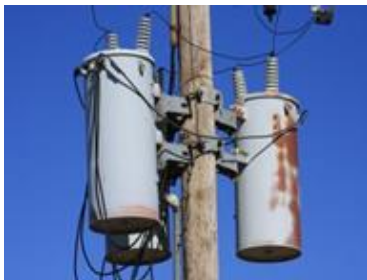
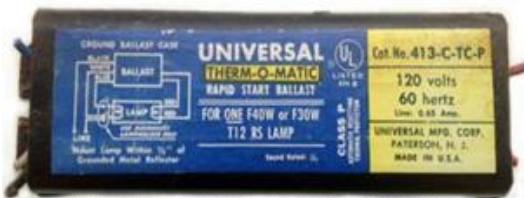
A typical pre-1979 PCB-containing fluorescent light ballast (FLB)

PCBs may be present as a yellow, oily liquid or in the tar-like potting material that leaks from the FLB or Transformers. A leaking FLB or Transformer may increase PCB levels in the air, therefore, measures should be taken to avoid personal exposure.

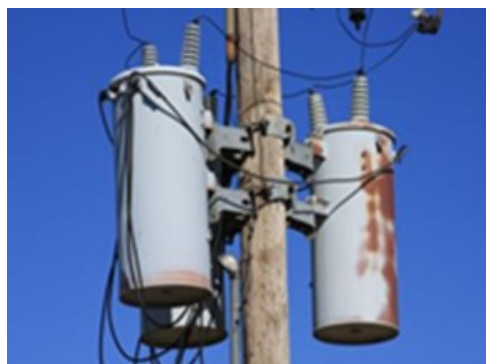
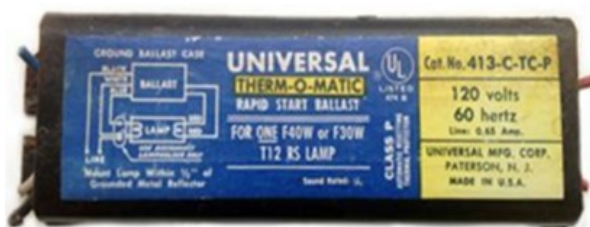
A typical pre-1979 PCB-containing fluorescent light ballast (FLB)

PCBs may be present as a yellow, oily liquid or in the tar-like potting material that leaks from the FLB or transformer. A leaking FLB or transformer may increase PCB levels in the air. Therefore, measures should be taken to avoid personal exposure.
