**ELIGIBILITY ASSESSMENT OF THE PARRISH HOUSE,
BUILDING 5001, FT. CAMPBELL, KENTUCKY**

**Prepared for:
USACE Louisville District
600 Martin Luther King Drive
Louisville, Kentucky 40202-2232**

**Prepared by:
Samiran Chanchani, Ph.D.
Principal Investigator
BHE Environmental, Inc.
11733 Chesterdale Road
Cincinnati Ohio 45246-3405
513-326-1500
www.bheenv.com**

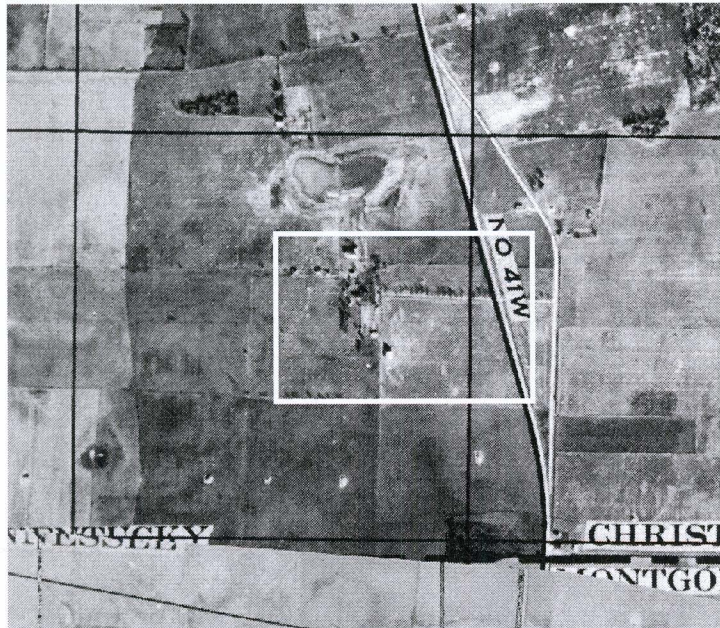
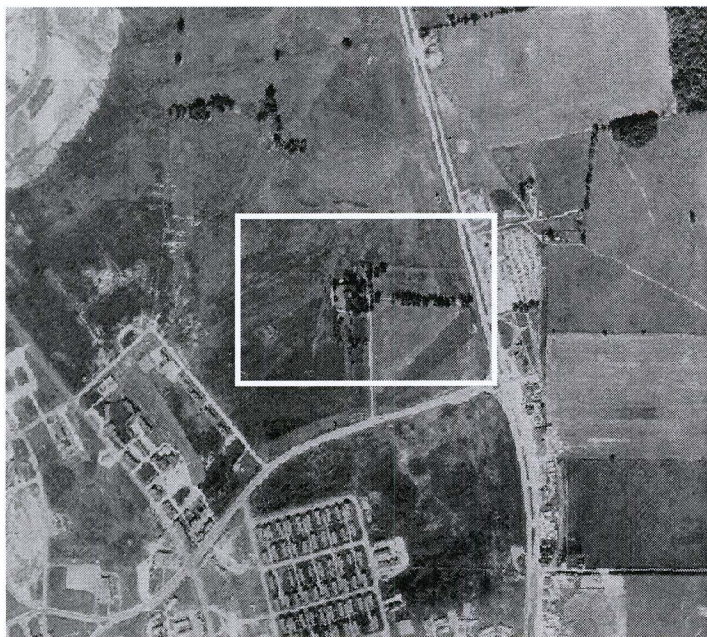
Fig. 3 (a): Aerial Photograph of the Camp Campbell Area, 1941, showing the location of Parrish House and associated properties; (b) Aerial Photograph of Ft. Campbell, 1945-58, showing the location of Parrish House

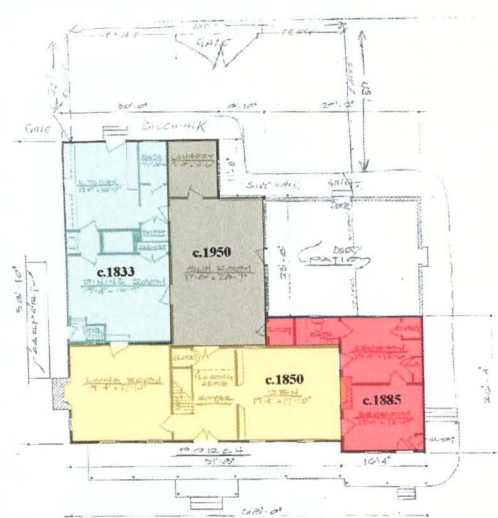
1ST FLOOR PLAN (QTRS 5001)

Fig. 4: First Floor Plan and , Parrish House, Housing Division, Ft. Campbell.

The kitchen, the adjacent dining room (used by the current residents as a sitting room), and the passage in between comprised the first floor of the original log cabin (Figs. 4, 13). The original second story of the cabin now serves as an attic. On the first floor, interior finishes cover the original log construction to unify the interior appearance of the house. However, certain characteristics inherent to log construction reveal the presence of the original cabin within the walls of these rooms. First, the rooms have low ceilings (approximately 8'-0" high) typical of log construction. Second, door and window openings reveal the thickness of the structural walls to be 10" to 12", another characteristic feature of log construction (Fig. 14).

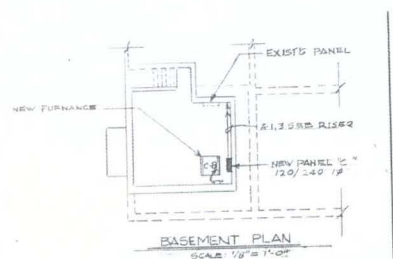
Fig. 5(a): Second Floor Plan and key plan of construction history, Parrish House (b) Basement Plan, Parrish House

On the upper level are two bedrooms with attached baths, a dressing area for the master bedroom, and an attic accessible from a hatch in the master bath (Fig. 5). The master bedroom is directly above the living room; the second bedroom is directly above the den. The second floor landing is walled in to make room for a dressing area for the master bed. The attic, which included the upper level of the original log cabin, testifies to the past of the building. Here is evidence of the original construction, including the walls, the old hearth, and an old post where there were steps to the main level. The fireplace in the master bedroom has been refurbished and is in working condition. In the second bedroom, a niche in the wall and the surround indicate the location of the original fireplace.

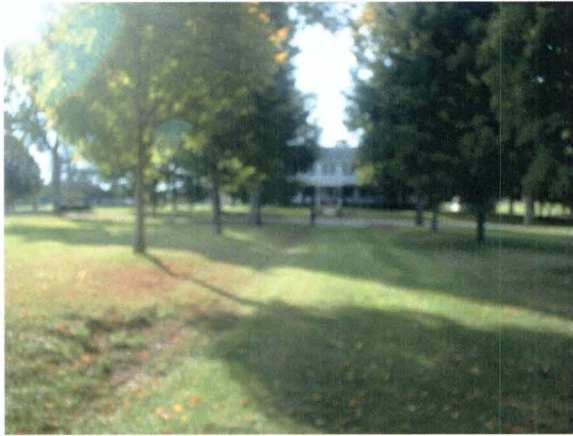
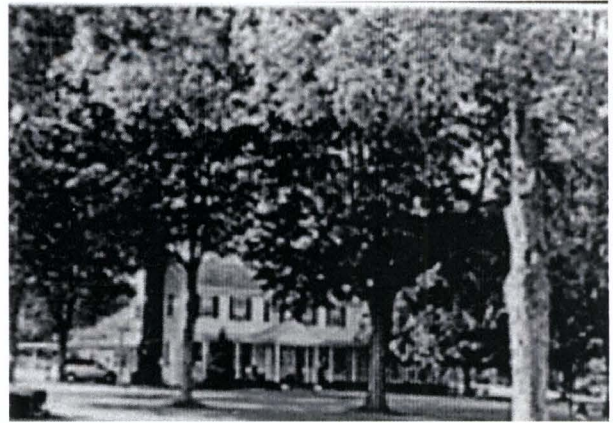
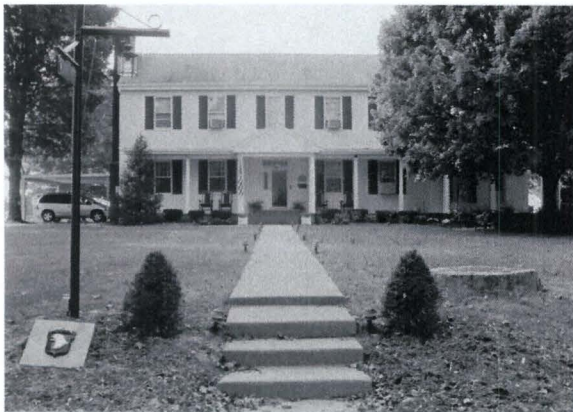
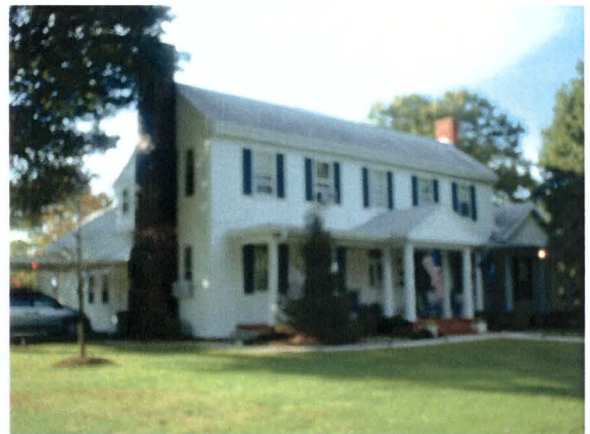
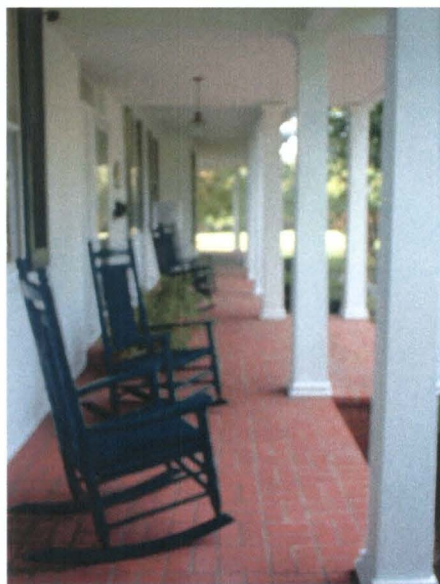
Fig. 6 (a) Trees marking old approach from 41A; (b)Parrish House, approach; (c) Front Facade; (d)South and Front facades (e) Porch

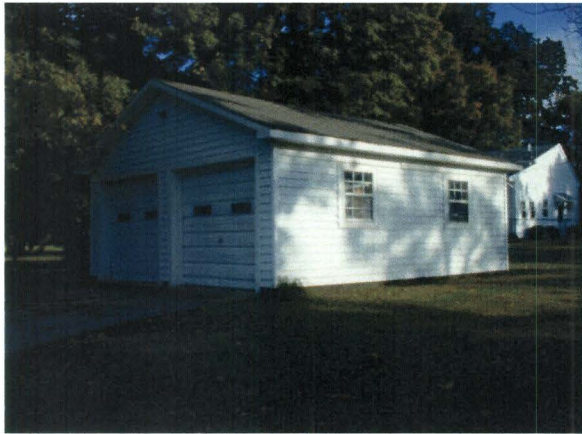
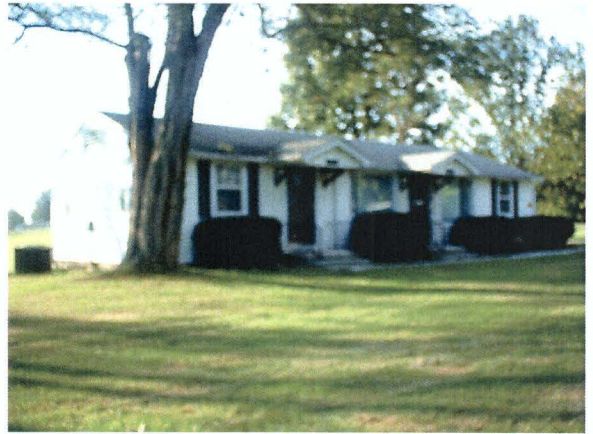
Fig. 8 (a): Outbuilding - Garage looking north; (b) Outbuilding - Guesthouse, looking west

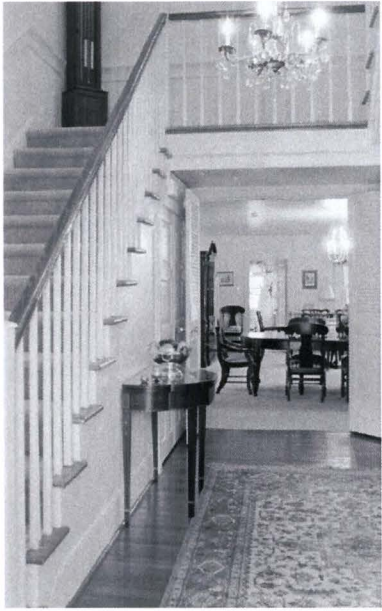
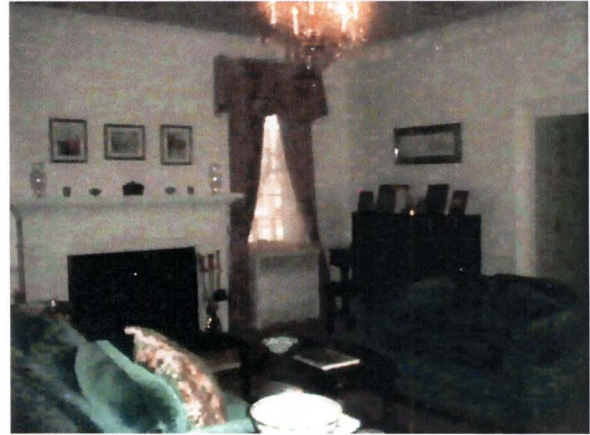
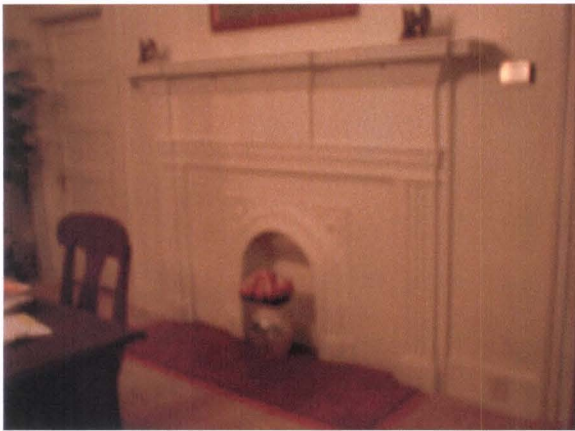
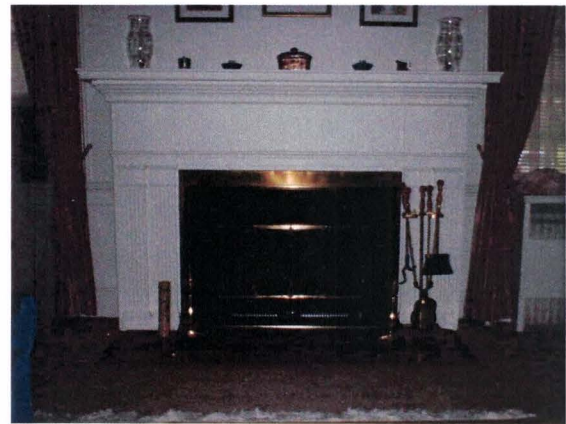
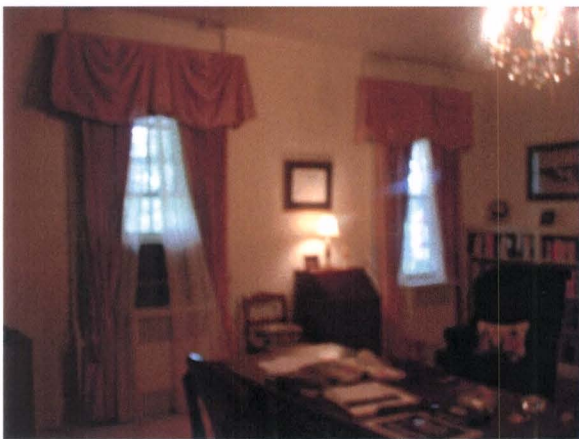
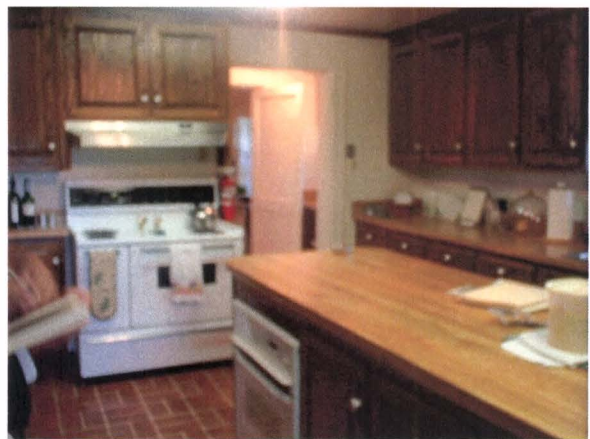
Fig. 9 (a) Entrance Hallway looking west; (b) Living Room, looking south; (c) Fireplace, Den - Italianate Motif; (d) Fireplace - Living Room; (e) Den, looking northwest; (f) Kitchen - part of the original log cabin, looking west

Inside, the house is compact in plan and has few corridors or hallways. Especially on the first floor, rooms typically provide access to neighboring rooms. This plan-type – in which rooms, rather than lengthy hallways, give access to other rooms - allows residents and visitors to experience and access the building and its rooms in various ways (Fig. 4). The main entrance leads to a foyer flanked symmetrically by rooms on either side, leading to the ‘sun room’ through a large, two-panel door in front. On the left side is an open well staircase that leads to the upper floor. A mid-landing with a large window is situated across from the main entrance and above the door to the sunroom. Left of the foyer is the living room with a classically styled, Greek Revival fireplace on the south wall with windows on either side. The original picture rail is still in place in this room. A centrally positioned door on the west wall of the room leads to the dining room and kitchen suite, which are two steps down. A door from the dining room leads directly to the sunroom, while one from the kitchen also provides access to the same room, but this time mediated by a passage. At the rear of the house, and abutting the kitchen are a laundry room and a small bath. The sunroom, which is a dining area, connects to the patio (Fig. 9 a, b, d).

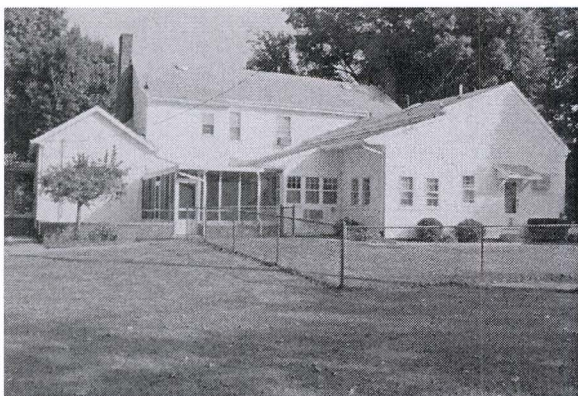
10

Fig. 10: View of rear elevation showing the three major components of the building, looking east.

The main building on the property is a composite structure with numerous additions and modifications carried out since its original construction (Fig. 10). The original structure, a log cabin constructed in 1833, was absorbed into the present-day farmhouse (Fig. 11). In the 1850s, a large addition was made to the building, greatly changing its original character. A second major addition was constructed in the 1880s (Fig. 12). These and other lesser modifications mark the building's changes in form through time. The structure also has changed in use, from a farmhouse to the residence of the CG at Ft. Campbell with part of the building used as a dentist's office in the interim.

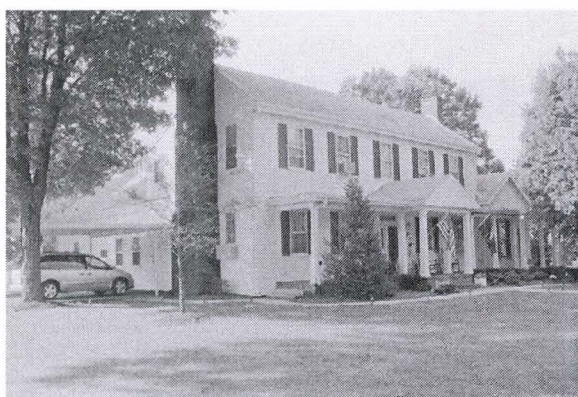
12

Fig. 12: View of front elevation of 1850s addition, looking northwest.

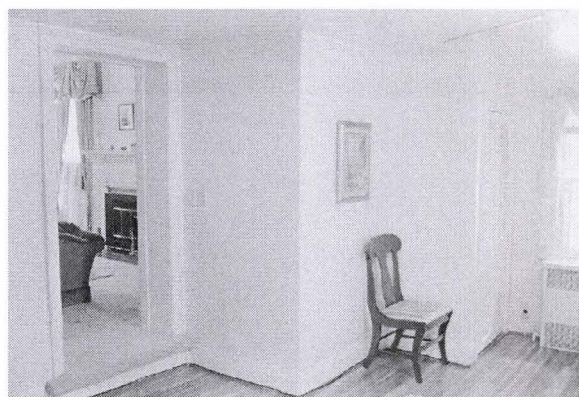
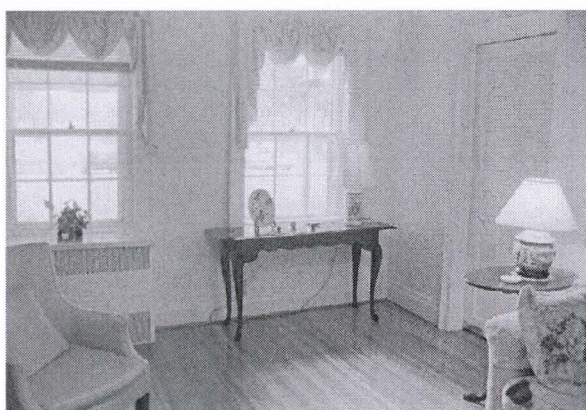
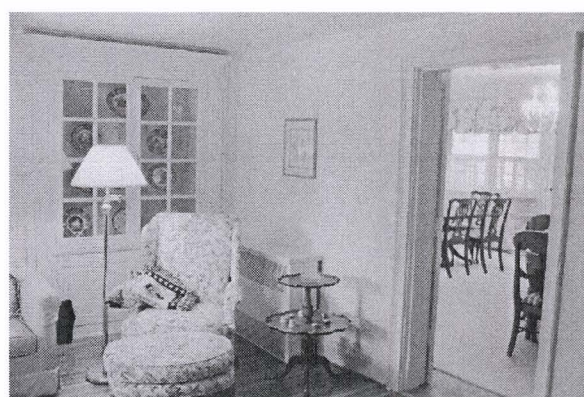
Fig. 13: a): View of the northeast corner of the dining room, looking northeast; (b)View of the dining room, looking southwest; (c) View of the dining room, looking west northwest

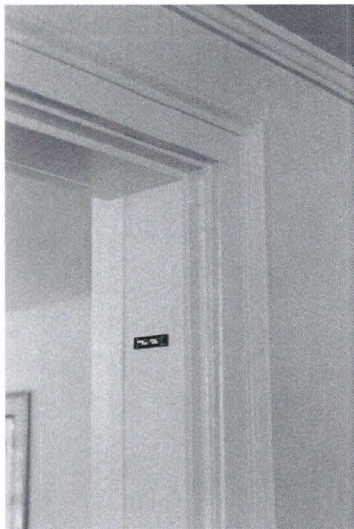
14

Fig 14: Detail of door opening from sitting room to dining room showing width of walls, looking southeast.

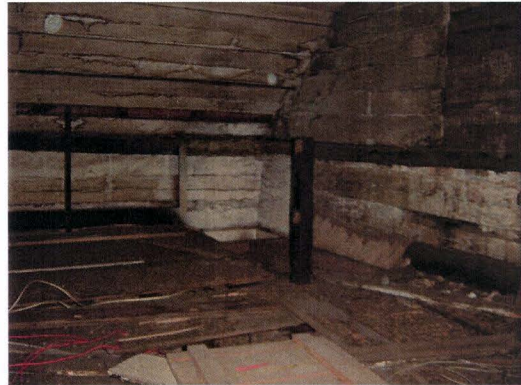
15

Fig 15: Detail of second floor of log cabin

The layout and other details of the original cabin are more clearly visible on the second floor (Fig. 15). Used as an attic that may be accessed from the master bath, the upper level of the log cabin is relatively unaltered. Floor Plans from 1946 (Office of the Post Engineer 1946), when compared with the recent drawings included in this report indicate that the master bath has been expanded by capturing previously unused space on the second floor of the log cabin structure. It is possible to gauge from here that the log cabin was a two-storied, two-chamber structure (Fig. 16). The cabin was oriented east to west, and it is probable that the entrance was located in the center of the south elevation. The structure was constructed as two chambers (sometimes referred to as "pens") separated by a massive stone fireplace. This configuration resulted in an approximately 4½ ft. area between the two "pens" that extends across the entire structure (Fig. 17). On the main level, this space contains a cupboard where back-to-back cupboards were indicated in the 1946 floor plan (Fig. 18).

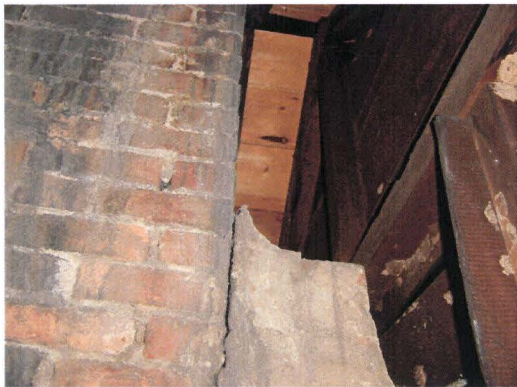
16	Detail showing fireplace opening in second floor of log cabin.	27

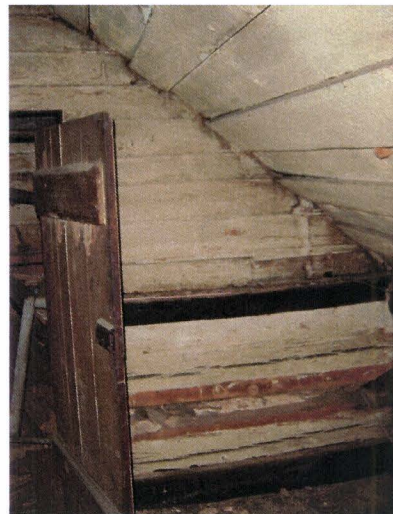
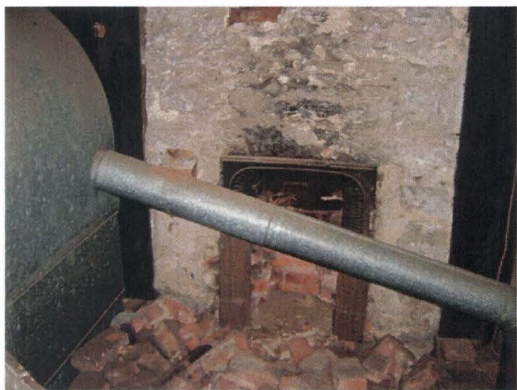
Fig. 17: (a) Detail showing door between two chambers on upper level of log cabin (b) Detail showing chimney on second floor of log cabin.

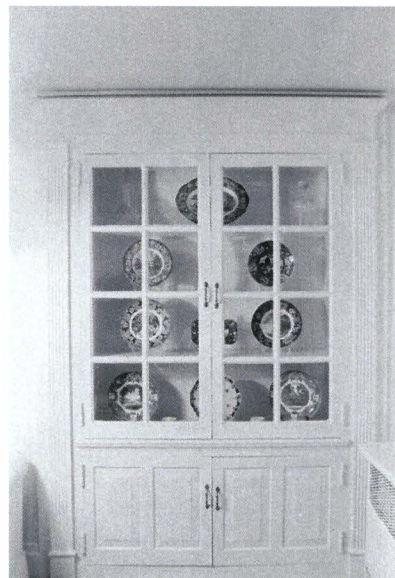
18

Fig. 18: View of sitting room built-in cabinet, looking west.

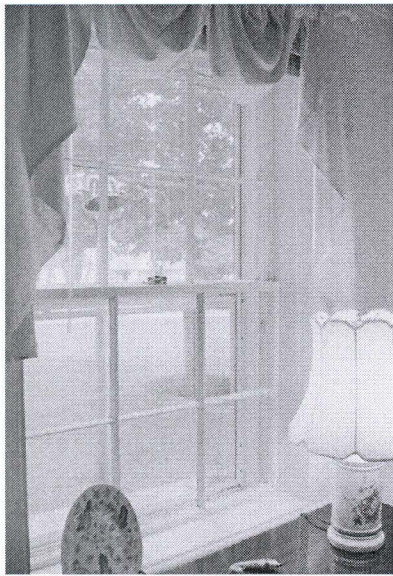
19

Fig. 19: View of sitting room window looking southwest

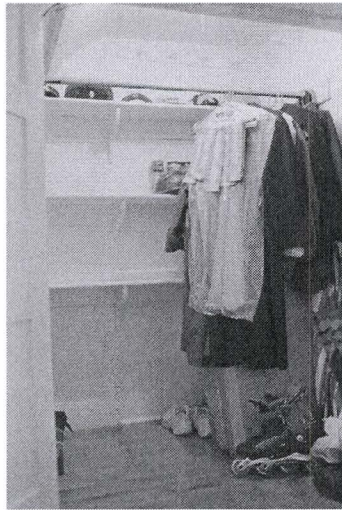
22

Fig. 22: View of the closet under the stairs, showing the location of an earlier pantry window, looking south.

Other modifications that may be mentioned are replacement windows and new openings in the master bedroom, staircase tread and balustrade replacement, pantry door/window in the coat closet under the staircase; fireplace –Italianate on the lower floor, and the covered one in the master bedroom.

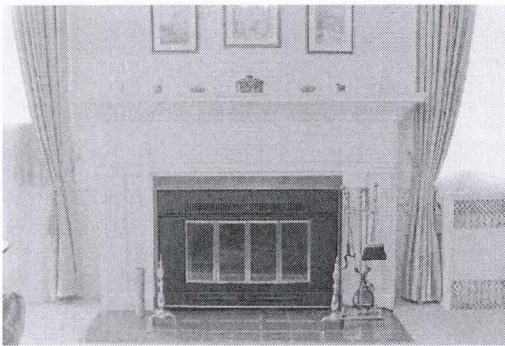
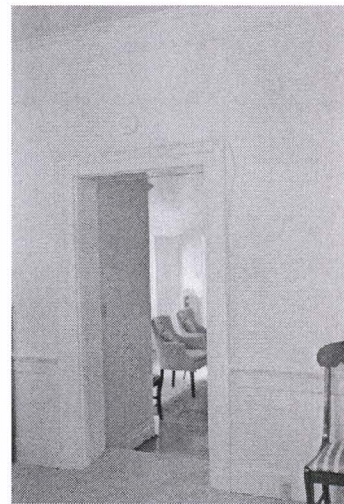
24(a)

Fig. 24: (a) View of the living room fireplace in the south chamber of the 1850s addition looking south (b) View of Greek Revival detail in living room, looking west southwest

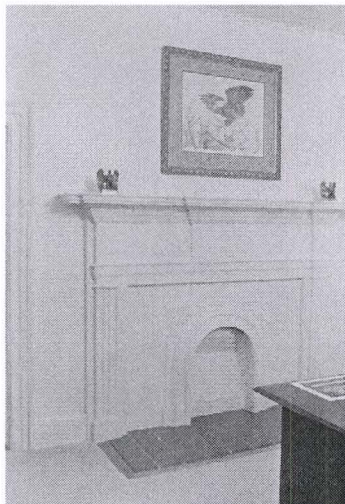
25

Fig. 25: View of fireplace in general's office (den), north chamber of 1850s addition, looking north northeast.

Inside, the foyer also served as the main stair hall to provide access to the upper level. A monumental stair, reversing at an intermediate platform level, dominates this entry (Fig. 21). This stair was originally an open, or flying assembly, evidenced by the remnants of a passageway beneath the intermediate landing (Fig. 22). Later modifications to this stair have replaced the original railing and balusters (Fig. 23). On either side of the foyer were main parlors, and above them large bedrooms. While the formal layout of the entrance foyer and the flanking rooms retain their characteristics, the uses of the rooms on the lower level have changed. These function as a living room and the General's office. The chambers upstairs are still used as bedrooms. This addition is characterized by Greek Revival design elements inside and out, including the very formal floor plan, moldings, and other classical decorative features. The fireplaces in this addition, on both the first and second floors, retain their Greek Revival detailing (Fig. 24). The only one of the four fireplaces remaining intact is that in the living room. The fireplaces in the den and the bedroom above were modified to accept coal, and the fireplace in the bedroom was covered over (Fig. 25). The addition more than doubled the footprint of the

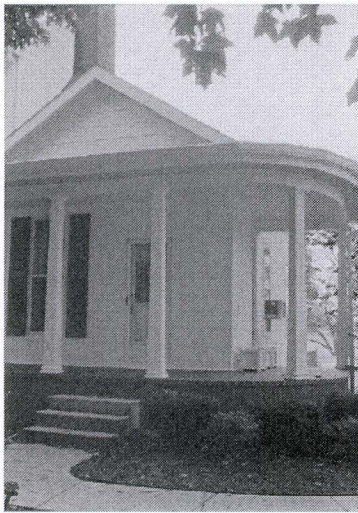
26a

Fig. 26: (a) View of 1880s addition, looking west

A second addition was constructed, possibly in the mid- to late-1880s. This one-story construction was added to the north end of the 1850s building; however, its elevation, including a roof ridge perpendicular to that of the 1850 house, gives the impression of a disconnected, almost independent structure (Fig. 26). This addition was in the 1930s as a dentist’s office. Its layout and the fact that it has a separate entrance suggest that it was, in all likelihood, constructed specifically to house business activities. This addition is different in form and character from the rest of the farmhouse. Unlike the 1850s building with its 9½ feet high ceilings, the addition is characterized by 11-foot high ceilings. Moreover, it has tall narrow double-hung windows with sills only 12 to 14 inches above the finished floor, two-over-two sash divide by vertical muntins, and Eastlake type decorative features on the porch entry door (Fig. 27). The style, associated with the 1880s gives another indication of the building’s date of construction. There are closets built into the two original chambers addition within the last 20 years.

- * Proportions are rectangular rather than square
- * 11-foot high ceilings
- * tall narrow double hung windows with sills only 12 to 14 inches above the finished floor,
- * The windows are two over two sash divide by vertical muntins
- * porch entry door has Eastlake style decorative features

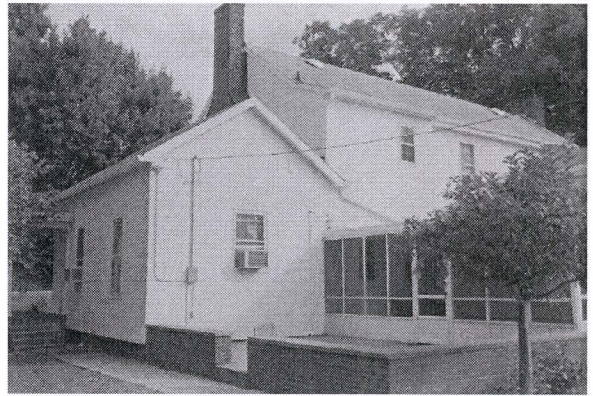
26b

Fig. 26 (b): View of 1880s addition from rear, looking southeast.
