**ENVIRONMENTAL ASSESSMENT AND FINDING OF NO
SIGNIFICANT IMPACT**

**PROPOSED BREACH OF KU TREE DAM AT
EAST RANGE, SCHOFIELD BARRACKS, OAHU ISLAND, HAWAII**

Prepared By: U.S. Army Corps of Engineers, Honolulu District

Prepared For: U.S. Army Garrison, Hawaii

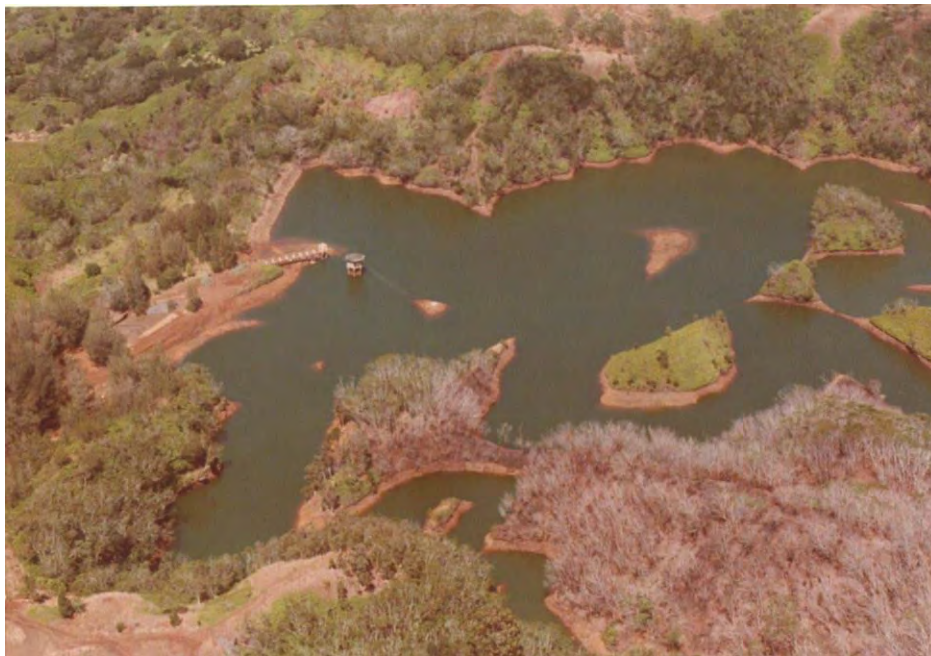
36 Plate 1. **Ku Tree Reservoir** (date unknown)
37 Source: Phase I Inspection Report, National Dam Safety Program (C-E Maguire, Inc., 1978)
38
39

13
14 At maximum capacity, the reservoir pool was 32 acres (13 hectares) in size and provided storage
15 of 900 acre-feet (293 million gallons) of water. Plate 1 below shows dam and reservoir at full
16 capacity.

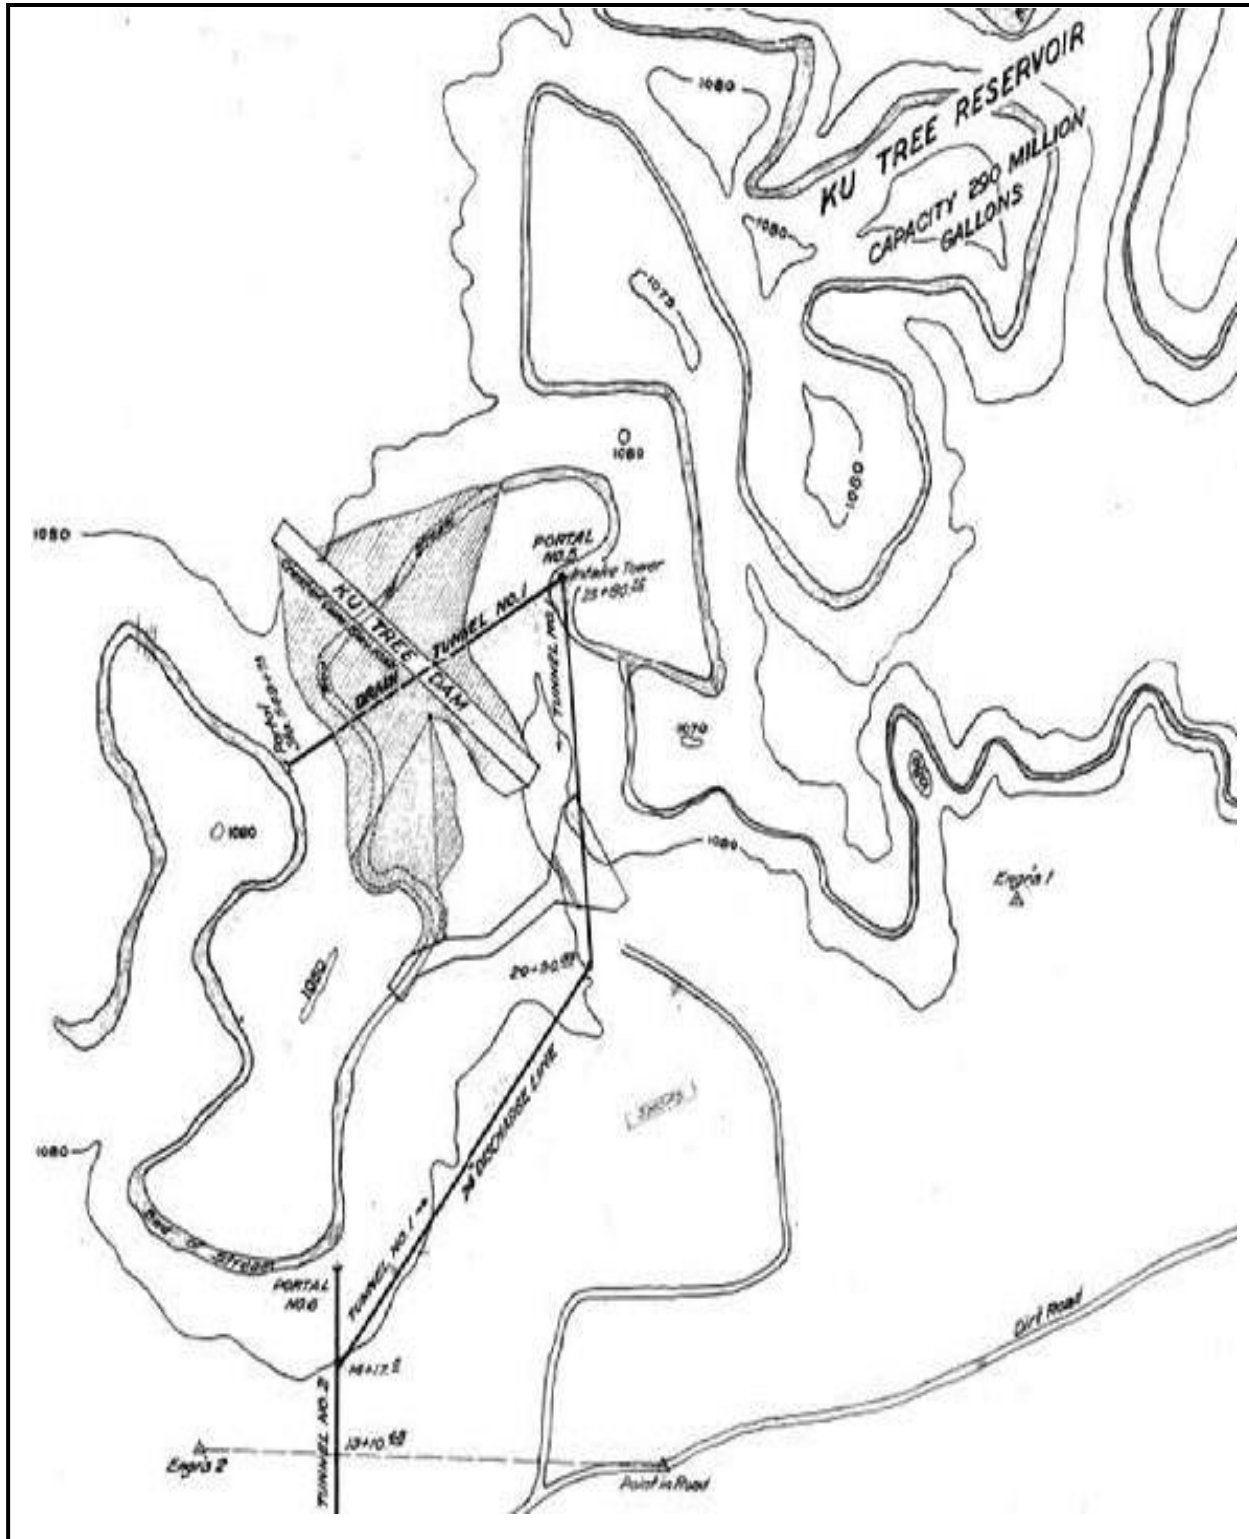
Figure 1. Relationship of Original Flow Path to Dam and Spillway

5
6 Ku Tree Dam is a hydraulic earth-filled dam that is approximately 550 feet long by 90 feet high
7 with a crest width of 30 feet. Construction of the dam crest blocked the original flow path of
8 South Kaukonahua Stream, impounding water behind the dam, and creating Ku Tree Reservoir
9 which drowned the two meandering tributaries of South Kaukonahua Stream behind the dam at
10 the 1,159-foot elevation. Looking downstream, a concrete converging spillway is located on the
11 left abutment of the dam. The spillway has a 160-foot ogee weir and drop section into a stilling
12 basin. Figure 1 below shows the relationship of the original flow path to the dam and spillway.

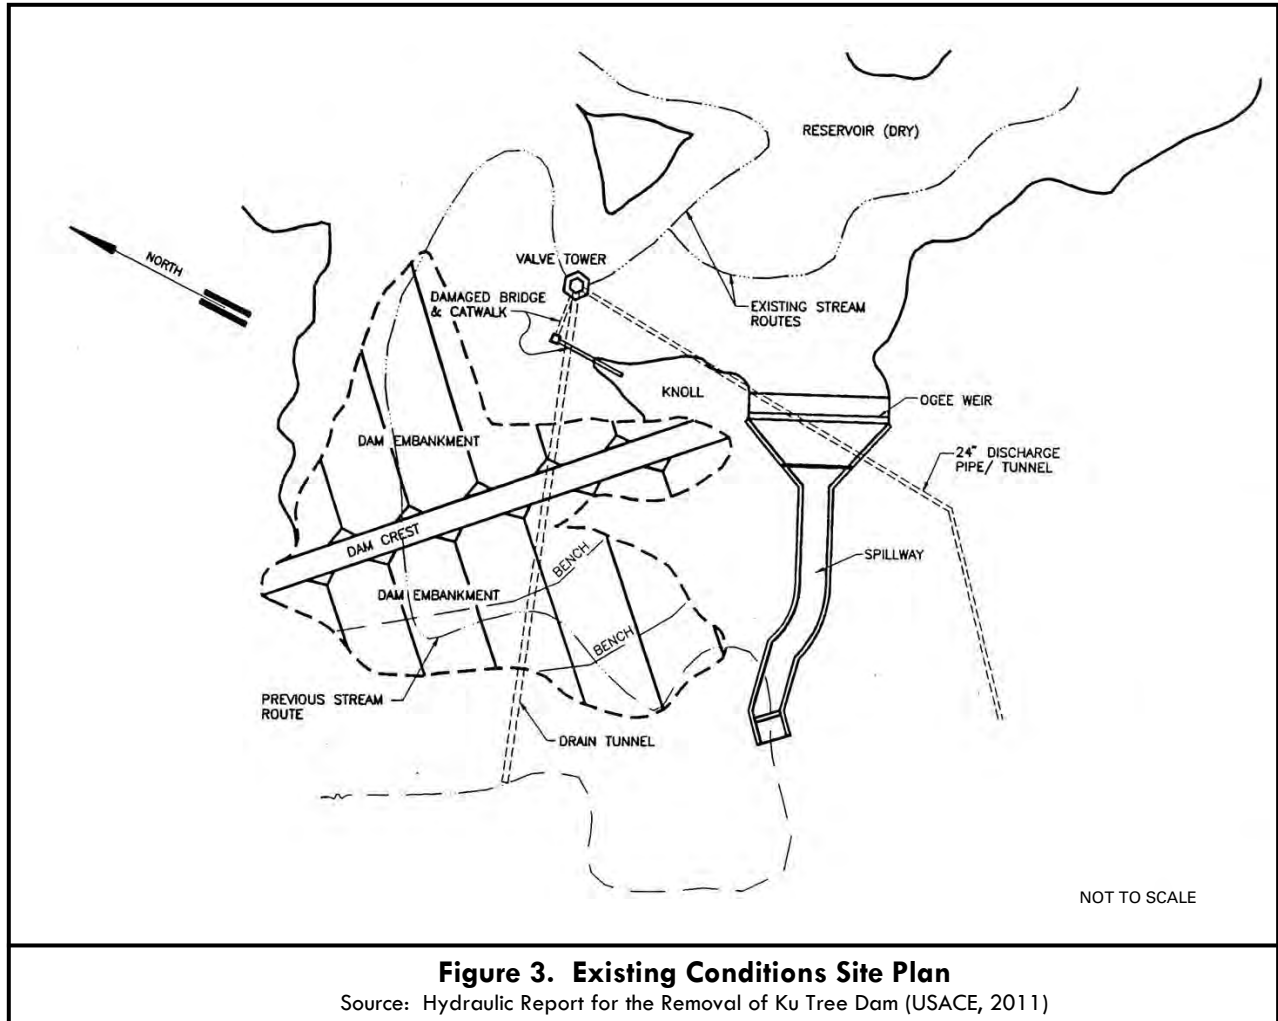
Figure 3. Existing Conditions Site Plan

The Ku Tree Dam and Reservoir is composed of several structural components, which are described below. Figure 3 shows a site plan of the dam and appurtenant structures.

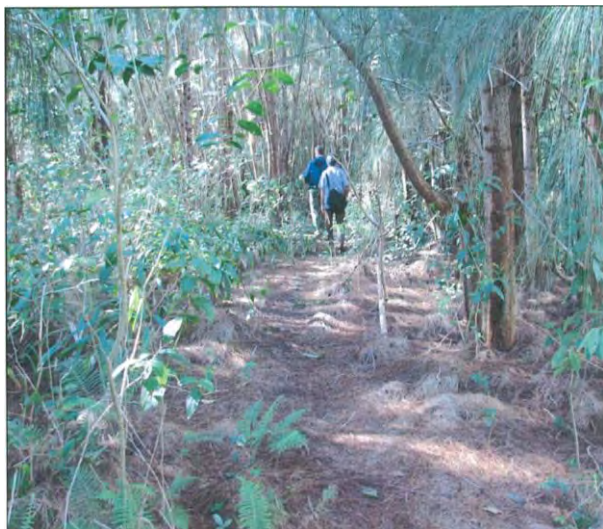
Plate 2. **Dam Crest**

The Ku Tree Dam is approximately 550 feet long and 90 feet high with a crest width of 30 feet. Both the upstream and downstream faces are sloped one vertical to three horizontal. The upstream slope is protected by riprap and the crest and downstream slope is grassed. Plates 2 through 4 show the current condition of the dam's crest and upstream slope. The embankment is homogeneous with the timber diaphragm core wall. The embankment crest is at elevation 1,085 feet above mean seal level (msl). Figure 4 shows a section and elevation of the existing dam structure. At full capacity, the dam was capable of impounding a 0.5-mile long reservoir with an estimated storage volume of 293,000,000 gallons or 900 acre-feet. At crest elevation, the depth of the reservoir was approximately 85 feet at its deepest point. The total surface area at spillway elevation was approximately 32 acres with a drainage area encompassing approximately 531 acres.

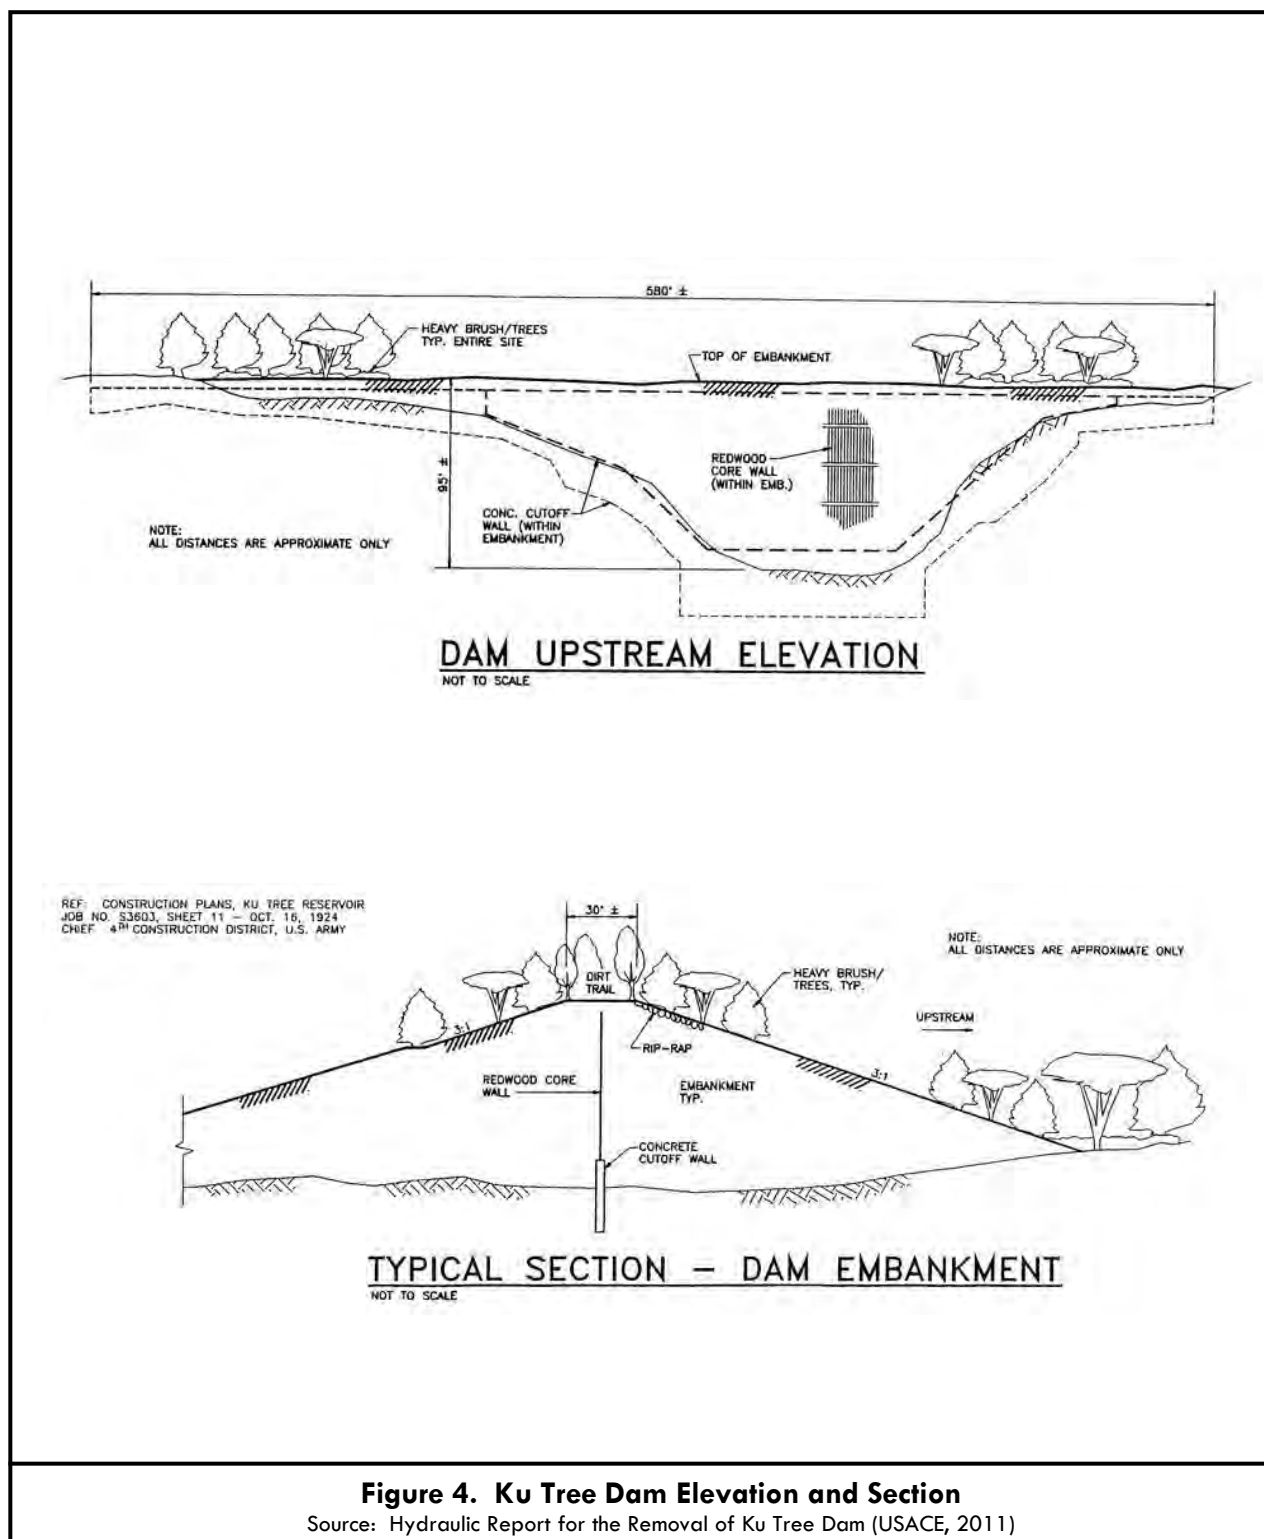
39
40 Ku Tree Dam is a hydraulic earth-filled dam that is approximately 550 feet long by 90 feet high
41 with a crest width of 30 feet. Looking downstream, a concrete converging spillway is located on
42 the left abutment of the dam. The spillway has a 160-foot ogee weir and drop section into a
43 stilling basin.
44

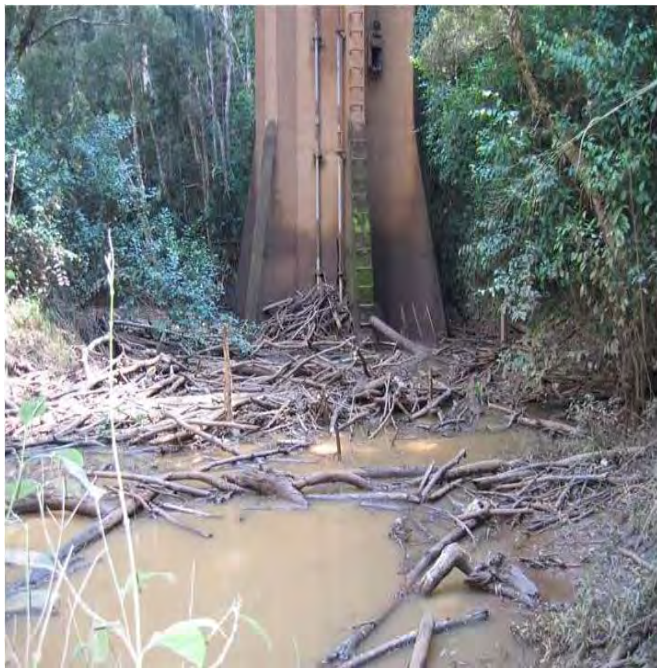
Plate 5. Base of the Valve Control Tower
Source: Limited Visual Inspection Report (USACE and DLNR, 2006)

The valve control tower contains the outlet works that regulated drainage for the Ku Tree Reservoir when it was in use (Plates 5 and 6). The tower is a hexagonal-shaped, reinforced concrete structure standing 102 feet in height. Five sluice gates are located on the various faces of the structure at incremental elevations of 1,065, 1,050, 1,035, 1,020, and 1,005 feet above msl. The gates are vertical slide mechanisms 18 inches x 24 inches with trash screens to block debris from clogging the outlet. Once manually-operated, the gates are currently inoperable and remain open to allow any retained water to pass through. When it was operational and the water level of the reservoir was at spillway crest-height, the outlet was able to pass a maximum of 619 cfs. At the base of the valve tower are inlets to the drain and discharge tunnels. Since being drawn down, water is discharged back to the stream below the dam through the drain tunnel. It is estimated that approximately 2.47 cfs or 1.6 million gallons per day (mgd) of flow enters the intake structure from the two streams above the reservoir (Kido, 2004).

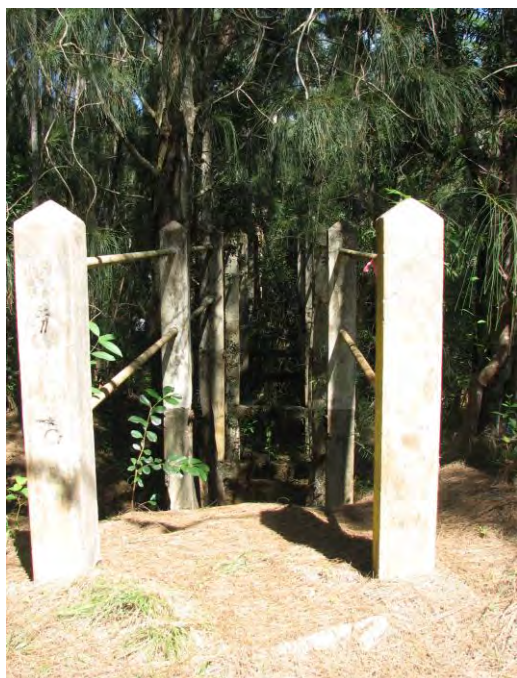
Plate 7. Remnants of Tower Footbridge from Dam Abutment

The tower foot bridge provided access from the dam to the wood-framed control room atop the valve control tower (Plates 7 and 8). It extended from a natural knoll along the left abutment of the dam. The bridge system was composed of an approach walk and a suspension bridge span. The 8-spanned approach walk was 80 feet long and had a wood deck. The suspension bridge was 67 feet long and was suspended by a pair of 1-inch diameter steel cables. The suspension spans have collapsed and the approach spans are seriously deteriorated. The wooden deck of the approach walk is no longer existent.

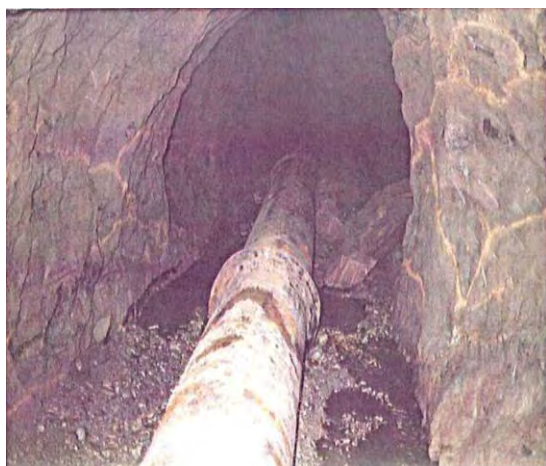
Plate 9. Discharge Tunnel

The discharge tunnel was primarily used to transport water from the reservoir to the Schofield Barracks water system (Plates 9 and 10). It is approximately 5 feet x 6 feet in diameter and accommodates a 24-inch diameter cast-iron pipe that transitions to a 20-inch pipe, which eventually leads to the Schofield Barracks water main. The total length of the tunnel is approximately 2,600 feet. The discharge tunnel is no longer in use.

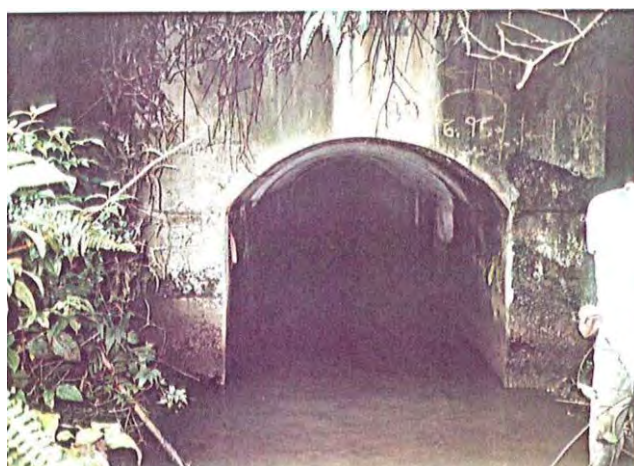
Plate 10. Downstream End of the Drain Tunnel

The drain tunnel is approximately 6 feet x 6 feet with a lined, arched roof and extends approximately 540 feet in length through the dam and discharges water to the stream below. The tunnel connects to the bottom of the valve control tower through a 3-foot x 6-foot sluice gate.

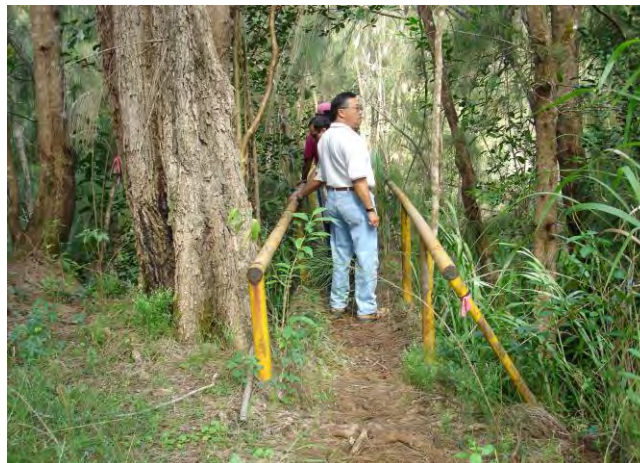
Plate 11. Footbridge Across Spillway

Looking downstream, the reinforced concrete spillway is located at the left abutment of the dam, on a natural hillside (Plate 11). The spillway is 160 feet wide, has a 20-foot concrete apron and an 8-foot ogee weir (Plates 12 and 13). The spillway structure converges from 160 feet at its crest to a 30-foot wide chute that drops to a stilling basin, which is approximately 100 feet below the crest. A 3.5-foot high weir is situated about 40 feet from the bottom end of the spillway chute. Refer to Figure 5.

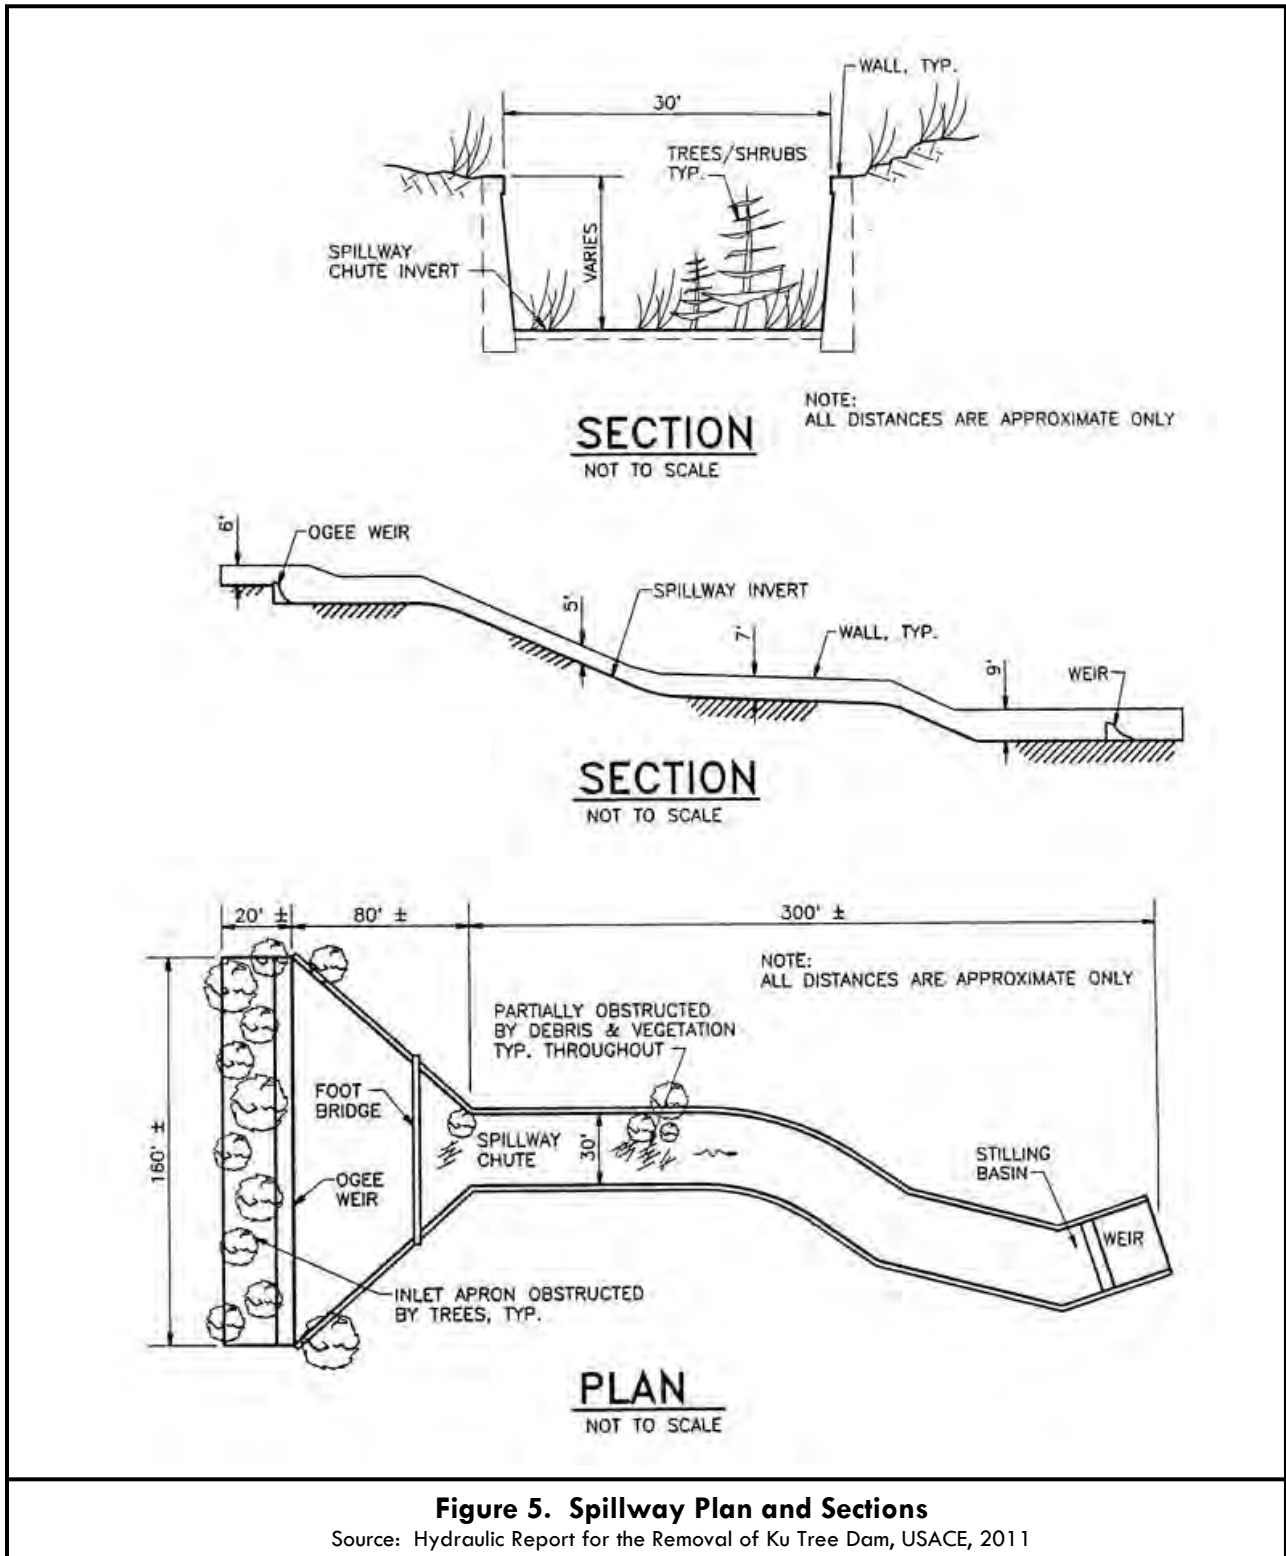
Figure 5. Spillway Plan and Sections

The spillway training walls vary in height—about 6 feet at the apron, 13 feet after the ogee weir, to approximately 5 to 7 feet at the top of the chute. The height of the chute walls vary from approximately 5 feet along the slope to about 7 to 9 feet at the lower, flat end of the chute. Figure 5 below shows a cross section, a longitudinal section and the plan of the existing spillway.

According to the 1978 inspection report (C-E Maguire, Inc.), hydraulic analyses indicated that the spillway can discharge capacity of 5,600 cfs at elevation 1,085 feet above msl (top of dam). It further noted that a flood equal to the PMF (8,300 cfs) would over top the dam by 0.87 feet.

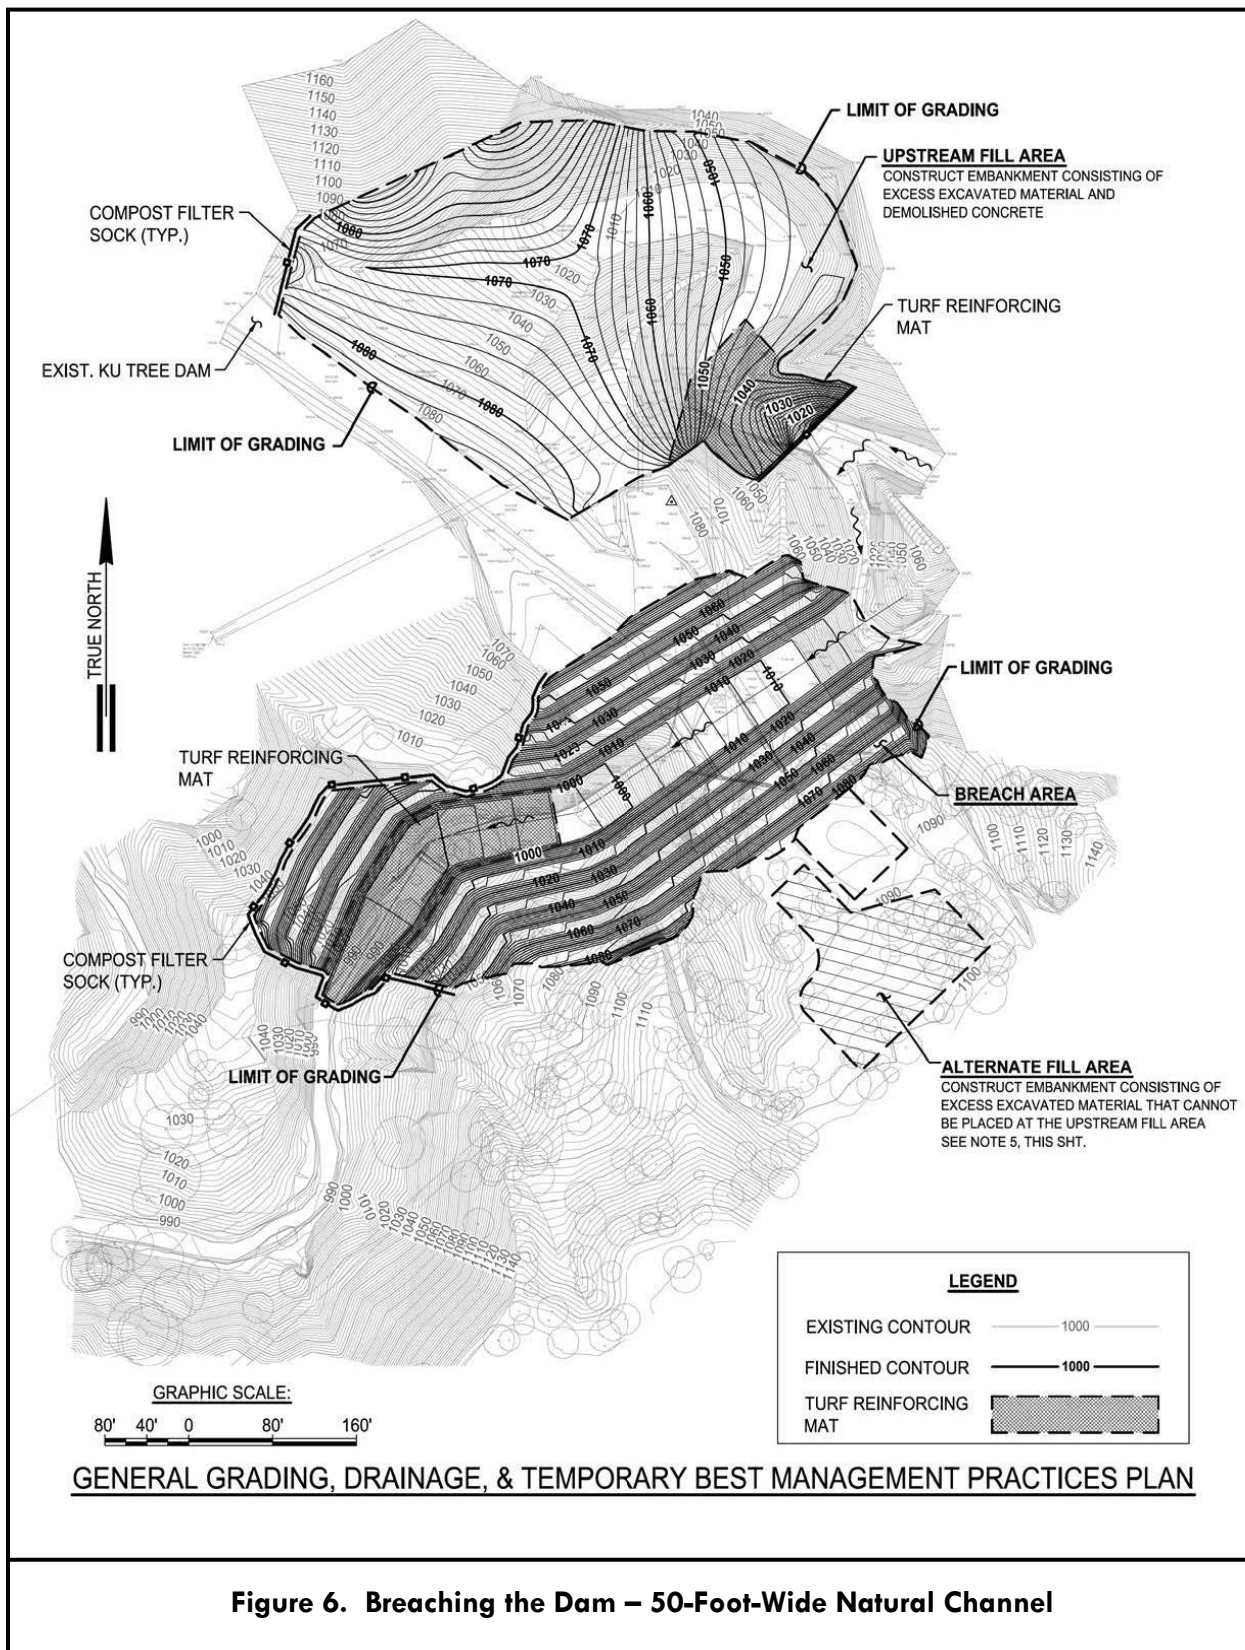
Figure 6. Breaching the Dam – 50-Foot-Wide Natural Channel

The Proposed Action would breach Ku Tree Dam by demolishing the spillway and excavating an approximately 500-foot long, natural channel through the natural hillside that supports the existing spillway. The hillside would be excavated to a depth of approximately 75 feet beneath the existing spillway entrance to match the elevation of the existing streambed. The natural channel would have a bottom width of approximately 50 feet with 1V:1H side slopes, benched every 20 feet to minimize erosion. The invert elevations of the new channel would range from approximately 1,015 feet above msl at its upstream end to approximately 990 feet above msl at the tie-in to the existing spillway channel. Provisions would be provided to ensure slope stability and establishment of vegetation. In areas subject to stream flow, turf reinforcement mats, made of pervious and flexible three-dimensional polypropylene, would be anchored to the soil to provide erosion control while allowing for mature plant growth at the up- and down-stream ends of the newly excavated natural channel. Over time, the environment in the vicinity of the natural channel is expected to transition into one that replicates naturally mature, vegetative conditions, further reducing erosion. Under this alternative, Ku Tree Dam would remain in place. The upstream dam would be filled with construction debris and approximately 112,000 cubic yards of excavated earth to block off water flow from entering the filled dam passage way. Figure 6 shows a conceptual section of the dam breach.

10 Two fill locations would be utilized for the project, the “upstream fill area” and “alternate fill
11 area.” The proposed fill locations are identified on Figure 6. To the largest extent possible,
12 excavated material would be reused on site or wasted on the upstream side of the dam (upstream
13 fill area) to minimize any off-site disposal. The alternate fill area would serve as a secondary fill
14 location for the placement of excavated material necessary to finish construction of the natural
15 channel and allow for the Contractor to remove the construction equipment from the site.
16 Demolished concrete would be used as fill at the upstream and alternate fill location.
17 Rebar/metal would be disposed of off-site.

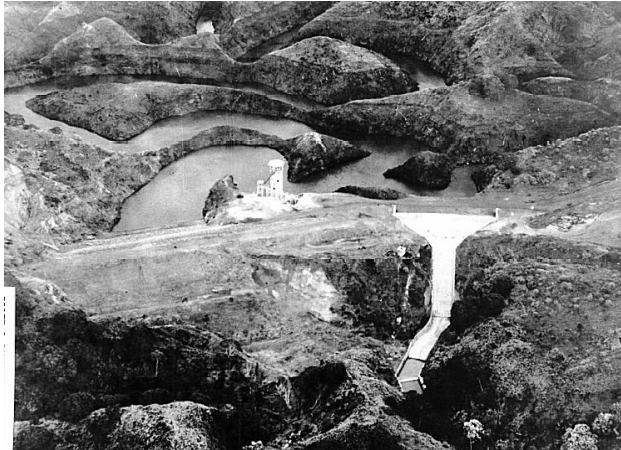
Plate 14 Looking Upstream at Ku Tree Dam Shortly After Construction (c. 1925)

22 Ku Tree Dam is a hydraulic earth-filled dam, approximately 550 feet long by 90 feet high with a
23 crest width of 30 feet. Construction of the dam crest blocked the original flow path of South
24 Kaukonahua Stream, impounding water behind the dam, and creating Ku Tree Reservoir which
25 drowned the two meandering tributaries of South Kaukonahua Stream behind the dam at the
26 1,159-foot elevation. Figure 1 shows the relationship of the original flow path to the dam. The
27 captured streams are located in narrow, meandering, forested gulches, populated primarily by
28 alien plant species, which cover 0.83 square miles (531 acres) of drainage area (AECOS, 1984).
29 The drainage area associated with Ku Tree Reservoir represents approximately 5 percent of the
30 drainage basin that supplies water to Wahiawā Reservoir. Plates 14 and 15 below are aerial
31 photos that show the dam, spillway and concrete control tower, which regulated the water levels

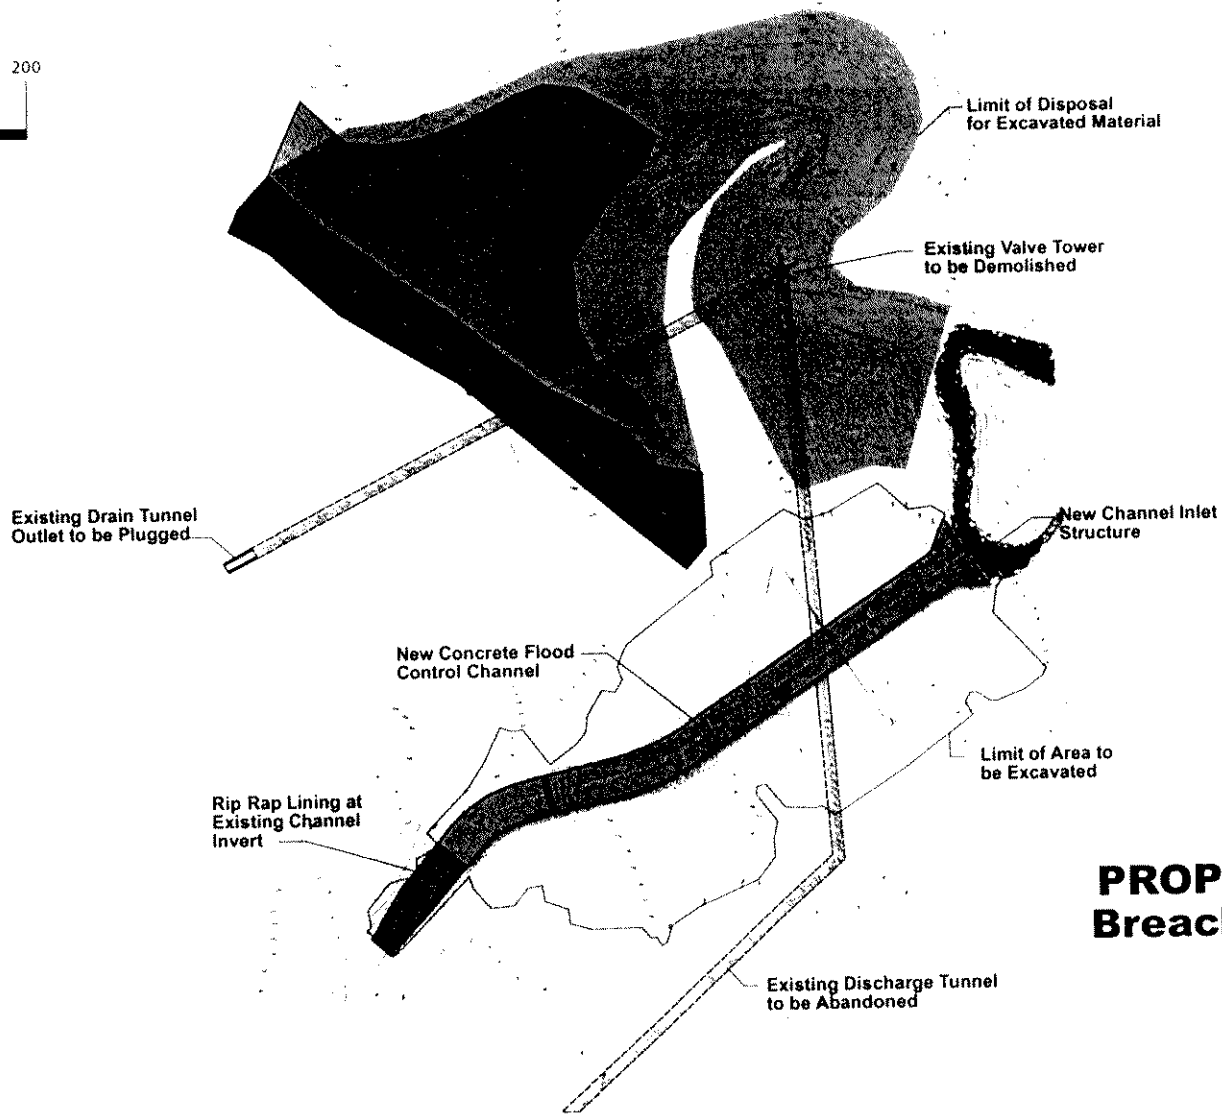
FIGURE 2

PROPOSED ACTION Breach Ku Tree Dam

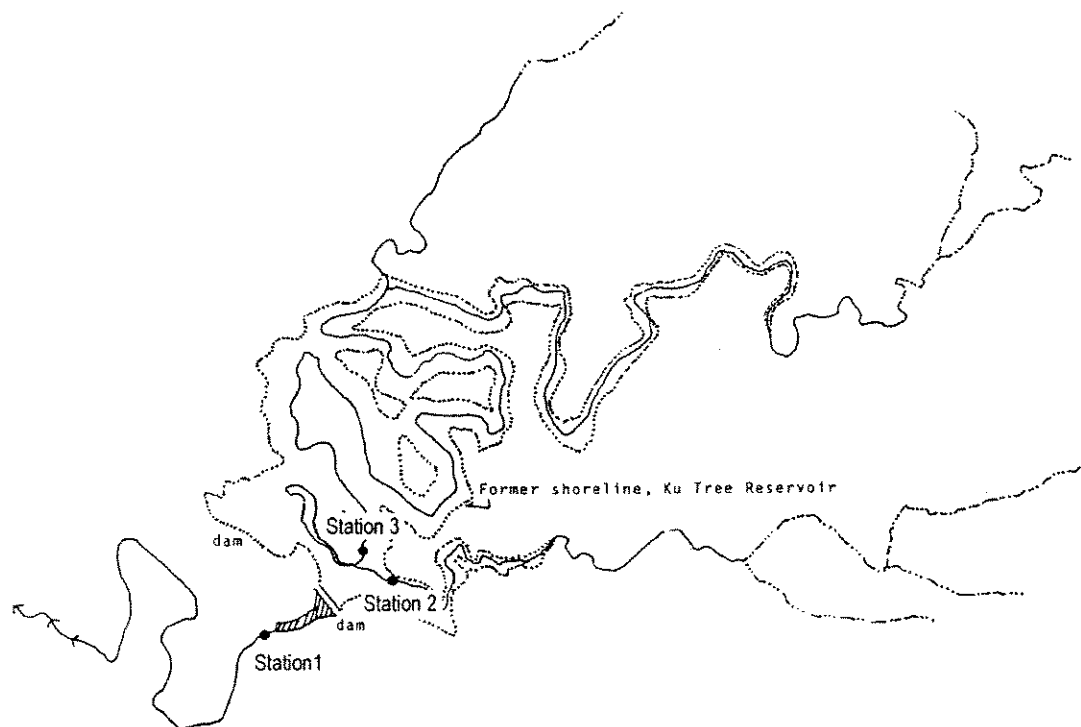
Figure 2. Sampling locations for the January 12, 2004 water quality sampling of an unnamed tributary to South Kaukonahua Stream, East Range, O'ahu.

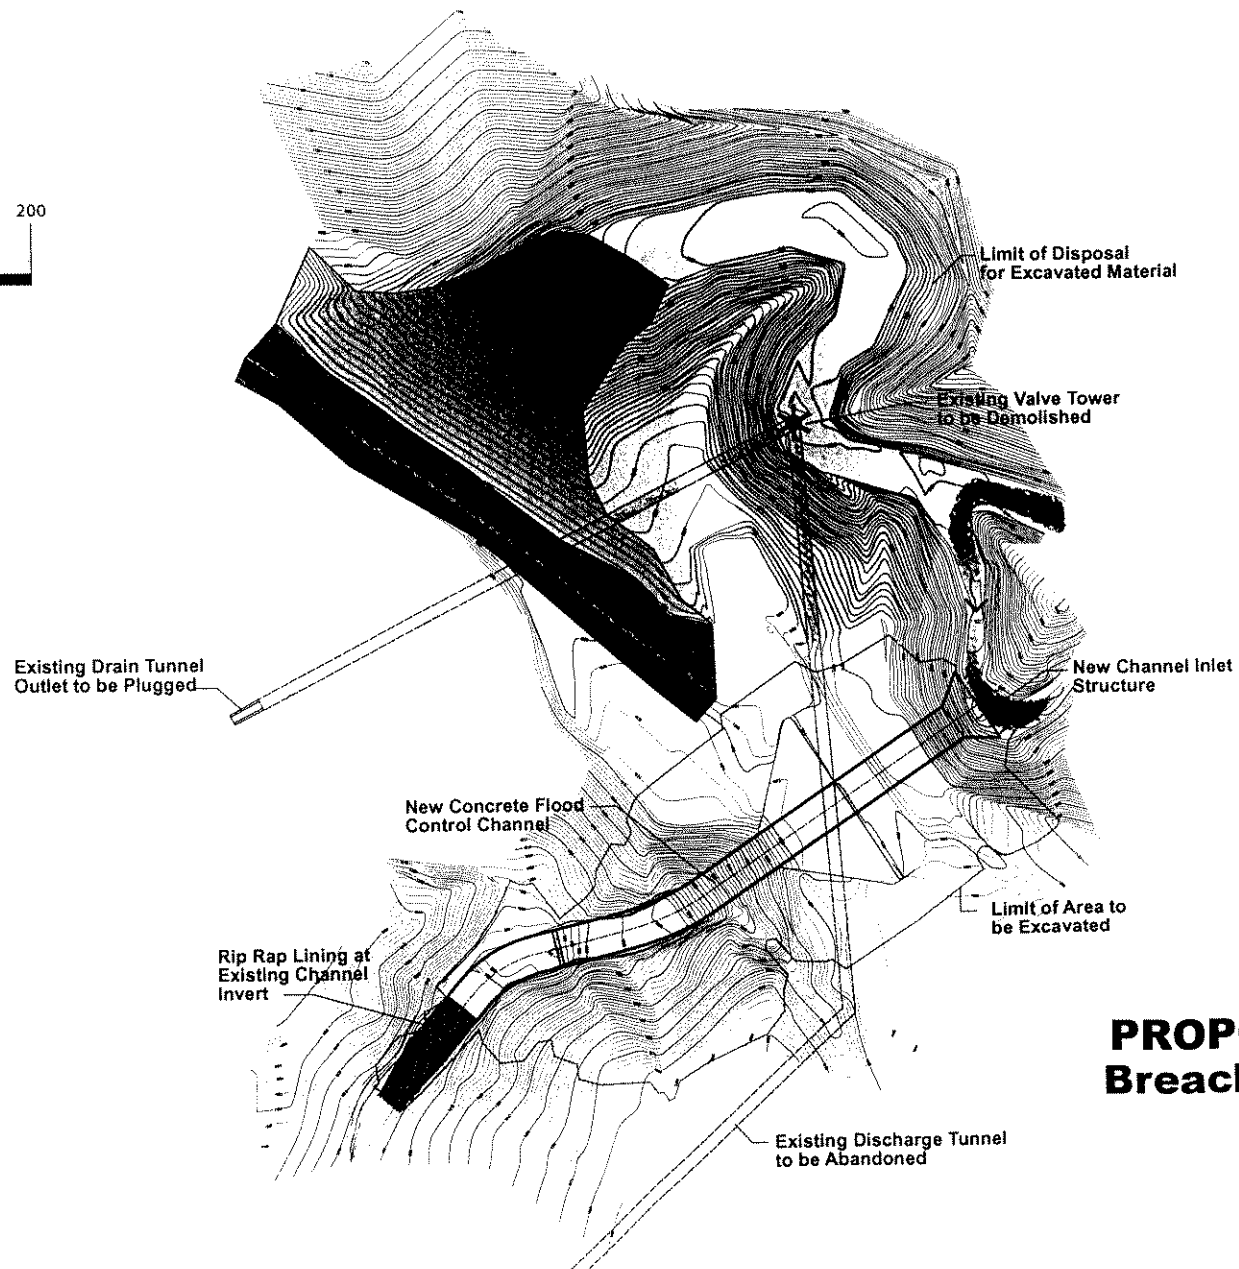
Figure 3

PROPOSED ACTION Breach Ku Tree Dam

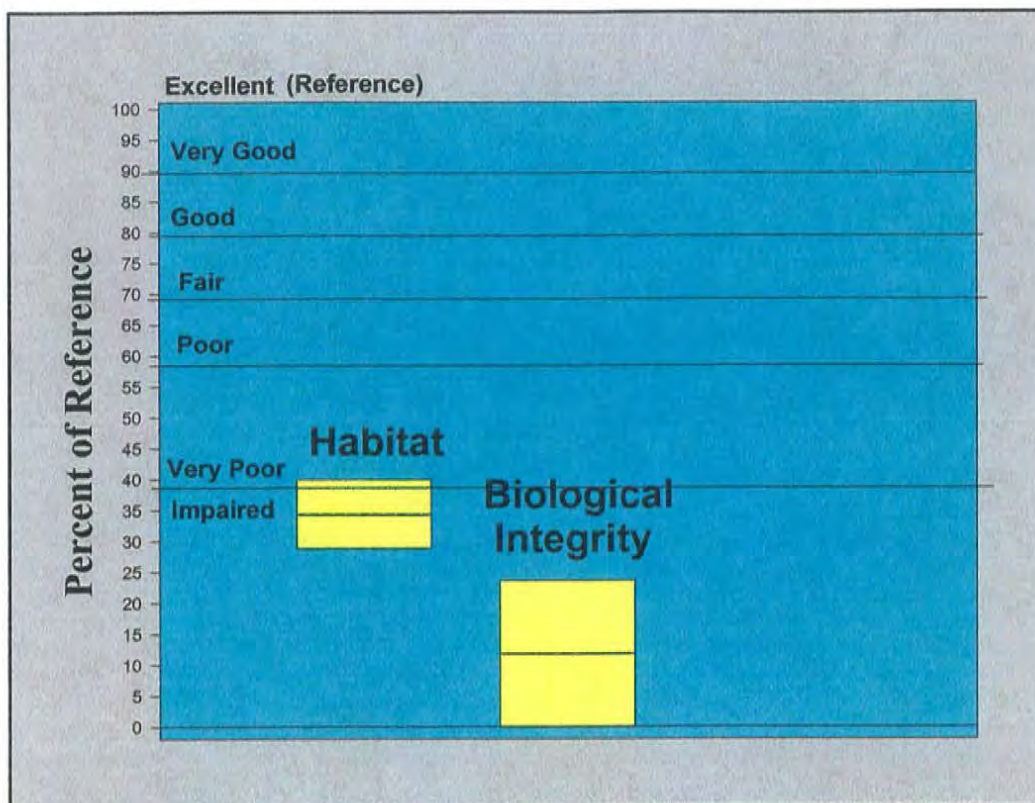
Figure 2. Box plots of overall Habitat and Biotic Integrity ratings by the HSBP of Ku Tree Reservoir streams (upper and lower lines of boxes indicate 90th and 10th percentiles respectively; dotted line inside box is the mean).

Based upon the surveys of the four formal HSBP bioassessment study sites established along the continuum of the stream above and below Ku Tree Reservoir, the overall habitat and biotic integrity condition of these streams were rated as being highly “Impaired” (34.4 ± 4.431 % and 11.8 ± 6.813 % of reference respectively) (Fig. 2). Impaired habitat and integrity ratings indicate that the stream system had been degraded to the point that it had lost natural ecosystem function and resilience.

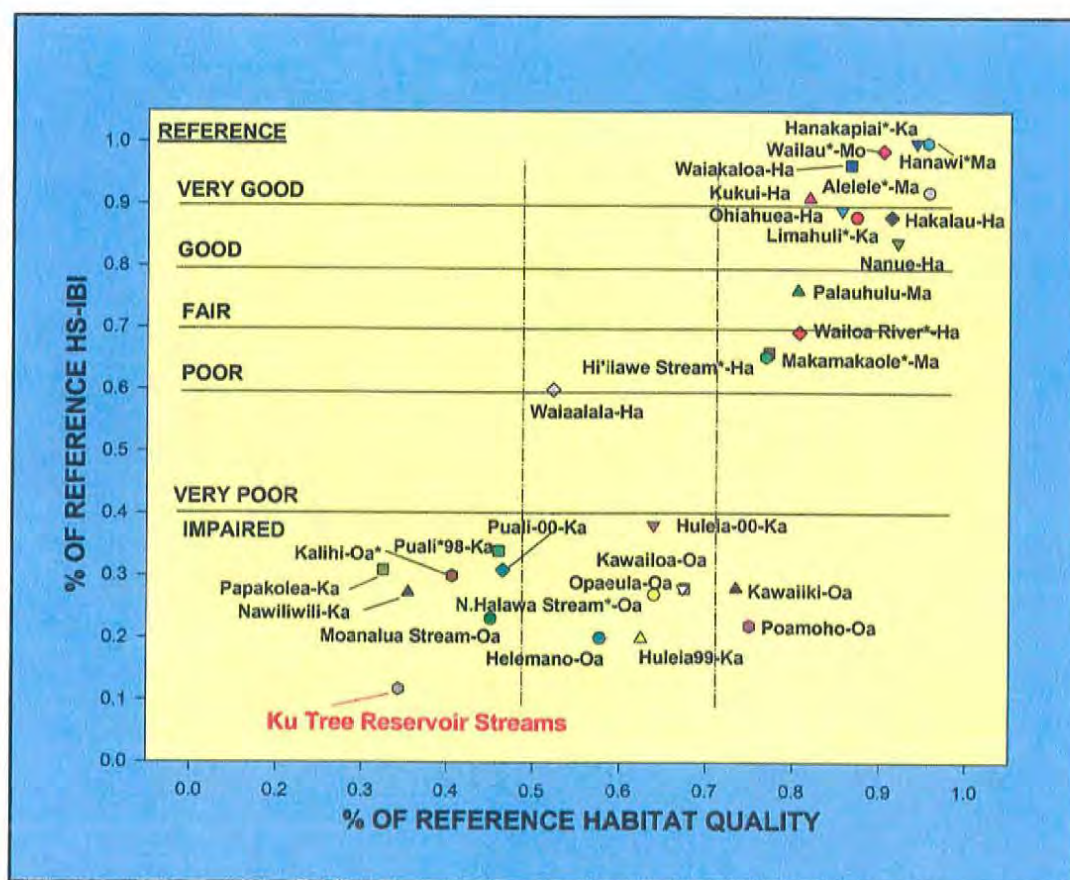
Figure 3. Statewide comparisons of stream biotic integrity (HS-IBI) and condition of supporting habitat in Ku Tree Reservoir streams (Oahu) (*averaged values in streams that have been sampled at multiple elevations and / or times, Ka = Kauai, Oa = Oahu, Ma = Maui, Mo = Molokai, Ha = Hawaii).

Overall physical habitat quality and biological integrity in Ku Tree Reservoir streams were found to be severely "Impaired" by channel modifications, chronic sedimentation, stream flow reductions and the physical presence of the reservoir. HSBP ratings for these particular streams were, in fact, the worst yet determined for streams thus far surveyed in the Hawaiian Islands (Fig. 3). Not only were no native aquatic species observed in stream study sites, but alien species diversity and abundance was also conspicuously low indicating very severe impairment of ecosystem function and loss of resilience.

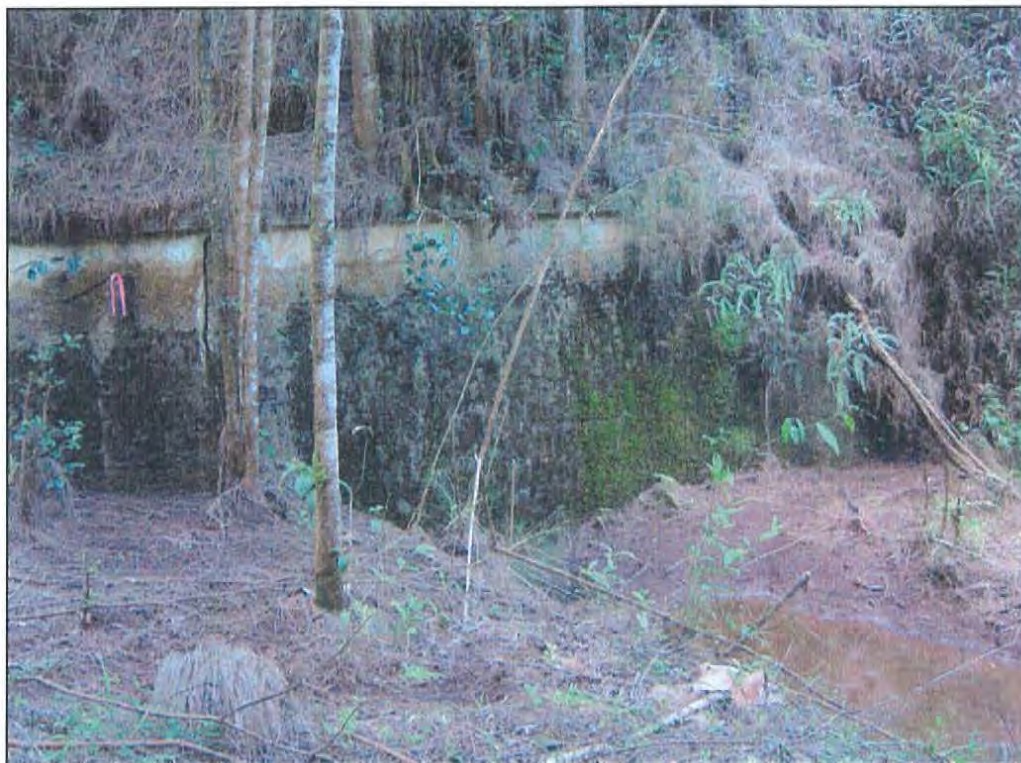
Photo 1. Concrete-lined spillway for reservoir over-flow into the natural stream channel.

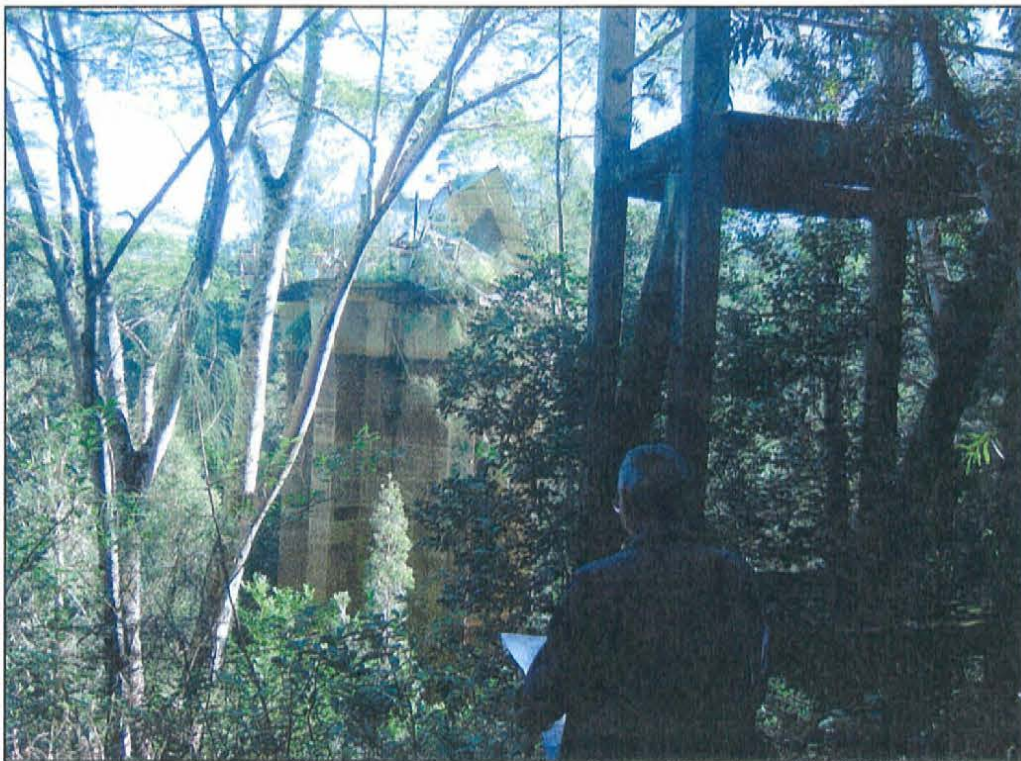
Photo 2. Top of concrete control tower and remnants of elevated access walkway.
