**ENVIRONMENTAL ASSESSMENT AND FINDING OF NO
SIGNIFICANT IMPACT**

**PROPOSED BREACH OF KU TREE DAM AT
EAST RANGE, SCHOFIELD BARRACKS, OAHU ISLAND, HAWAII**

Prepared By: U.S. Army Corps of Engineers, Honolulu District

Prepared For: U.S. Army Garrison, Hawaii

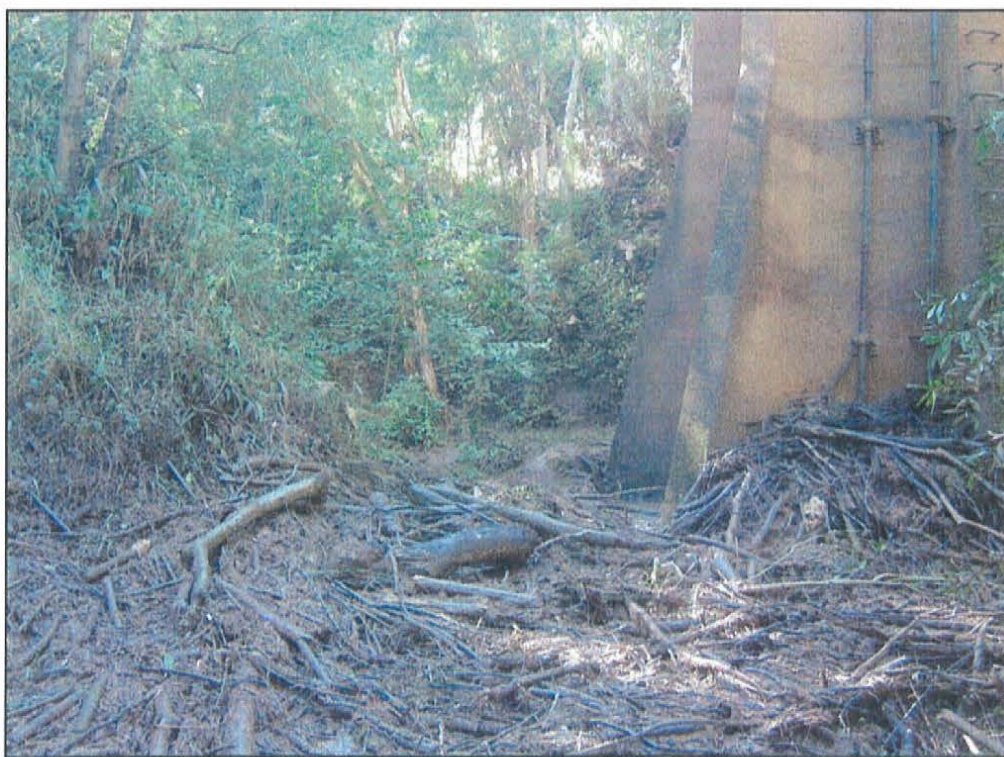
Photo 3. Tons of organic debris deposited at the control tower base after flooding.

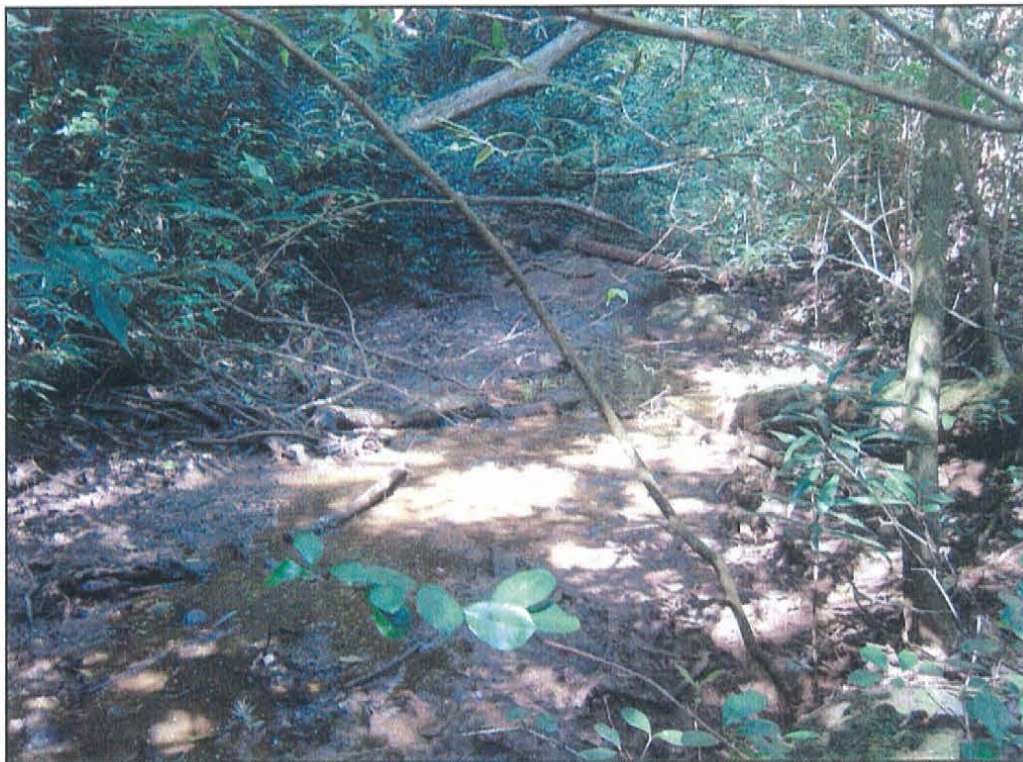
Photo 4. Excessive sedimentation of stream channel in Site 2 below Ku Tree reservoir.

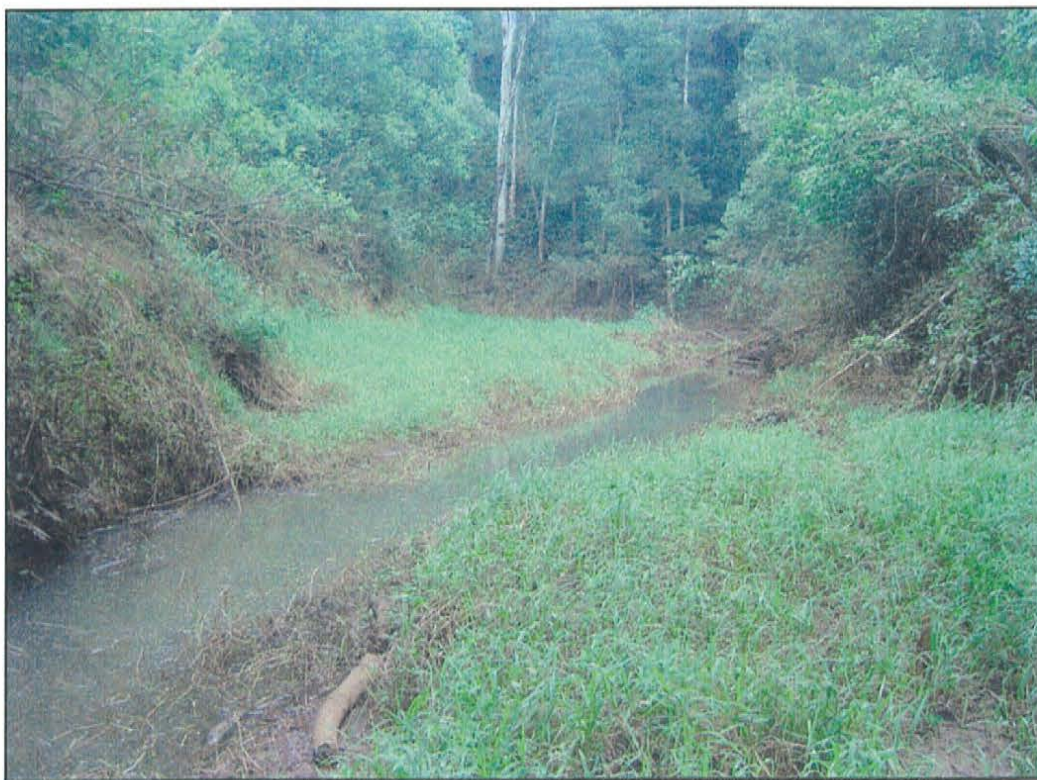
Photo 5. High sediment deposition area in Site 4 above Ku Tree Reservoir intake tower.

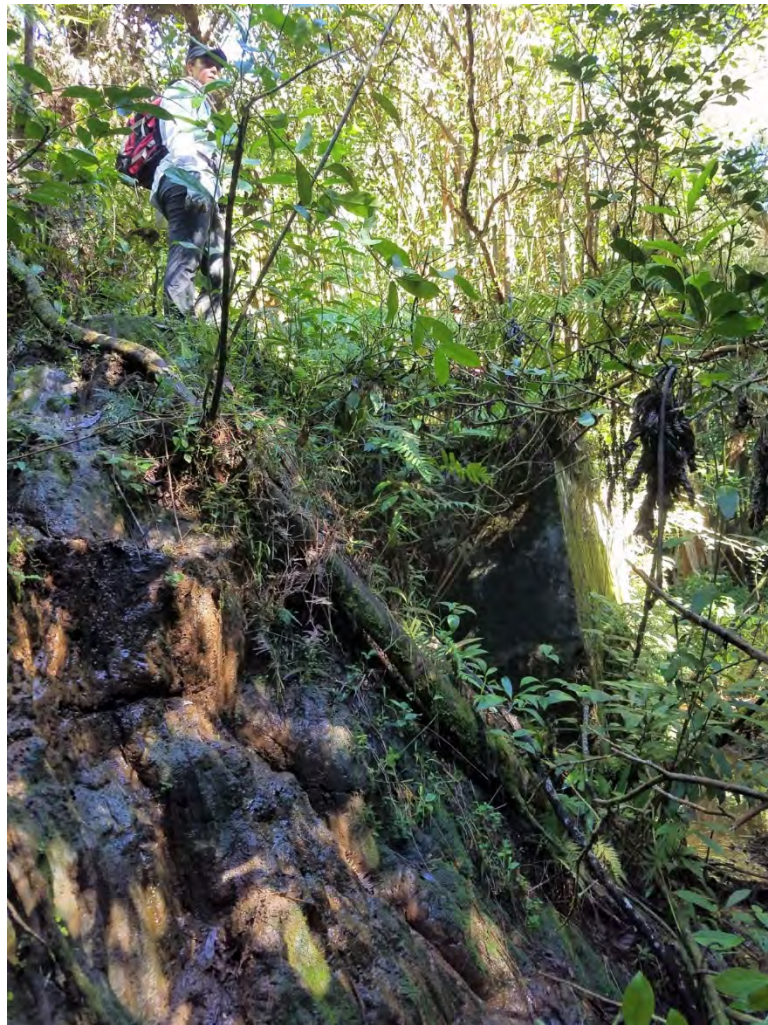
Figure 5 – Looking upstream at the mud and clay walls along the scoured stream channel at the end of the concrete spillway in the downstream portion of the APE.

On December 10, 2019, USAG-HI archaeologists inspected the downstream portion of the project area to document current conditions and look for any cultural resources and potential historic properties that might be present. The team found the area to be a narrow, deeply incised stream channel that was heavily scoured by water, bounded by dangerously steep mud and clay walls and cliffs, and covered with dense, often impassible, vegetation (Figures 5-6).

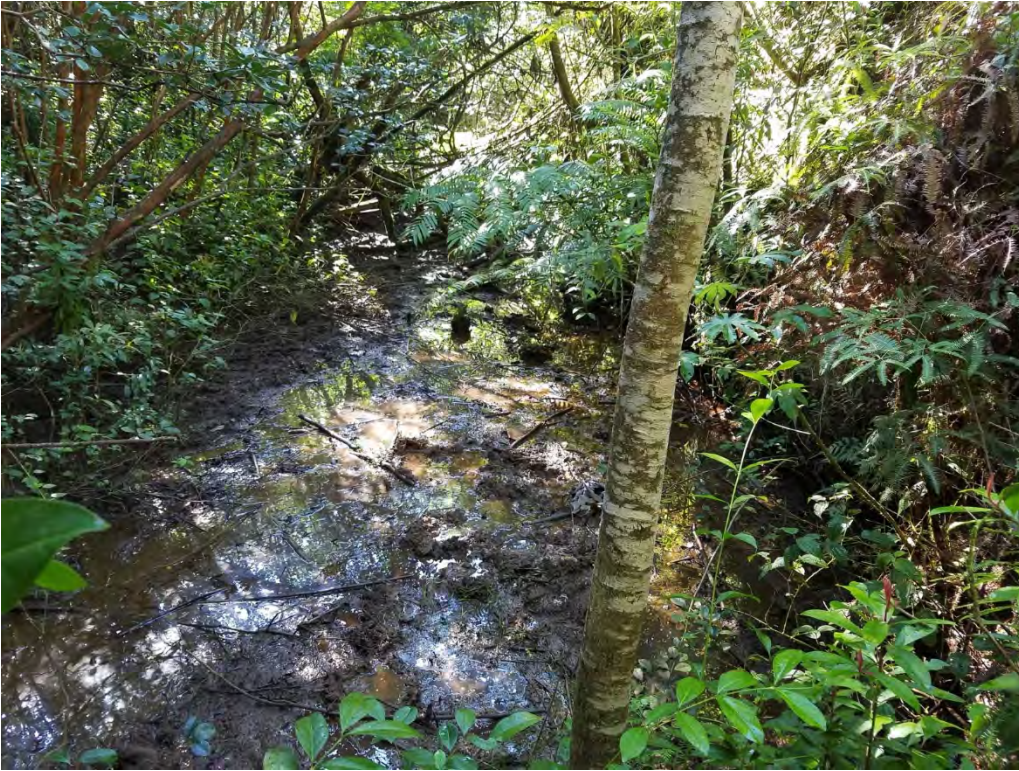
Figure 6 – Looking downstream in the APE at the narrow incised stream channel below the spillway bounded by steep slopes and dense vegetation.

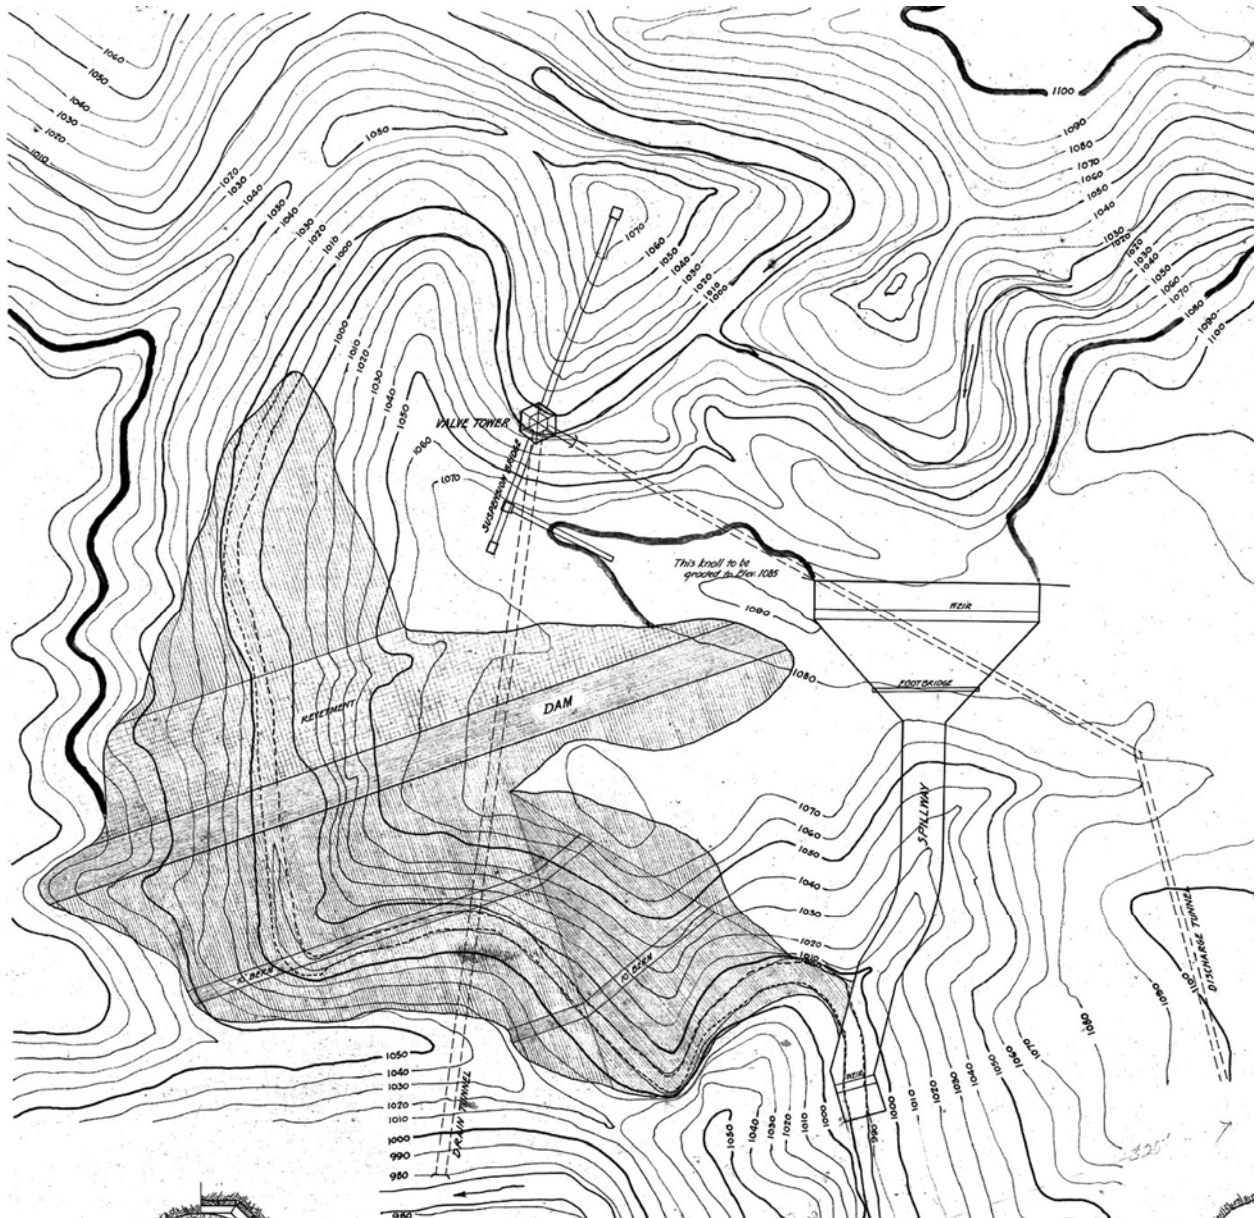
Figure 2: Plan of Dam, Ku Tree Reservoir. Job No. S3603, Sheet 4, dated July 1924.

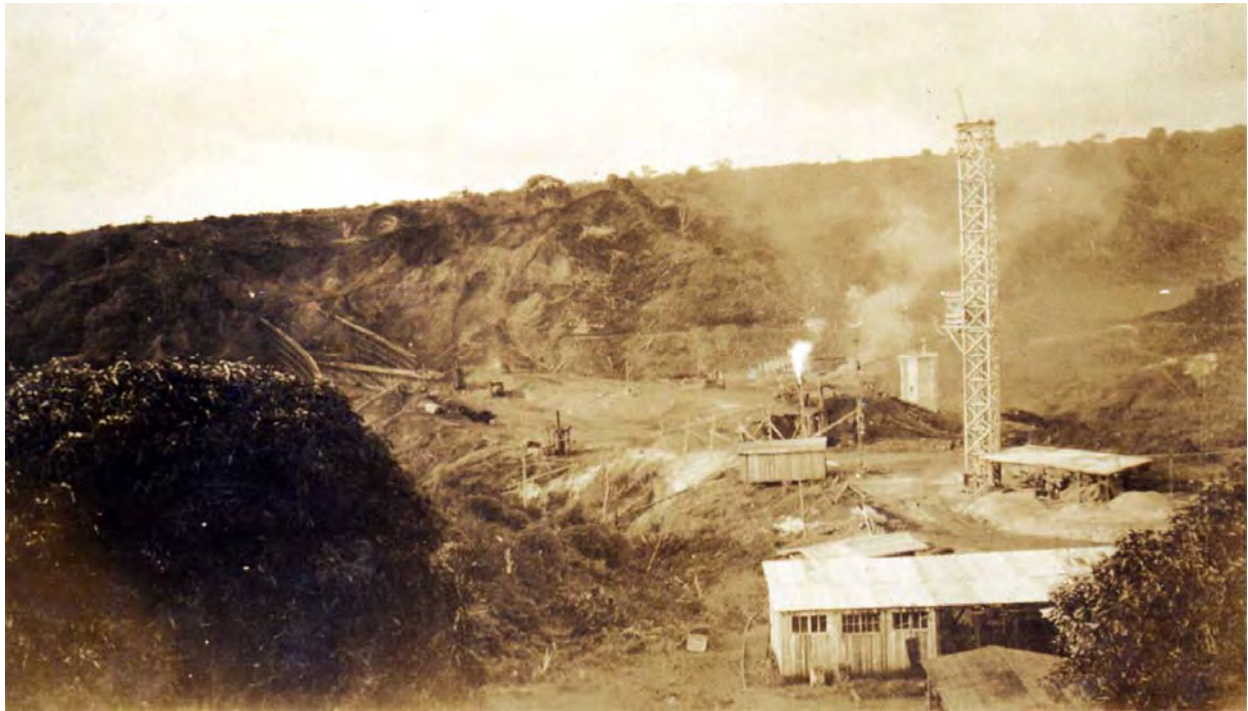
Figure 6: Ku Tree Dam, c. 1923-25, under construction. (Tropic Lightning Museum, Schofield Barracks, Hawaii, Historical photograph 87.76.01-03)

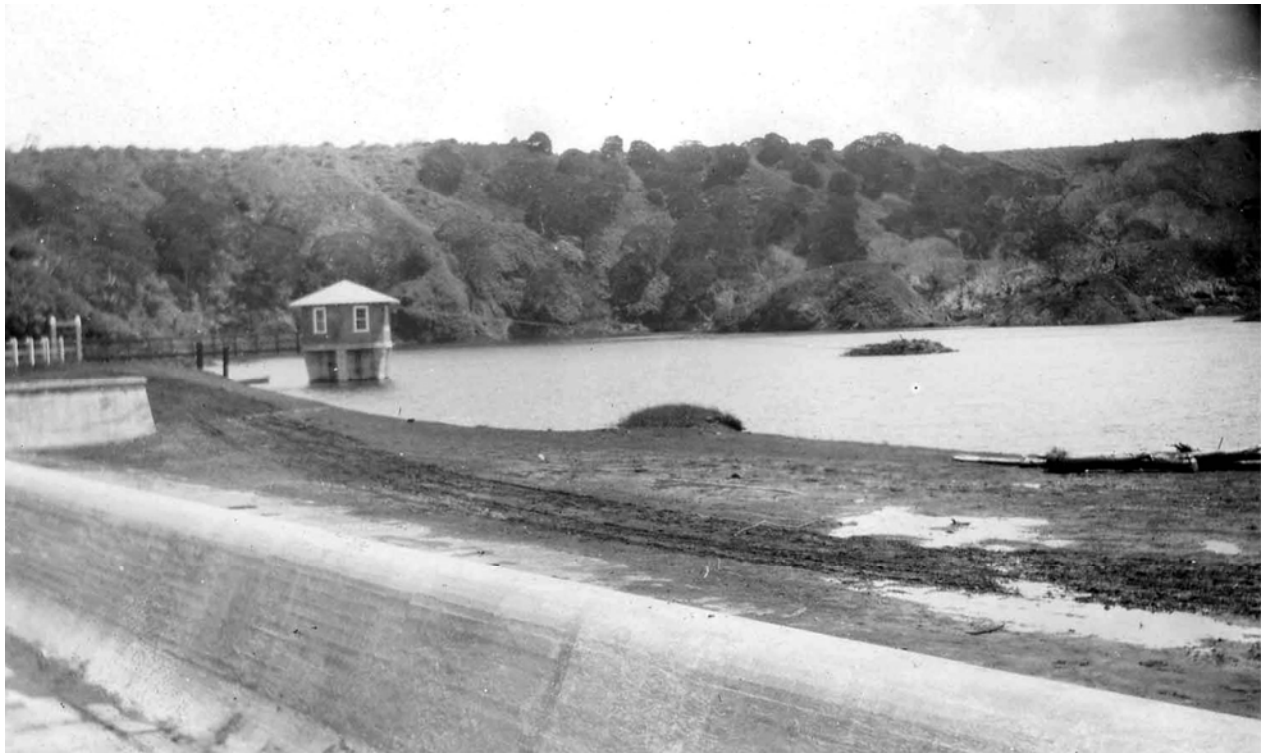
Figure 8: Dam with footbridge and valve house on tower in background. (U. S. Army Museum, Fort DeRussy, Hawaii, Historical photograph USAMH 6349)

The tower foot bridge provided access from the dam to the wood-framed control room atop the valve control tower (Plates 7 and 8). It extended from a natural knoll along the left abutment of the dam. The bridge system was composed of an approach walk and a suspension bridge span. The 8-spanned approach walk was 80 feet long and had a wood deck. The suspension bridge was 67 feet long and was suspended by a pair of 1-inch diameter steel cables. The suspension spans have collapsed and the approach spans are seriously deteriorated. The wooden deck of the approach walk is no longer existent.

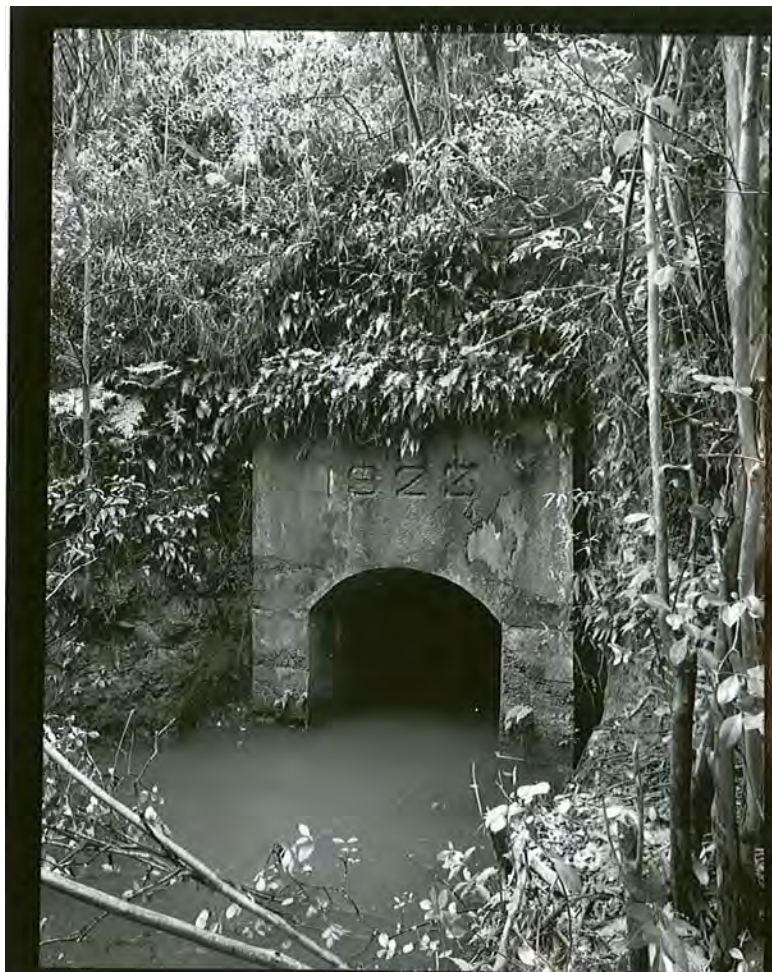
HAER No. HI-81-A-1

HI-81-A-1 DRAIN TUNNEL PORTAL. VIEW FACING NORTH.

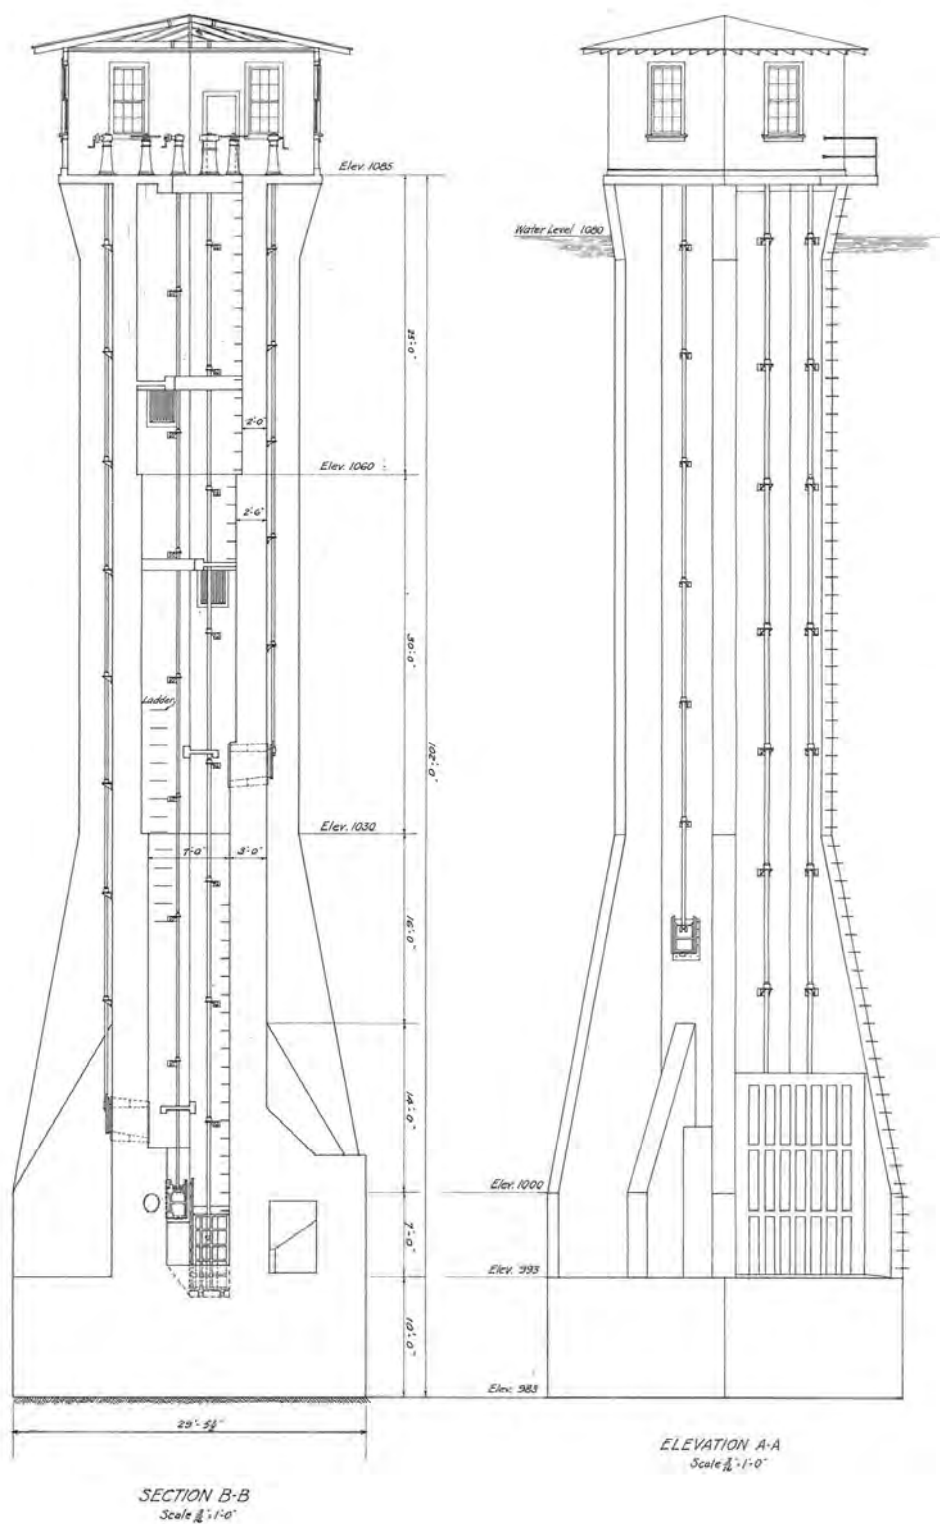
Figure 1: Elevation and Section, Valve Tower, Ku Tree Reservoir. Job No. S3603, Sheet 11, dated Sept. 3, 1924.

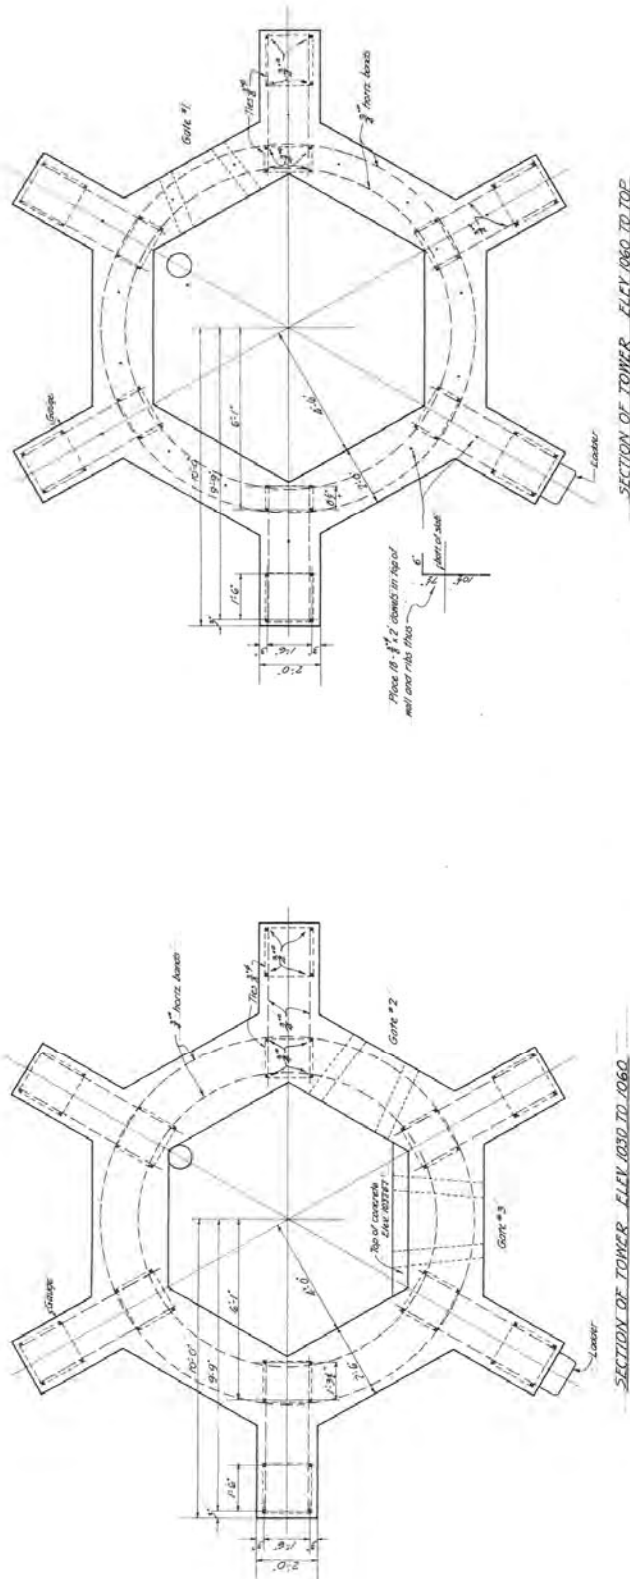
Figure 2: Valve Tower Details. Job No. S3603, Sheet 16, dated April 18, 1924.

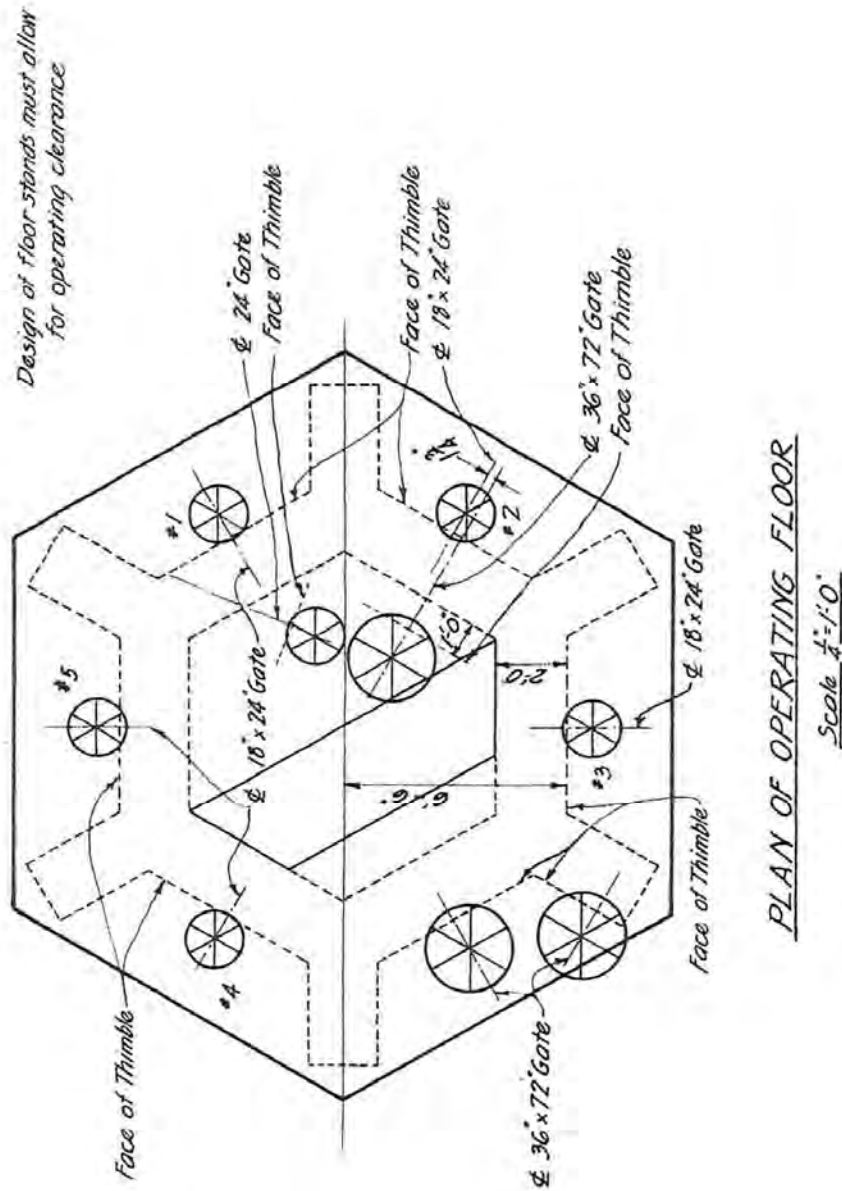
Figure 3: Gates for Valve Tower, Ku Tree Reservoir. Job No. S3603, Sheet 28, dated Dec. 1, 1923.

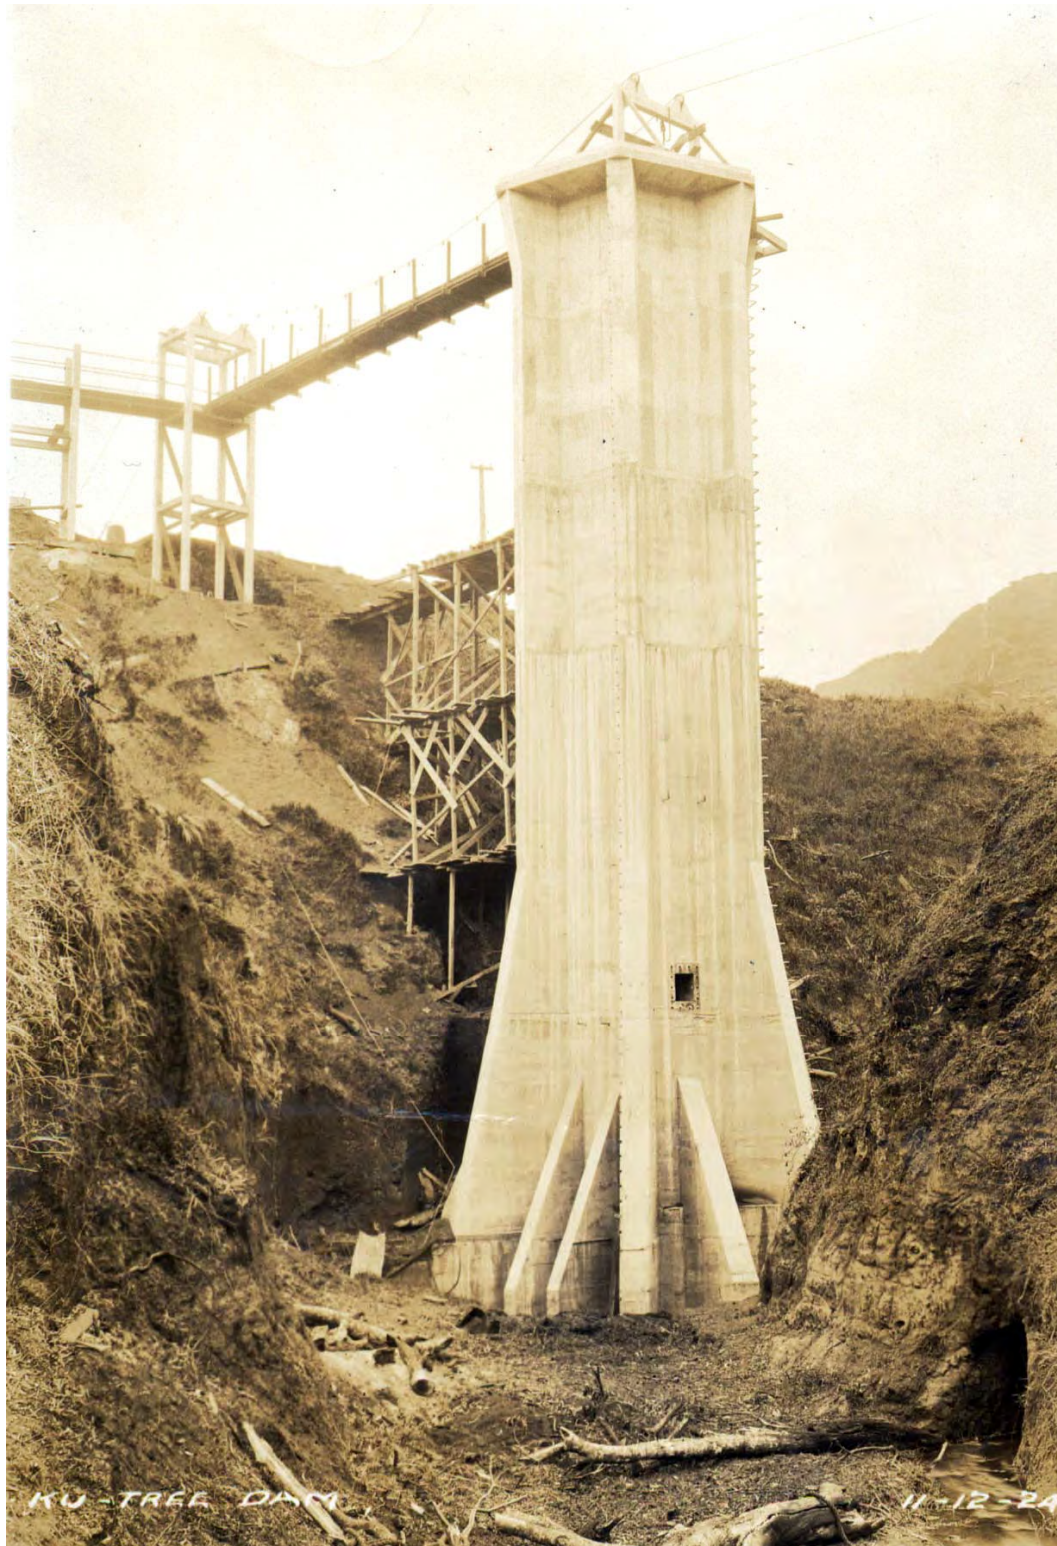
Figure 4: Valve tower, Ku Tree Dam, November 12, 1924. (Tropic Lightning Museum, Schofield Barracks, Hawaii, Historical photograph 87.76.01-27)

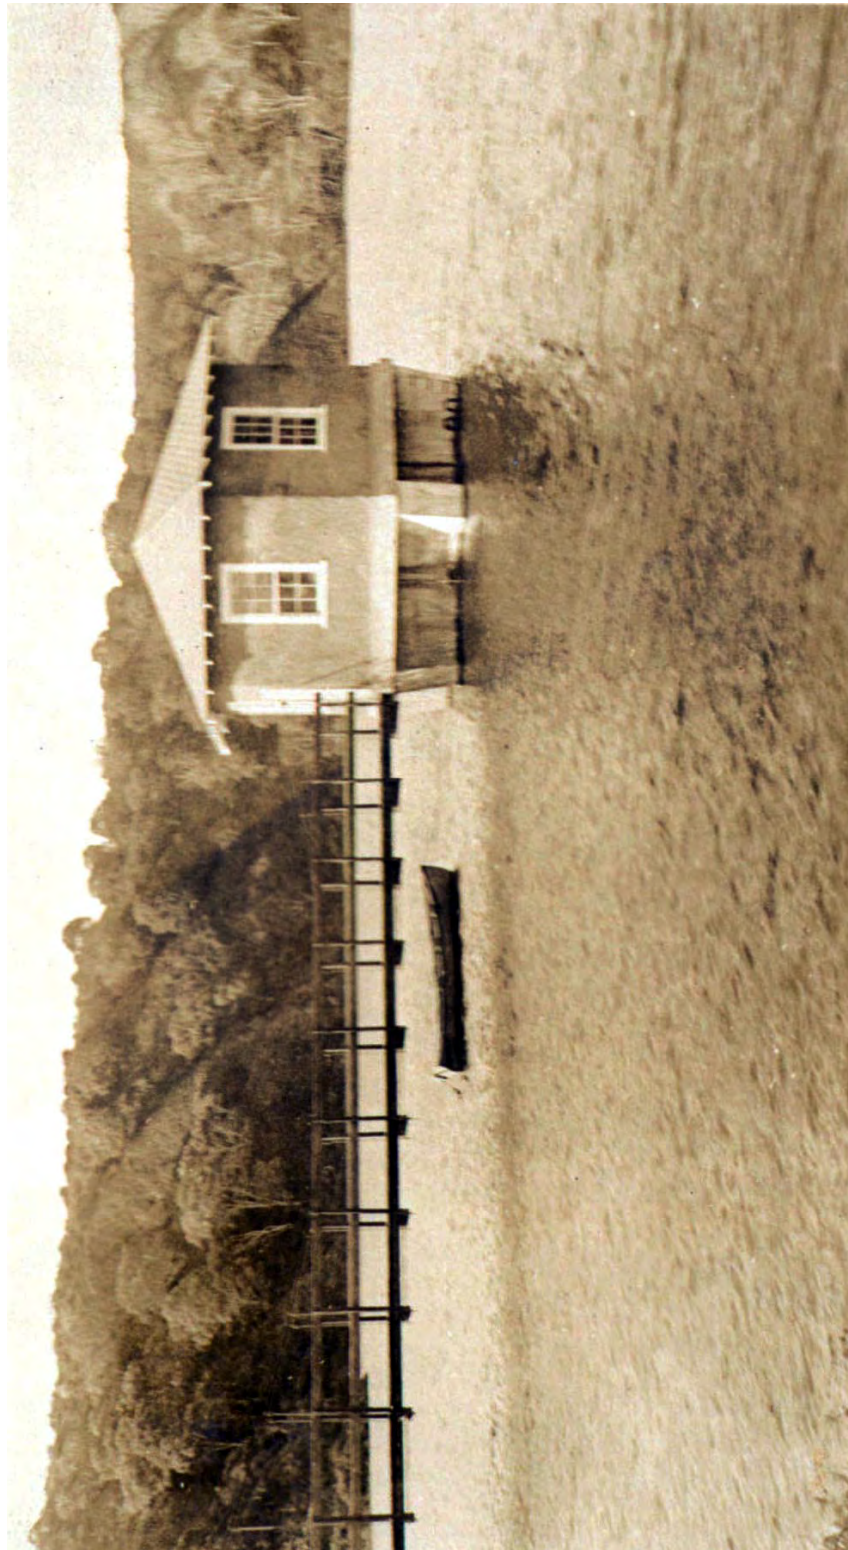
Figure 5: Enclosed valve house on tower with water in reservoir. (Tropic Lightning Museum, Schofield Barracks, Hawaii, Historical photograph 87.76.01-8)

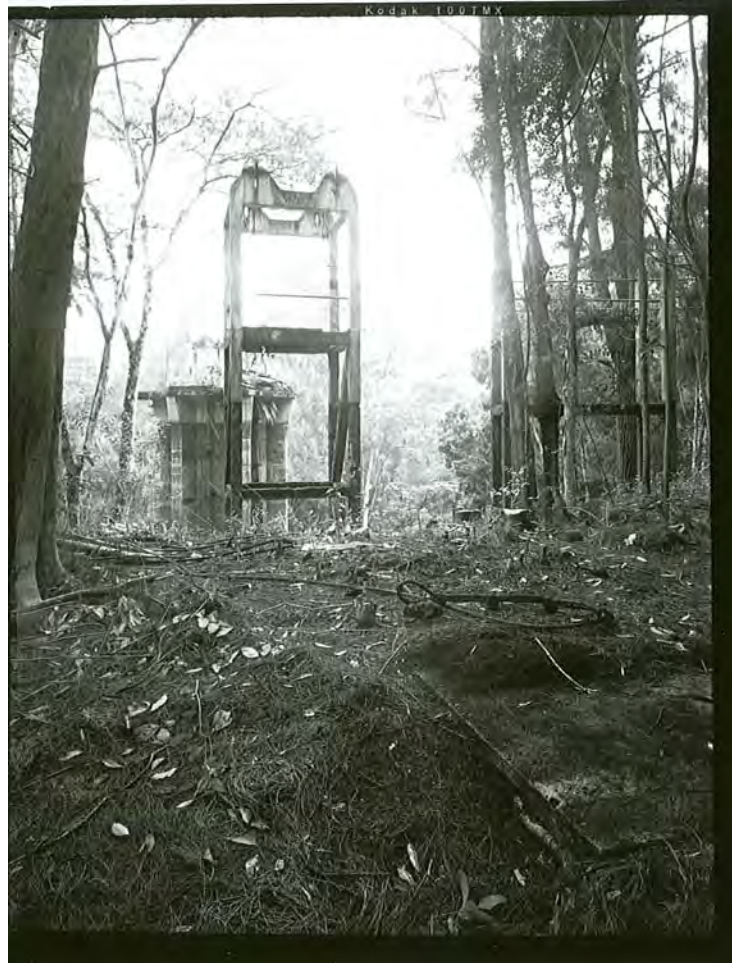
HAER No. HI-81-C-3

| HI-81-C-3 | CONCRETE PAD AND SUSPENSION BRIDGE TOWERS FOR CABLES FORMERLY SUPPORTING THE SUSPENSION BRIDGE PORTION OF VALVE TOWER FOOT BRIDGE. VIEW FACING NORTHEAST. |

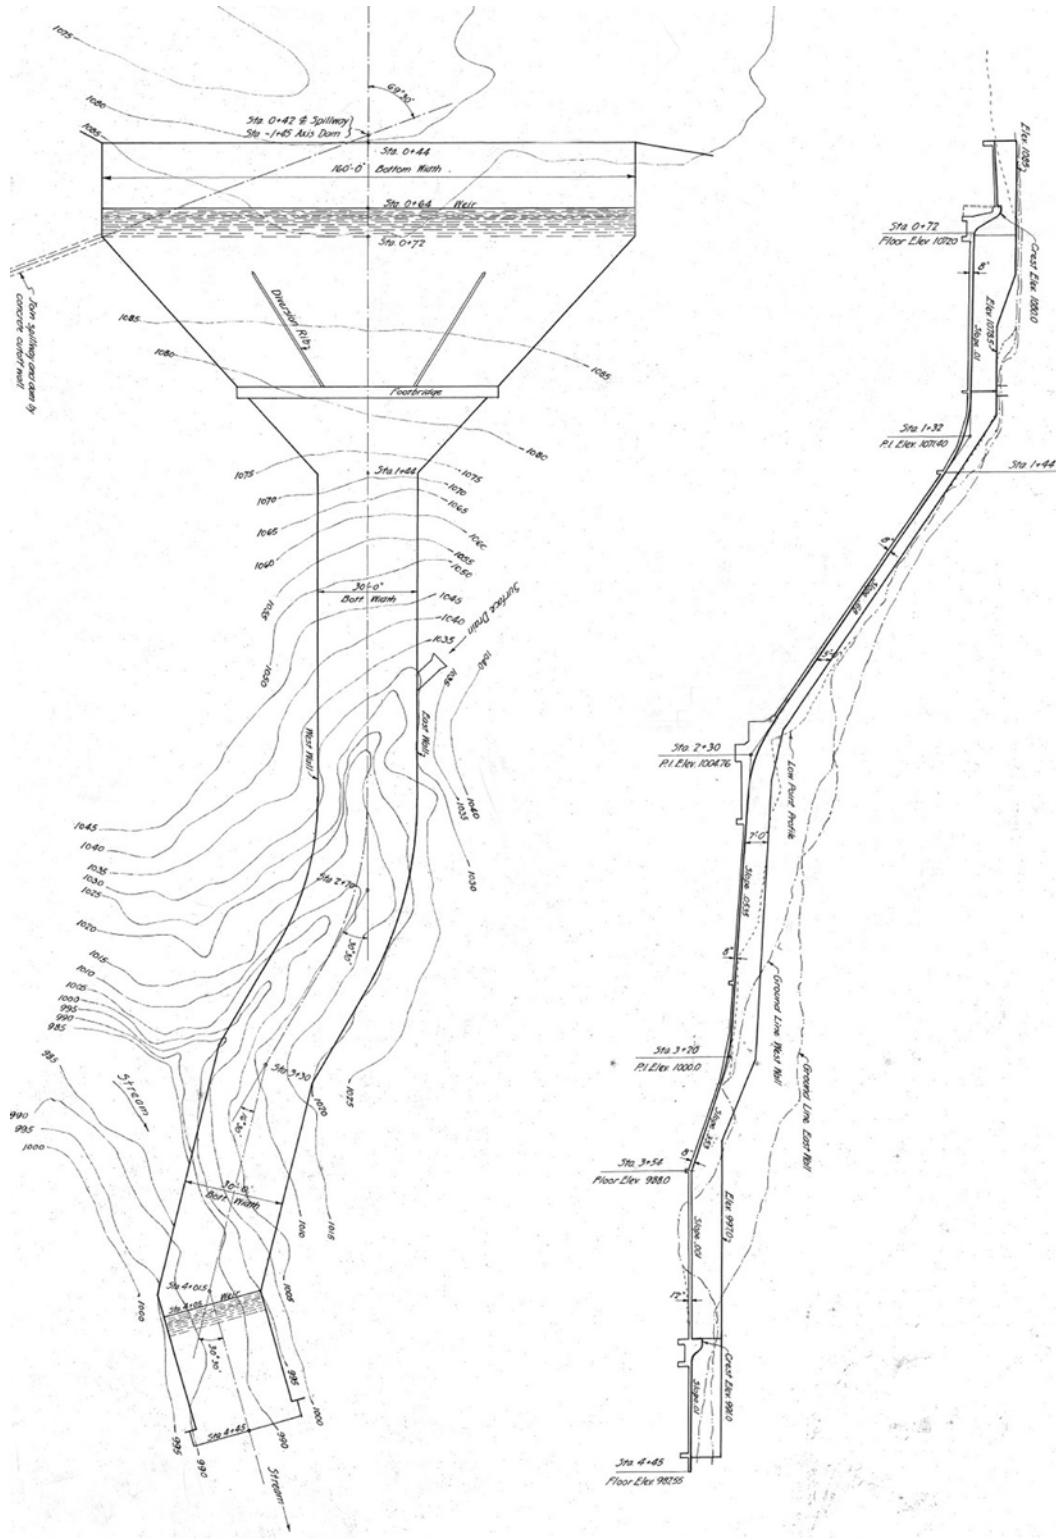
Figure 1: General Plan, Spillway, Ku Tree Reservoir. Job No. S3603, Sheet 6, dated June 14, 1924.

As is typical for spillways in earth-fill dams, this element of the Ku Tree Reservoir is isolated from the dam, traversing the natural abutment outside the limits of the dam. Its crest is at an elevation 5'-0" below the crest of the dam. This is the minimum variance in elevation recommended in a 1907 engineering book, *Design and Construction of Dams*, which suggested the spillway should be 5' to 25' below the top of the dam (Wegmann, 1907: 225).

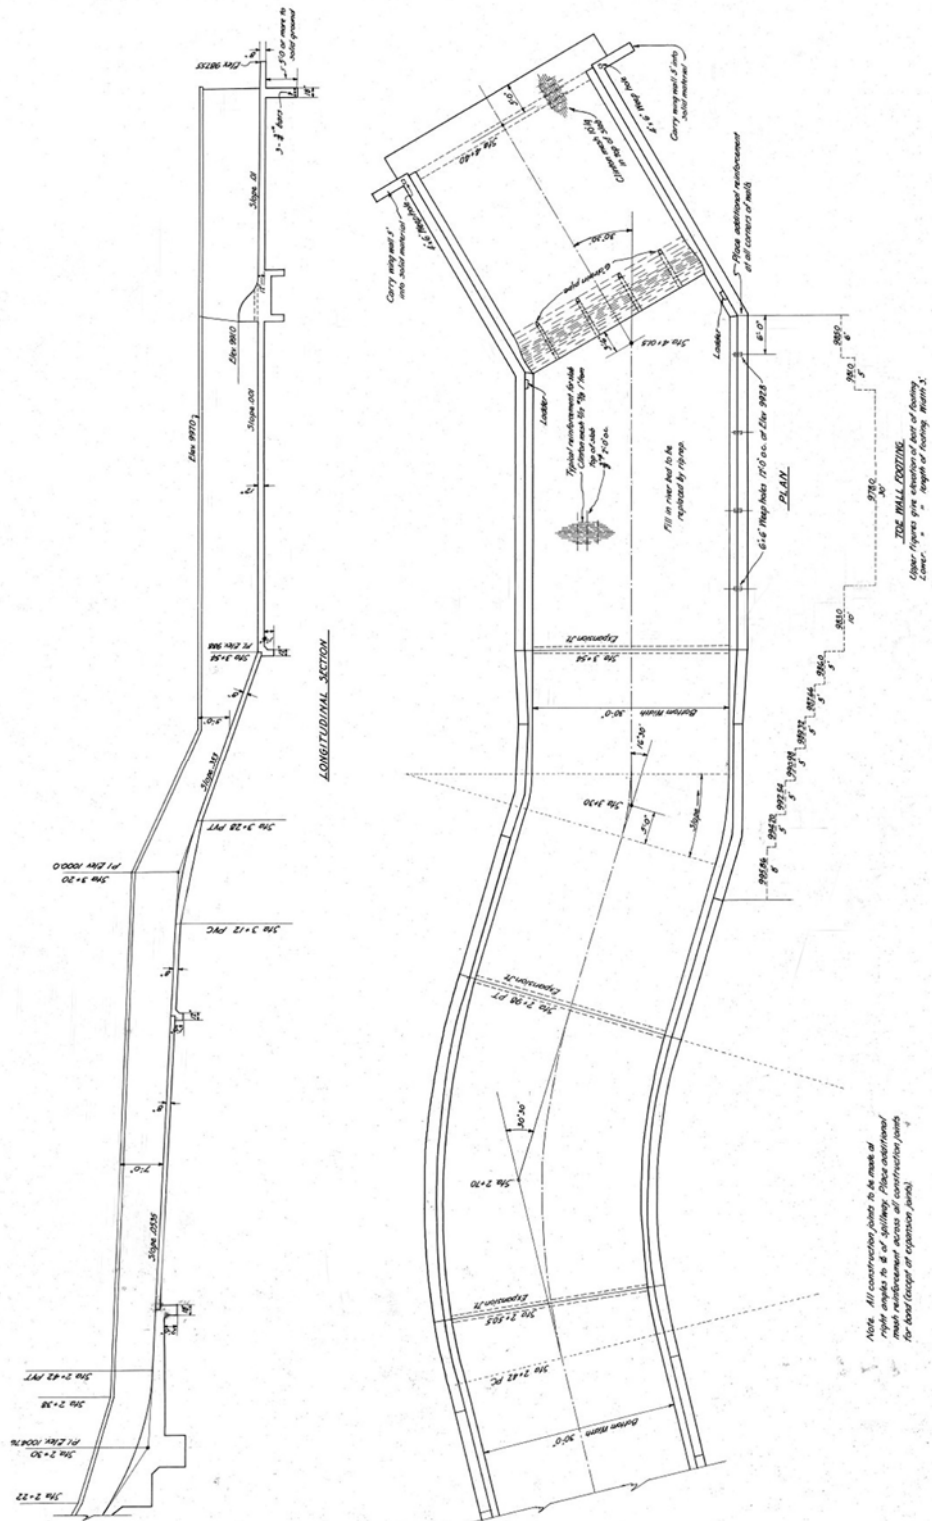
Figure 2: Plan and Section, Lower Half of Spillway, Ku Tree Reservoir. Job No. S3603, Sheet 8, dated June 14, 1924.

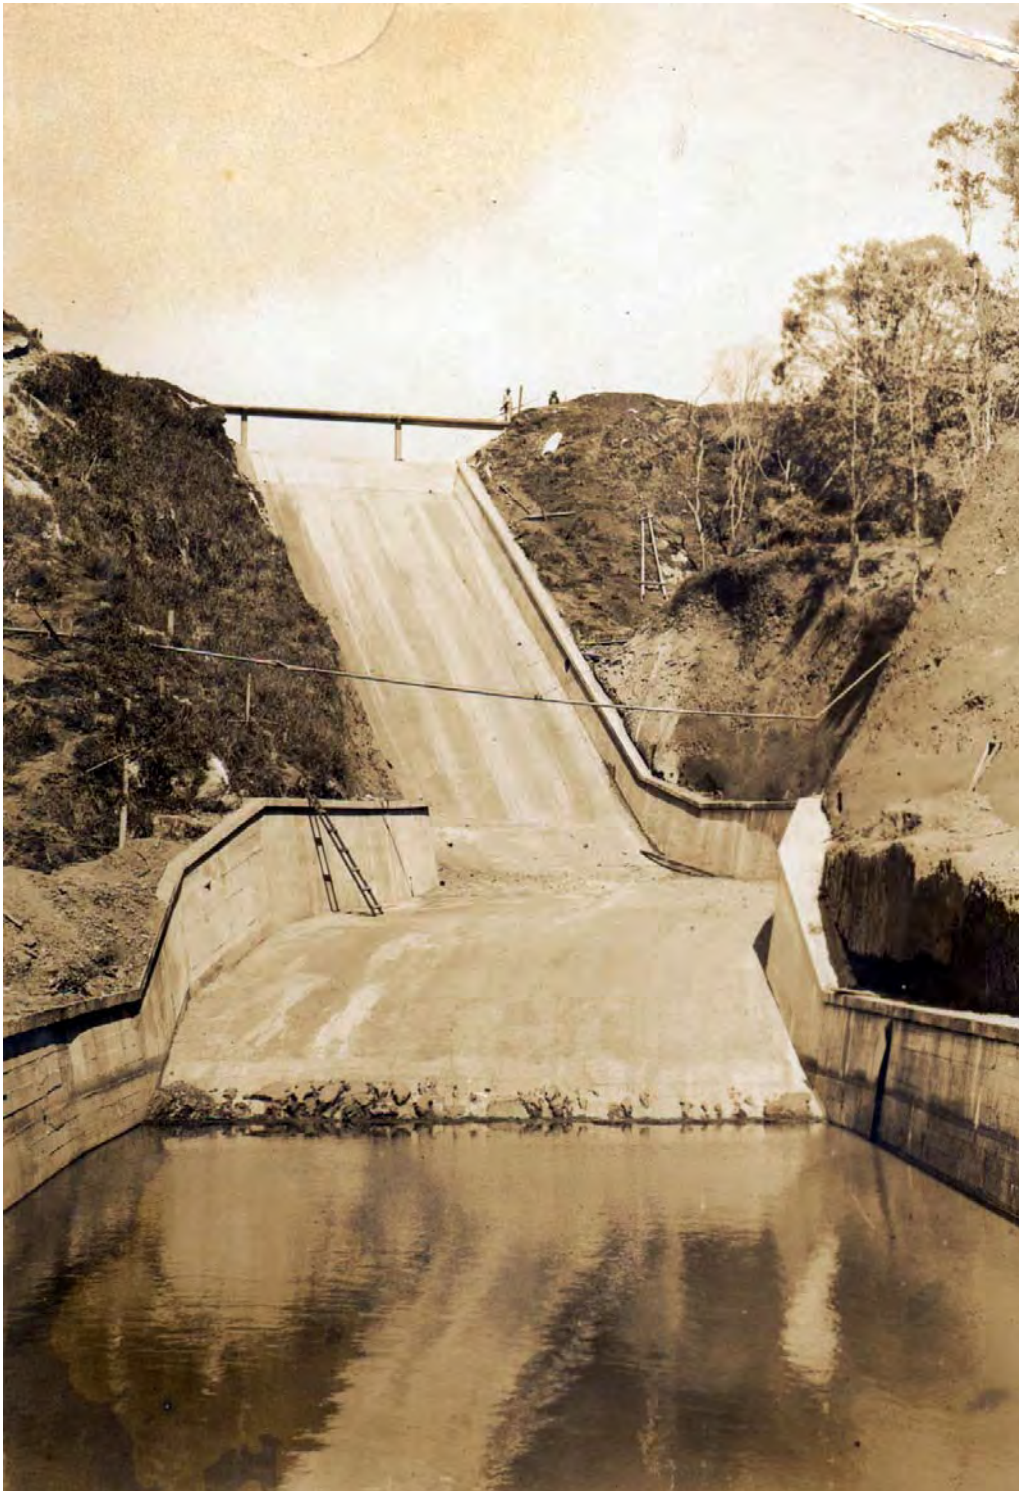
Figure 3: View in 1925 with stilling pond in foreground. (Tropic Lightning Museum, Schofield Barracks, Hawaii, Historical photograph 87.76.01-28)

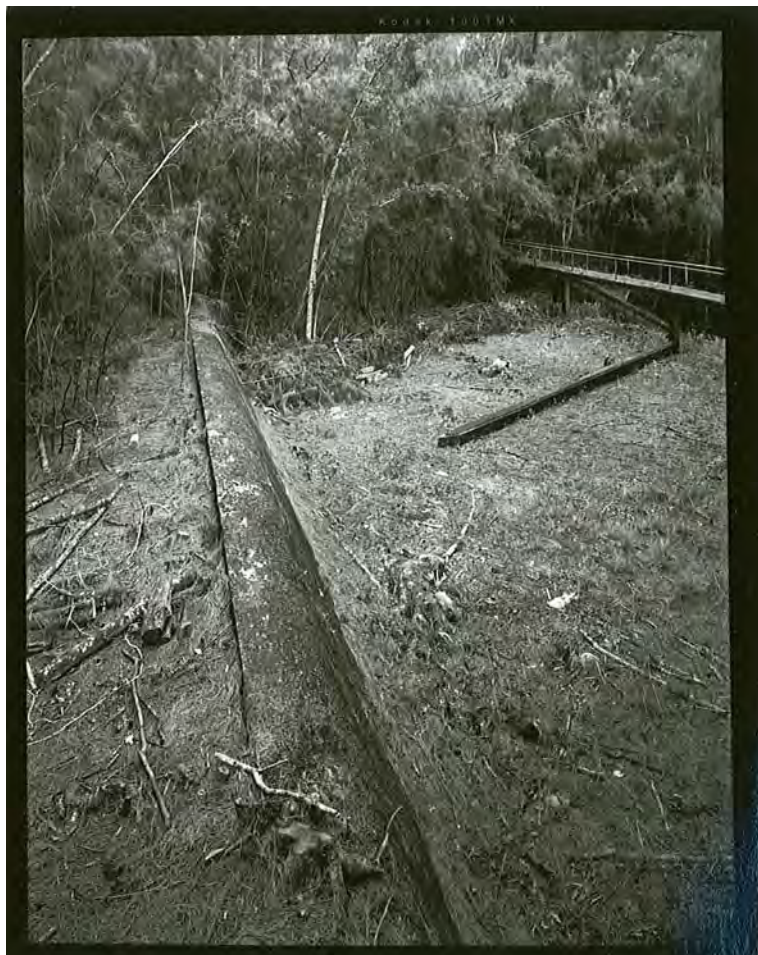
HAER No. HI-81-D-1

HI-81-D-1	LOOKING DOWN ON OGEE WEIR OF UPPER SPILLWAY. VIEW FACING SOUTHEAST.
HI-81-D-2	DIVERSION RIB IN UPPER SPILLWAY. VIEW FACING SOUTHWEST.
HI-81-D-3	UPPER SPILLWAY FROM APRON LOOKING TOWARDS SPILLWAY BRIDGE. VIEW FACING SOUTHWEST.
HI-81-D-4	VIEW OF UPPER SPILLWAY FROM UNDER SPILLWAY BRIDGE LOOKING TOWARDS APRON. VIEW FACING NORTHWEST.
HI-81-D-5	VIEW FROM SPILLWAY BRIDGE SHOWING SPILLWAY DROP ON LEFT. VIEW FACING NORTHWEST.
HI-81-D-6	VIEW FROM THE BOTTOM OF FIRST SPILLWAY DROP LOOKING UP TO THE SPILLWAY BRIDGE. VIEW FACING NORTHEAST.
HI-81-D-7	SPILL BASIN WEIR AT THE END OF THE SPILLWAY. VIEW FACING NORTH NORTHEAST.

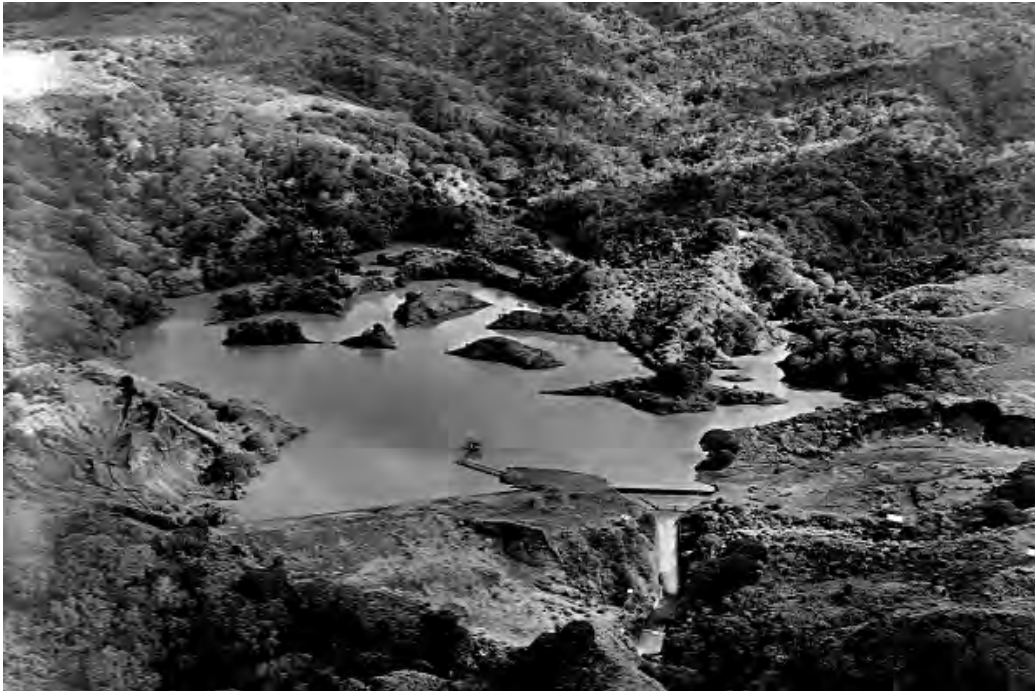
Fig. 1. An aerial photograph of the Ku Tree Dam, taken on 15 February 1932. NationalArchives II, Still Photo Section, photo order #18-AA-51-43.

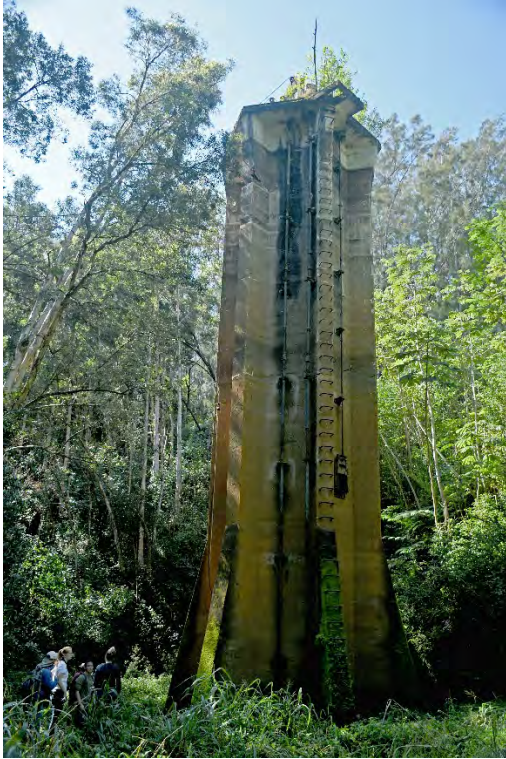
Fig. 3. The valve tower rising from the former reservoir pool area of the Ku Tree Dam.

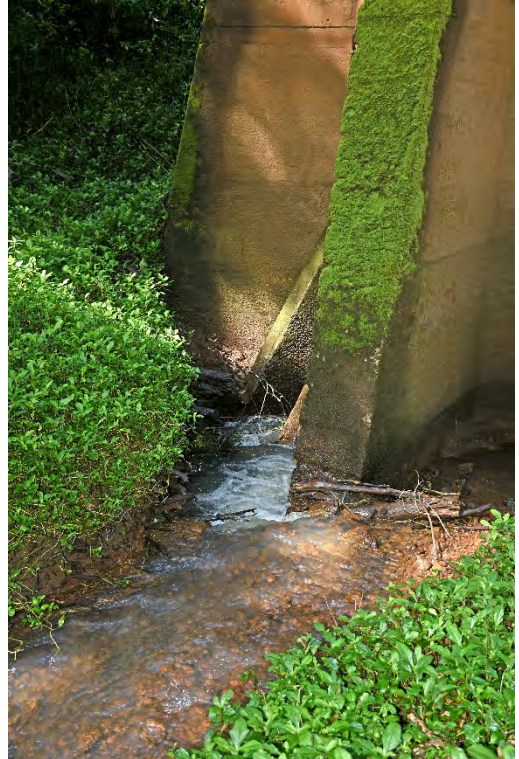
Fig. 4. Water flowing into the inlet to the drain tunnel at the base of the valve tower.
