**ENVIRONMENTAL ASSESSMENT AND FINDING OF NO
SIGNIFICANT IMPACT**

**PROPOSED BREACH OF KU TREE DAM AT
EAST RANGE, SCHOFIELD BARRACKS, OAHU ISLAND, HAWAII**

Prepared By: U.S. Army Corps of Engineers, Honolulu District

Prepared For: U.S. Army Garrison, Hawaii

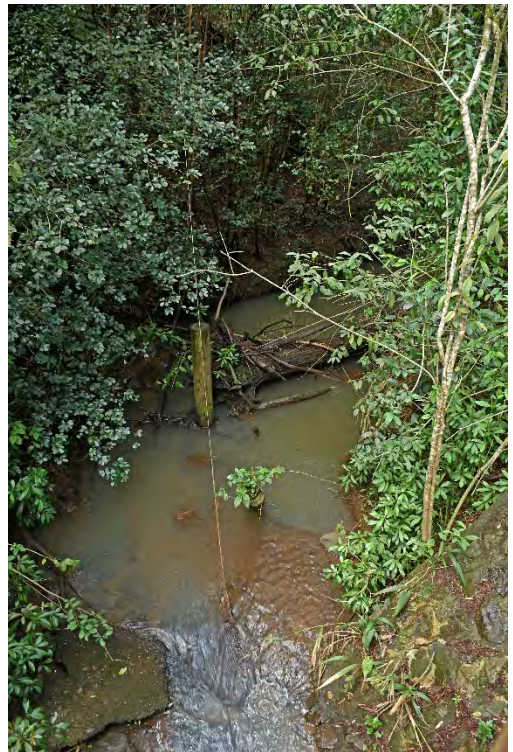
Fig. 6. Station 2, the main channel of the tributary to the South Fork of Kaukonahua Stream below Ku Tree Dam.

A brief visit was also made to the stream reach lying below the dam and the outlet of the drain tunnel, at a point where it is bridged by a road (Station 2, see Fig. 6). The stream had notably higher volume here than above the dam, indicating confluence with another undermined tributary somewhere between the dam and the bridge. Once again, no native freshwater fishes, crustaceans, mollusks, or insects were observed at this site.
