ROCKY MOUNTAIN ARSENAL

2024 BASIN F COVER AND GROUNDWATER MONITORING REPORT

Revision 0 November 19, 2024

Navarro Research and Engineering, Inc.

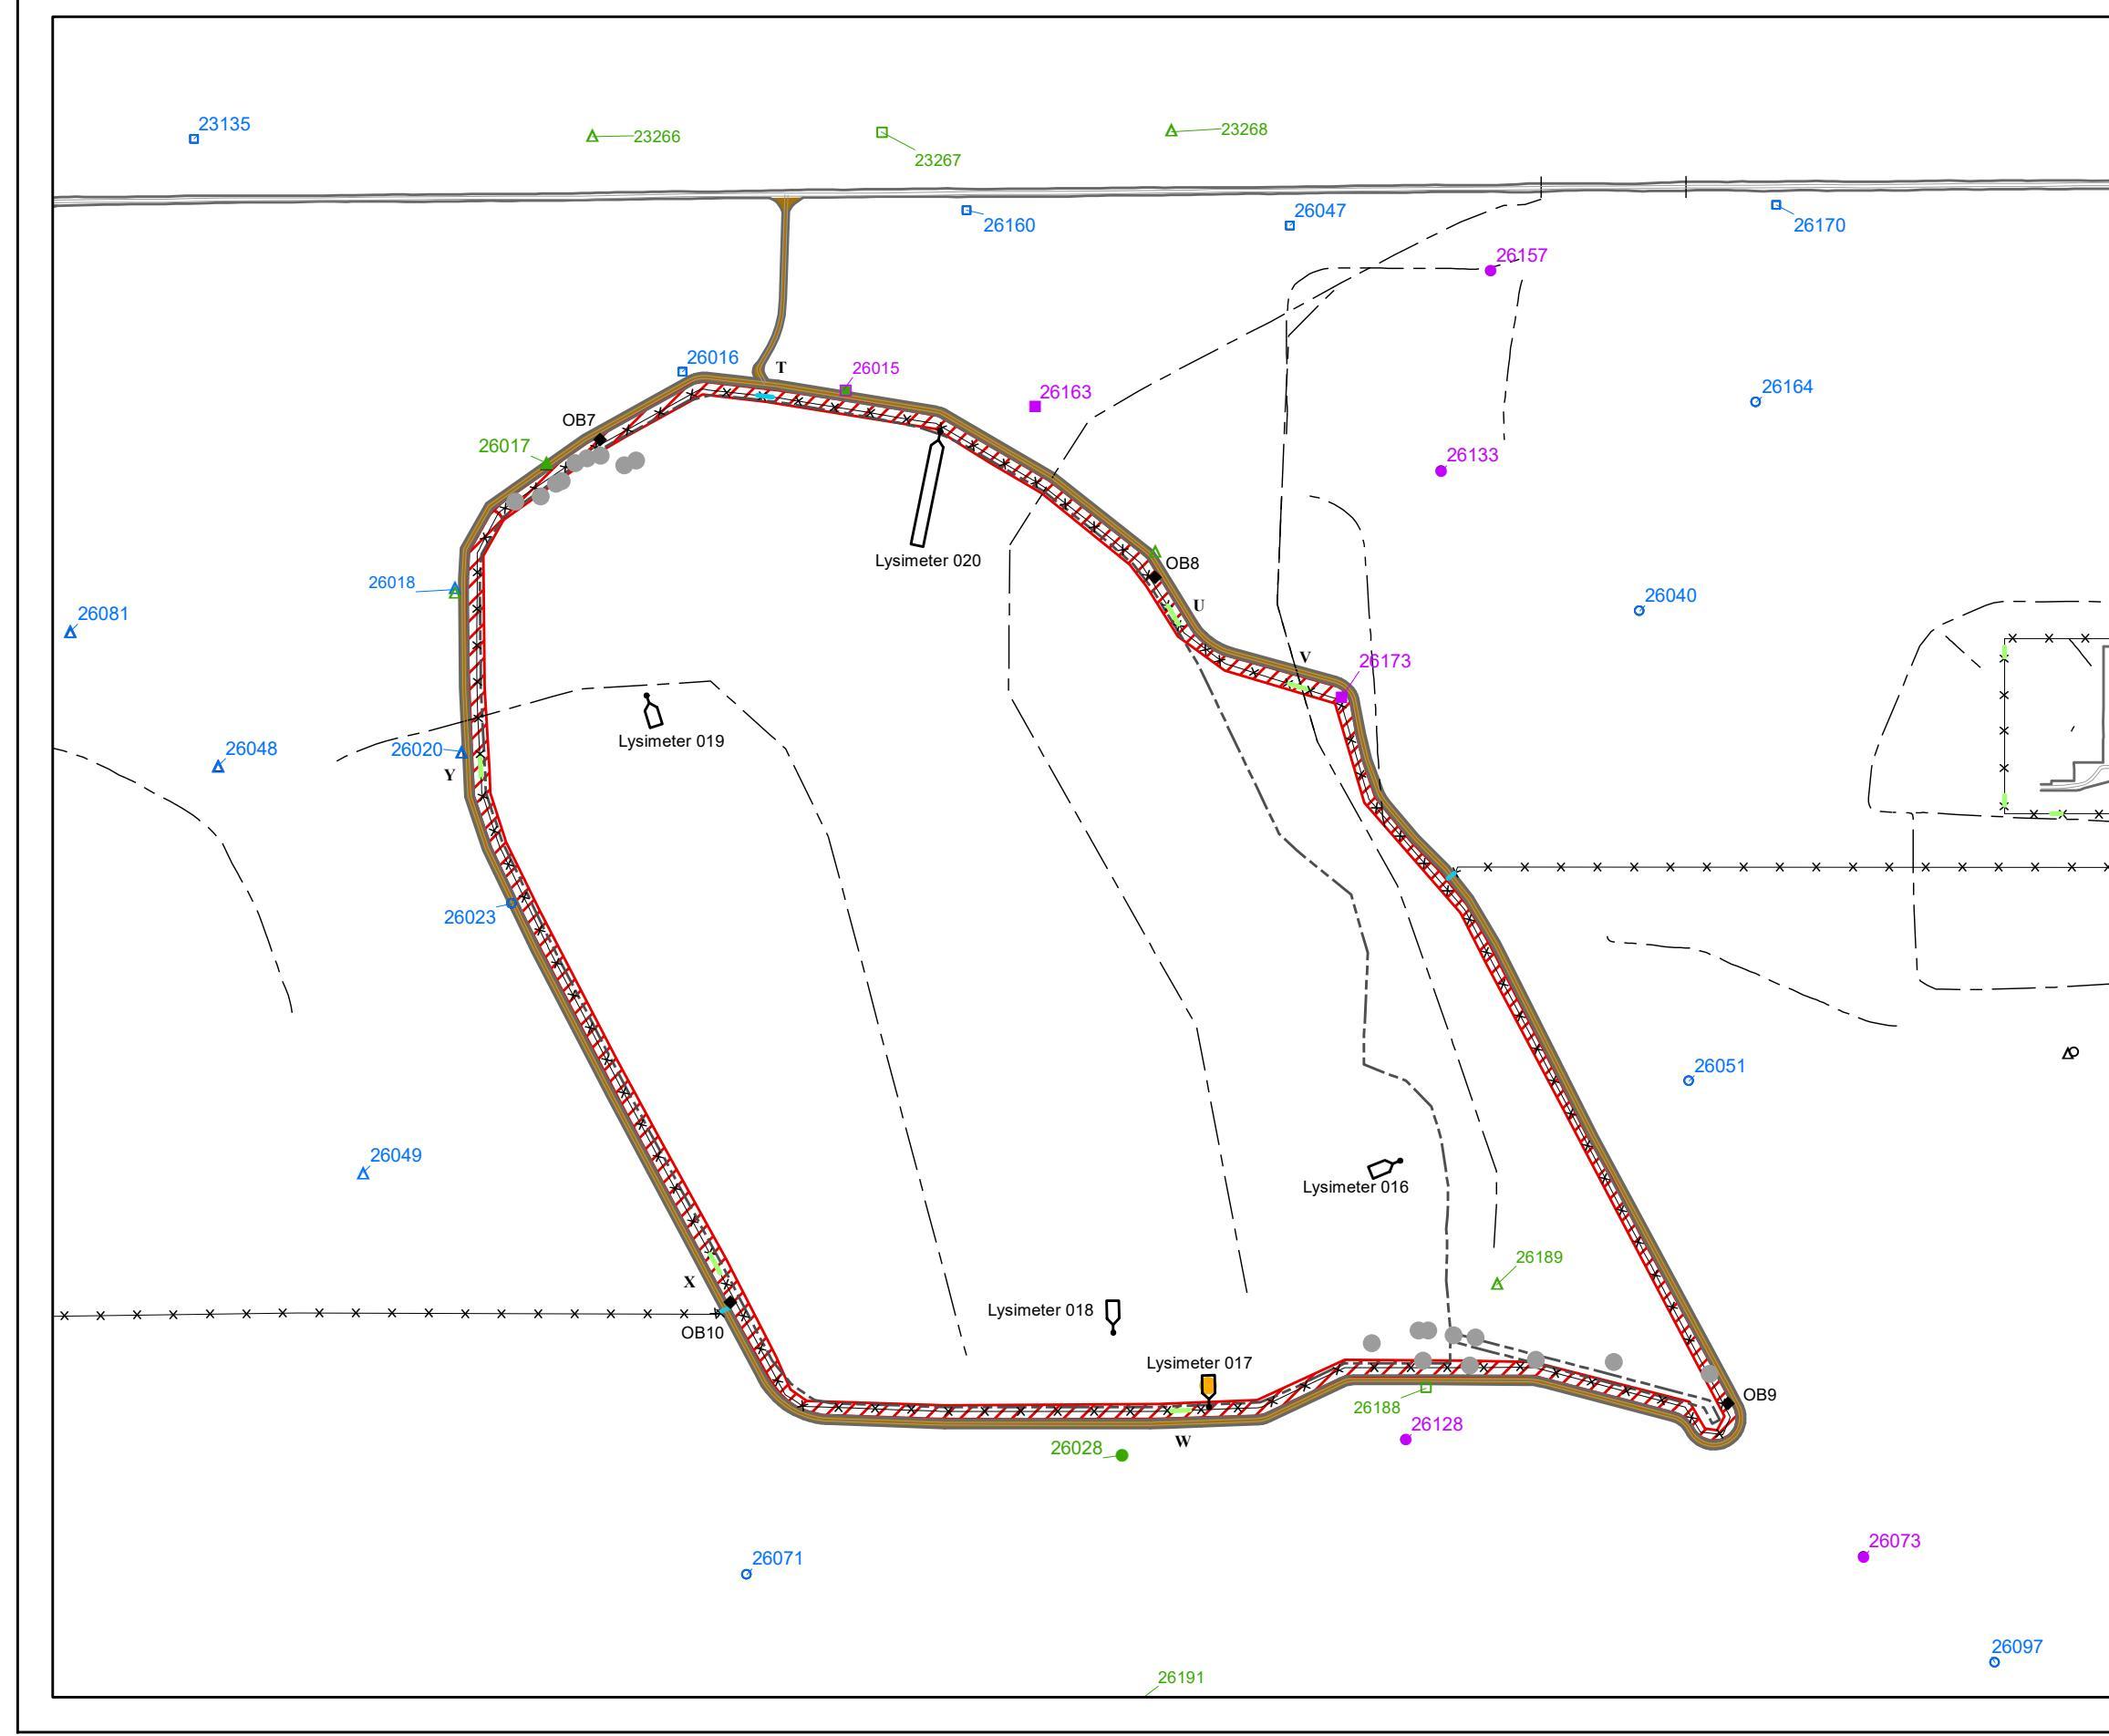
Note 1. The outside shoulder of the Perimeter Access Road defines the Army Maintained Area Boundary (AMA).
 Note 2. A prescribed burn was conducted over the entire Basin F AMA.

Task	Action	Date
Weed Control	Ground clear herbicide Plainview SC [®] was broadcast sprayed to working surfaces.	October 2023
Mowing	Mowed around the exterior and interior of the perimeter fence in anticipation for a prescribed burn.	October 2023
Prescribed burn	United States Fish and Wildlife Service (USFWS) performed a successful prescribed burn on the entire Basin F AMA.	March 2024

Non-Routine Action Plan (NRAP)-2023-002 (Navarro 2023c) documented the prescribed burn of the Basin F AMA that was successfully performed by the USFWS in March of 2024. This NRAP was approved in October of 2023.

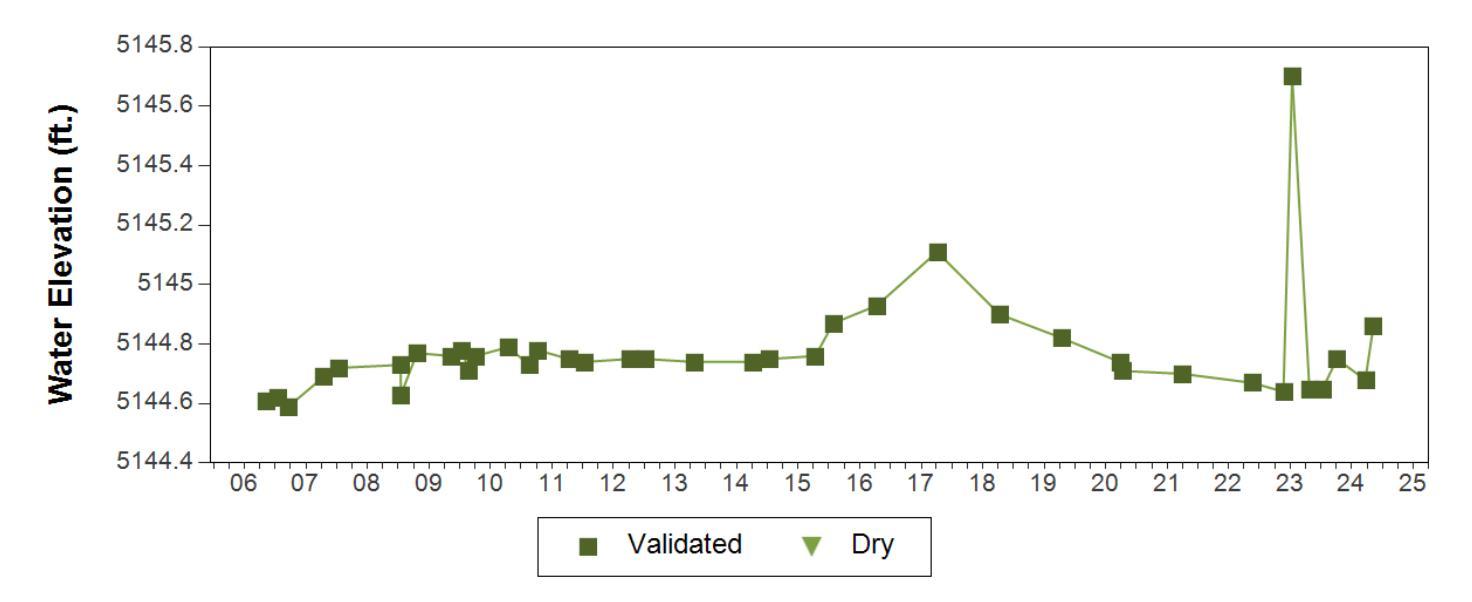
Hydrographs for Basin F Water Quality Wells

2006-04-01 to 2024-06-01 (Validated Data)

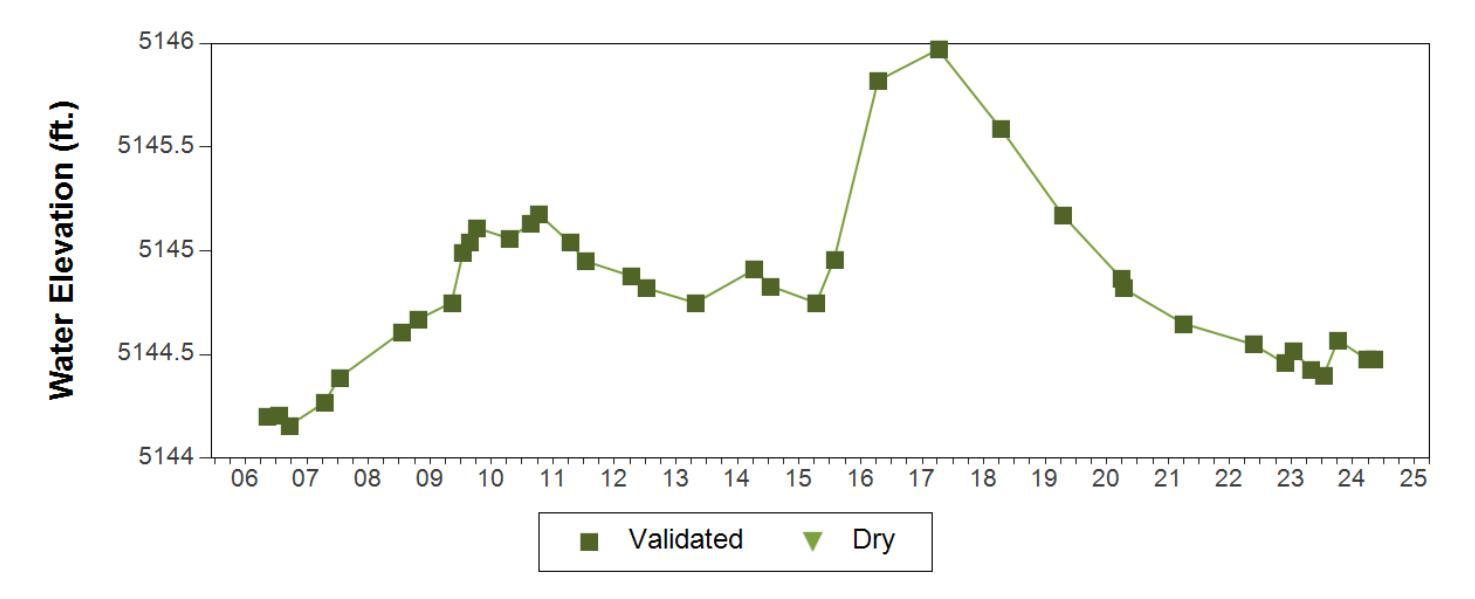
Water Levels for Well 26017

2006-04-01 to 2024-06-01 (Validated Data)

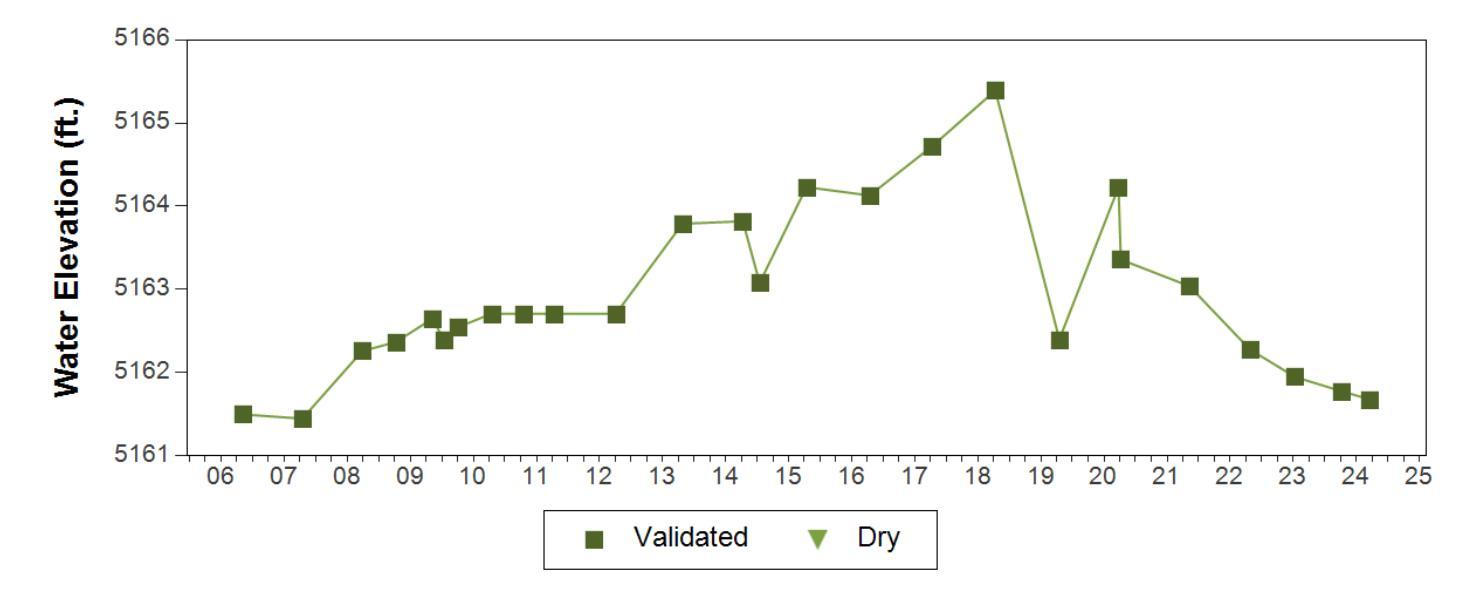
The water elevation increase of 0.94 feet on January 14, 2011 in well 26073 coincided with a top-of- casing elevation change resulting from modifications to the well. The well was resurveyed and updated in the Rocky Mountain Arsenal Database (RMAED). May 2024 measurement is anomalous and likely does not represent the true elevation.

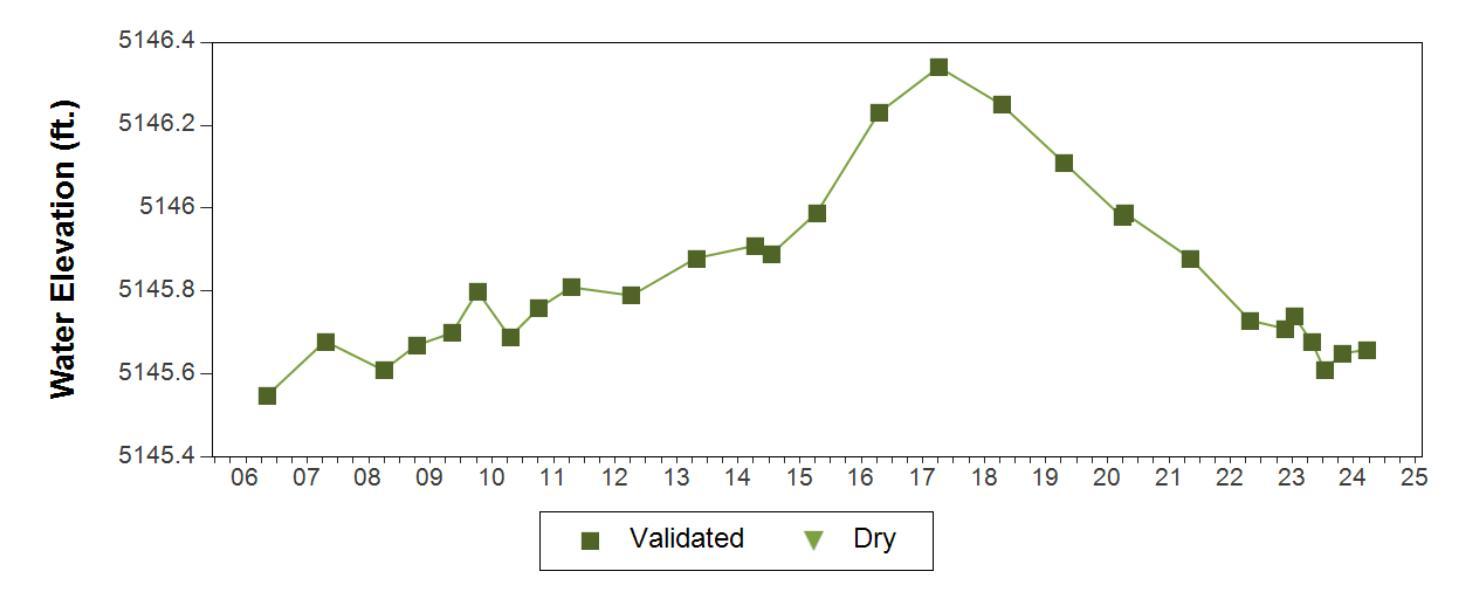
Water Levels for Well 26133

2006-04-01 to 2024-06-01 (Validated Data)
