JOINT BASE MYER – HENDERSON HALL MUNICIPAL SEPARATE STORM SEWER SYSTEM (MS4) PROGRAM PLAN

APPENDIX C.1

PCB TMDL ACTION PLAN

FOR FORT MYER & HENDERSON HALL INSTALLATIONS FORT MYER, VIRGINIA

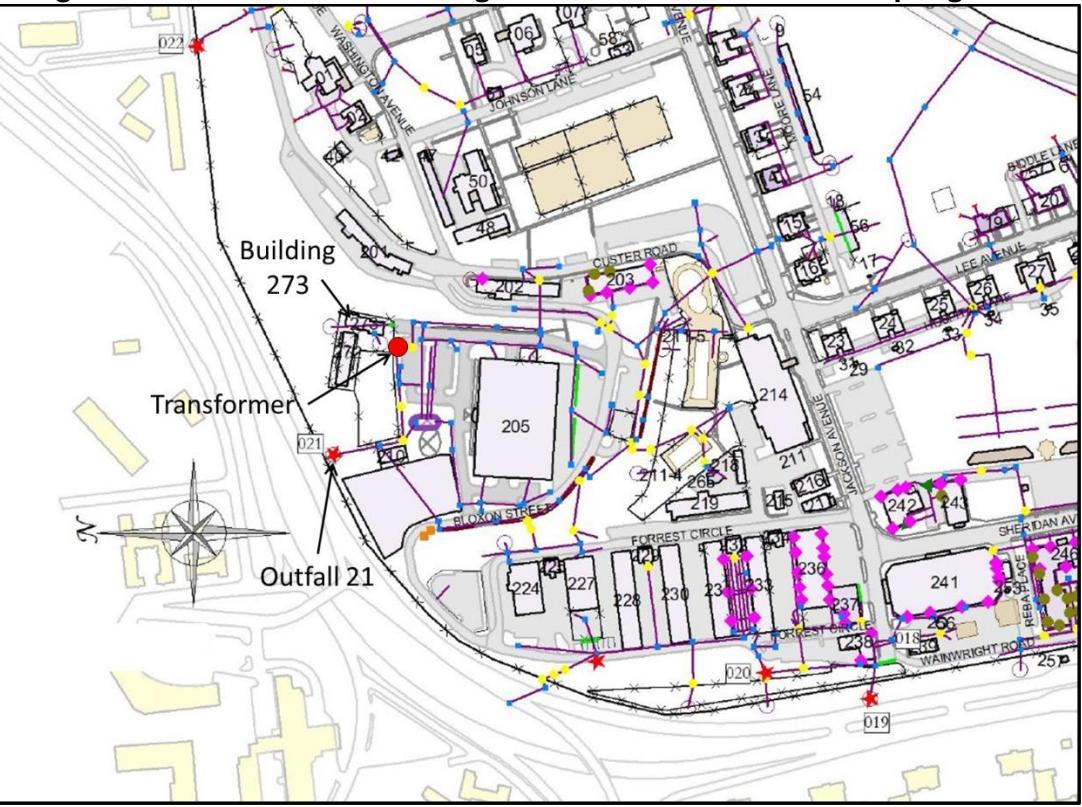
Figure 3. Transformer at Building 270/273 and Outfall 021 Sampling Point

Site access for sampling will be coordinated with facility staff. Stormwater runoff will be collected at stormwater Outfall 21 from two storm events to assess the runoff from the area of the transformer at Building 270/273 (Dog Kennels). **Figure 3** below shows the transformer and Outfall 21 locations.

Stormwater discharges from the area surrounding Building 270/273 Dog Kennels transformer that was observed with unidentified staining is treated by structural stormwater BMPs. The transformer is surrounded by a well-vegetated, grassy area, which would limit the transport of any soil that may be or become contaminated by PCBs. This area drains to a dry detention basin, which promotes settling of sediments.

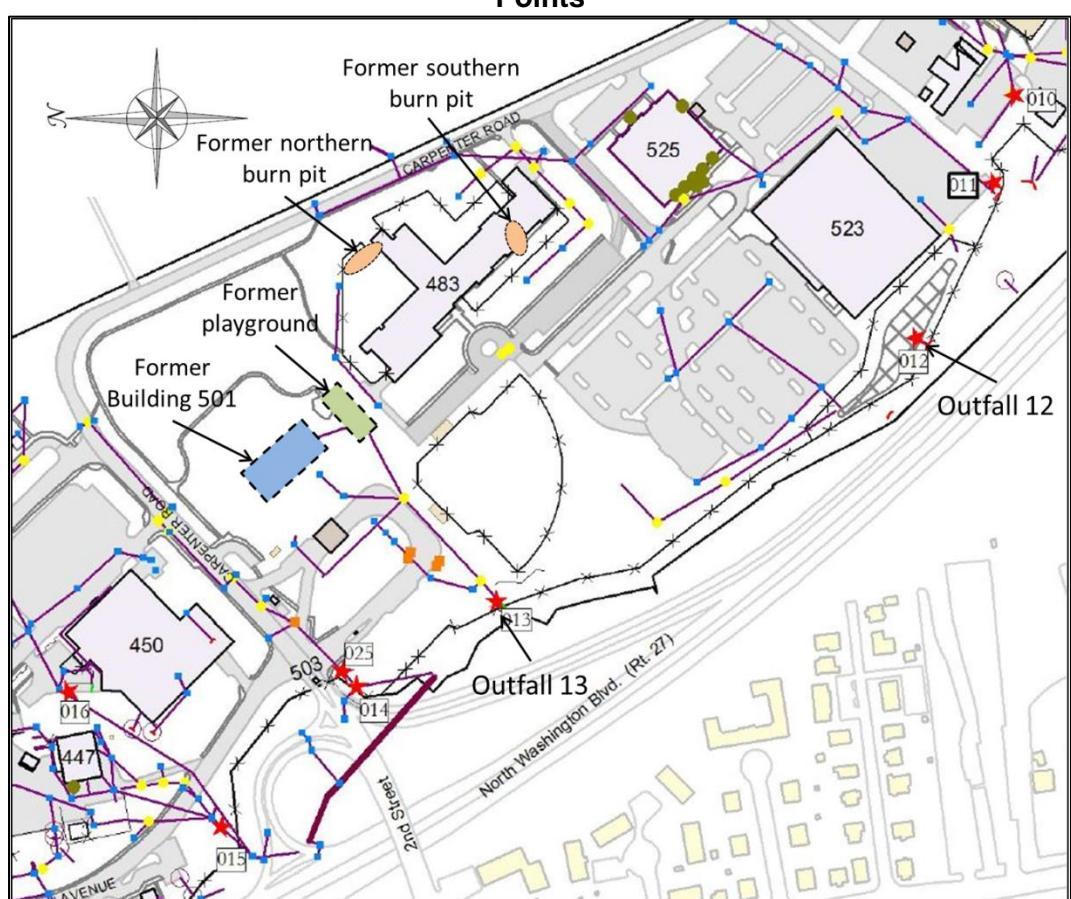
Figure 4. Area Surrounding Child Development Center and Outfalls 12 and 13 Sampling Points

Stormwater runoff will also be collected from stormwater Outfalls 12 and 13 from two storm events to assess the area surrounding the CDC. **Figure 4** below shows the locations of the former northern burn pit, southern burn pit, Building 501, and playground.

The CDC (Building 483), which is in the location of the former south and north burn areas, has a large building that occupies most of the former burn areas and is surrounded by vegetated and paved areas. The area to the east of the CDC is mostly occupied by a large parking lot. The area to the north of the parking lot is a maintained ballfield, and the area to the north of the CDC, the former Building 501 and playground, is a well-vegetated area. Buildings and paved areas essentially act as a cap preventing soils from eroding. If well maintained, the vegetated, grassy areas should prevent erosion.

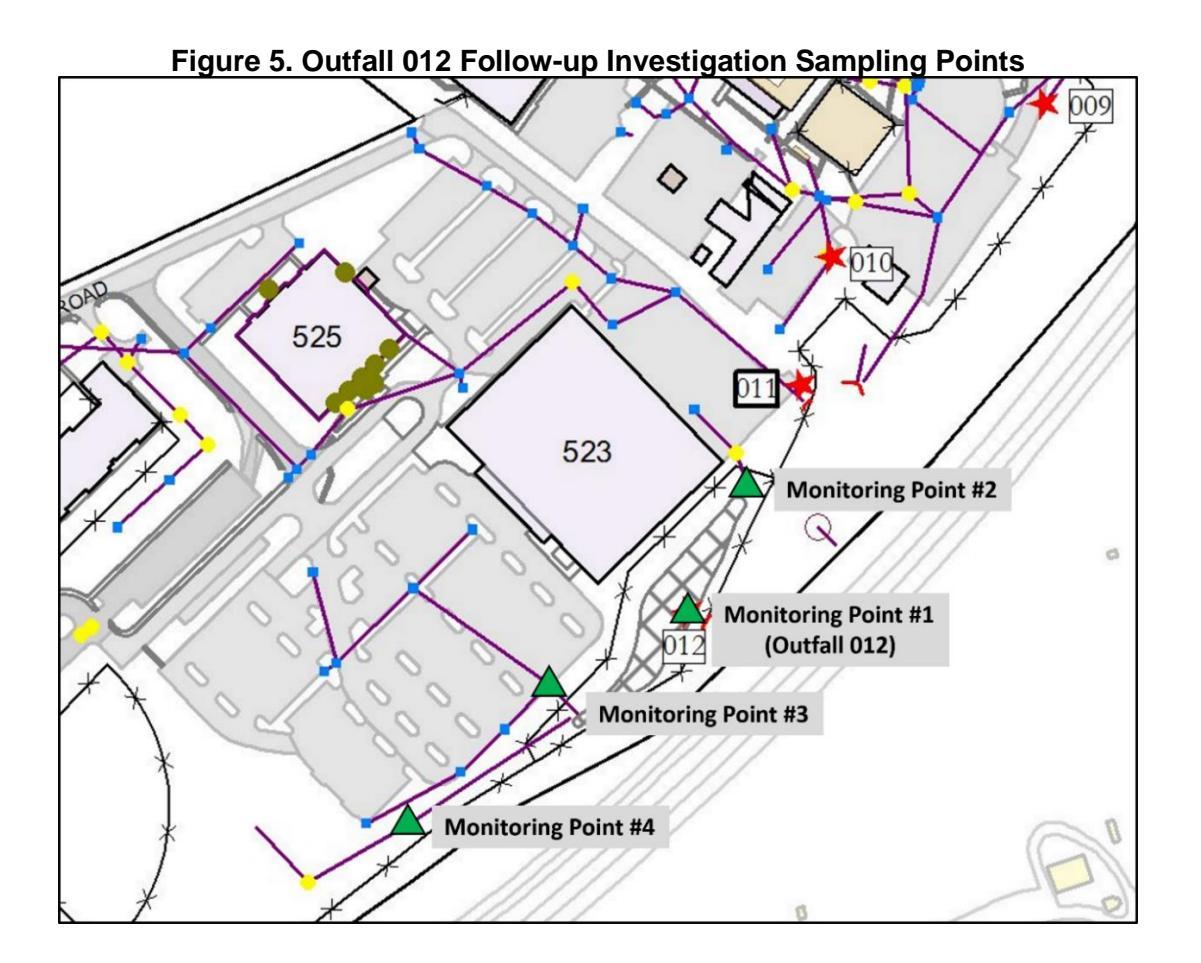
In November 2023, JBM-HH EMD collected stormwater samples from three inlets located upgradient from the Long Branch Detention Basin and associated Outfall 012, where the PCBs were detected in August 2022. These three stormwater inlets discharge to Outfall 012 and would therefore help to narrow down the potential source of PCBs. EMD collected an additional sample from Outfall 012 concurrent with the inlet samples for correlation and to provide an additional set of data points. The four monitoring points are shown in **Figure 5** below.
