## **PRELIMINARY SITE INSPECTION REPORT FOR FORT STEWART MILITARY RESERVATION**

Site Inspection Report No. 91034

Prepared For:  
U.S. Army Corps of Engineers  
Toxic and Hazardous Materials Agency  
Aberdeen Proving Ground, MD

Prepared By:  
Advanced Sciences, Inc.  
1250 Brass Mill Road  
Belcamp, MD 21017

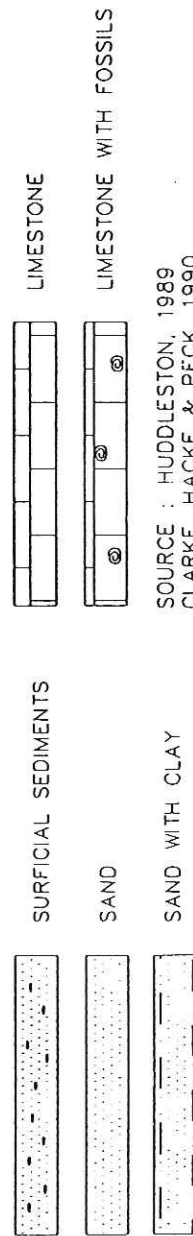
The geologic units beneath the site function as two aquifers (see Figure 2.8) that may be in hydrologic communication under certain conditions (ESE 1982). The upper aquifer or water table aquifer is present in the Recent to Pliocene age sediments. It is separated from the lower confined aquifer by the upper members of the Miocene age Hawthorn Group. The confined aquifer is the artesian Floridan aquifer. The recharge area for the Floridan aquifer is located northwest and outside of the study area. (G&M 1991)
