## **PRELIMINARY SITE INSPECTION REPORT FOR FORT STEWART MILITARY RESERVATION**

Site Inspection Report No. 91034

September 1992

Prepared By:  
Advanced Sciences, Inc.  
1250 Brass Mill Road  
Belcamp, MD 21017

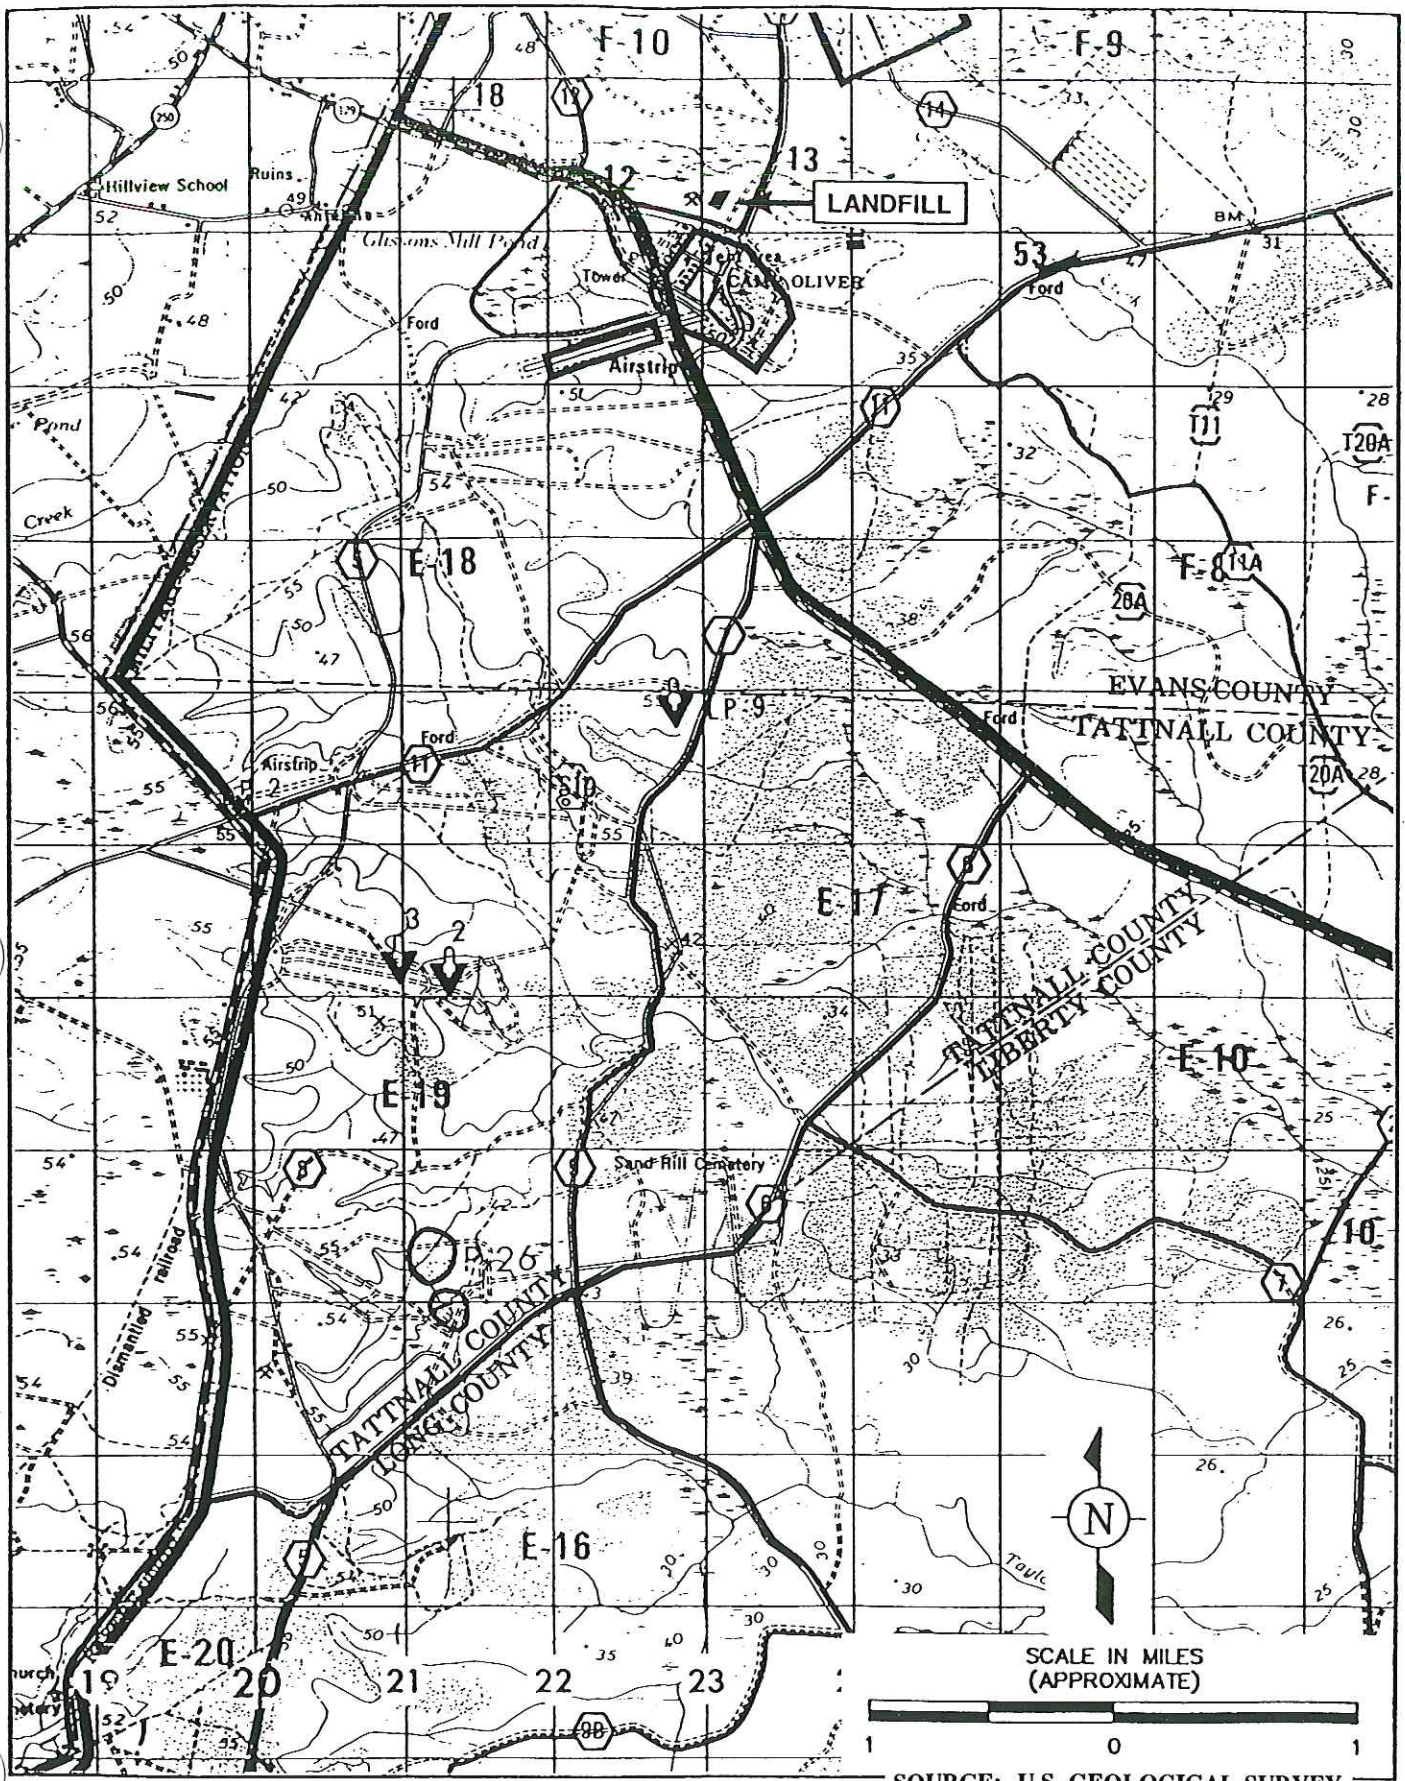
FIGURE 2.3. CAMP OLIVER LANDFILL LOCATION MAP  
FORT STEWART MILITARY RESERVATION

The northern portion of the landfill is within the floodplain of the Canoochee Creek. The soil in this area is loamy sand over a sandy subsoil and is poorly drained, which allows depressions and small drainageways to form. Due to soil conditions in this area, potential leachate release to the soil directly under the landfill is high (G&M 1991).

Regular analysis from two monitoring wells installed in 1980 has shown no contamination by any CERCLA-listed hazardous constituents. Iron (0.684 ppm to 8.750 ppm) was detected above the National Interim Primary Drinking Water Regulations (0.03 ppm). This high level of iron was attributed to high levels in the indigenous soils (G&M, 1991). Monitoring data does not indicate known releases that would impact the environment. Additional sampling is proposed under the planned RFI.
