# **US Army Corps of Engineers**

## **PRELIMINARY SITE INSPECTION REPORT FOR FORT STEWART MILITARY RESERVATION**

Site Inspection Report No. 91034

September 1992

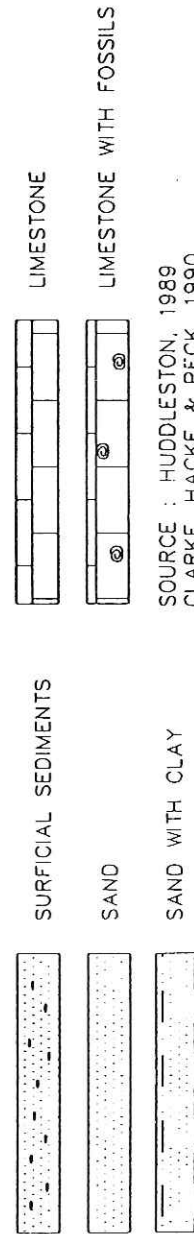
The geologic units beneath the site function as two aquifers (see Figure 2.8) that may be in hydrologic communication under certain conditions (ESE 1982). The upper aquifer or water table aquifer is present in the Recent to Pliocene age sediments. It is separated from the lower confined aquifer by the upper members of the Miocene age Hawthorn Group. The confined aquifer is the artesian Floridan aquifer. The recharge area for the Floridan aquifer is located northwest and outside of the study area. (G&M 1991)
