## **PRELIMINARY SITE INSPECTION REPORT FOR FORT STEWART MILITARY RESERVATION**

Site Inspection Report No. 91034

Prepared For:  
U.S. Army Corps of Engineers  
Toxic and Hazardous Materials Agency  
Aberdeen Proving Ground, MD

Prepared By:  
Advanced Sciences, Inc.  
1250 Brass Mill Road  
Belcamp, MD 21017

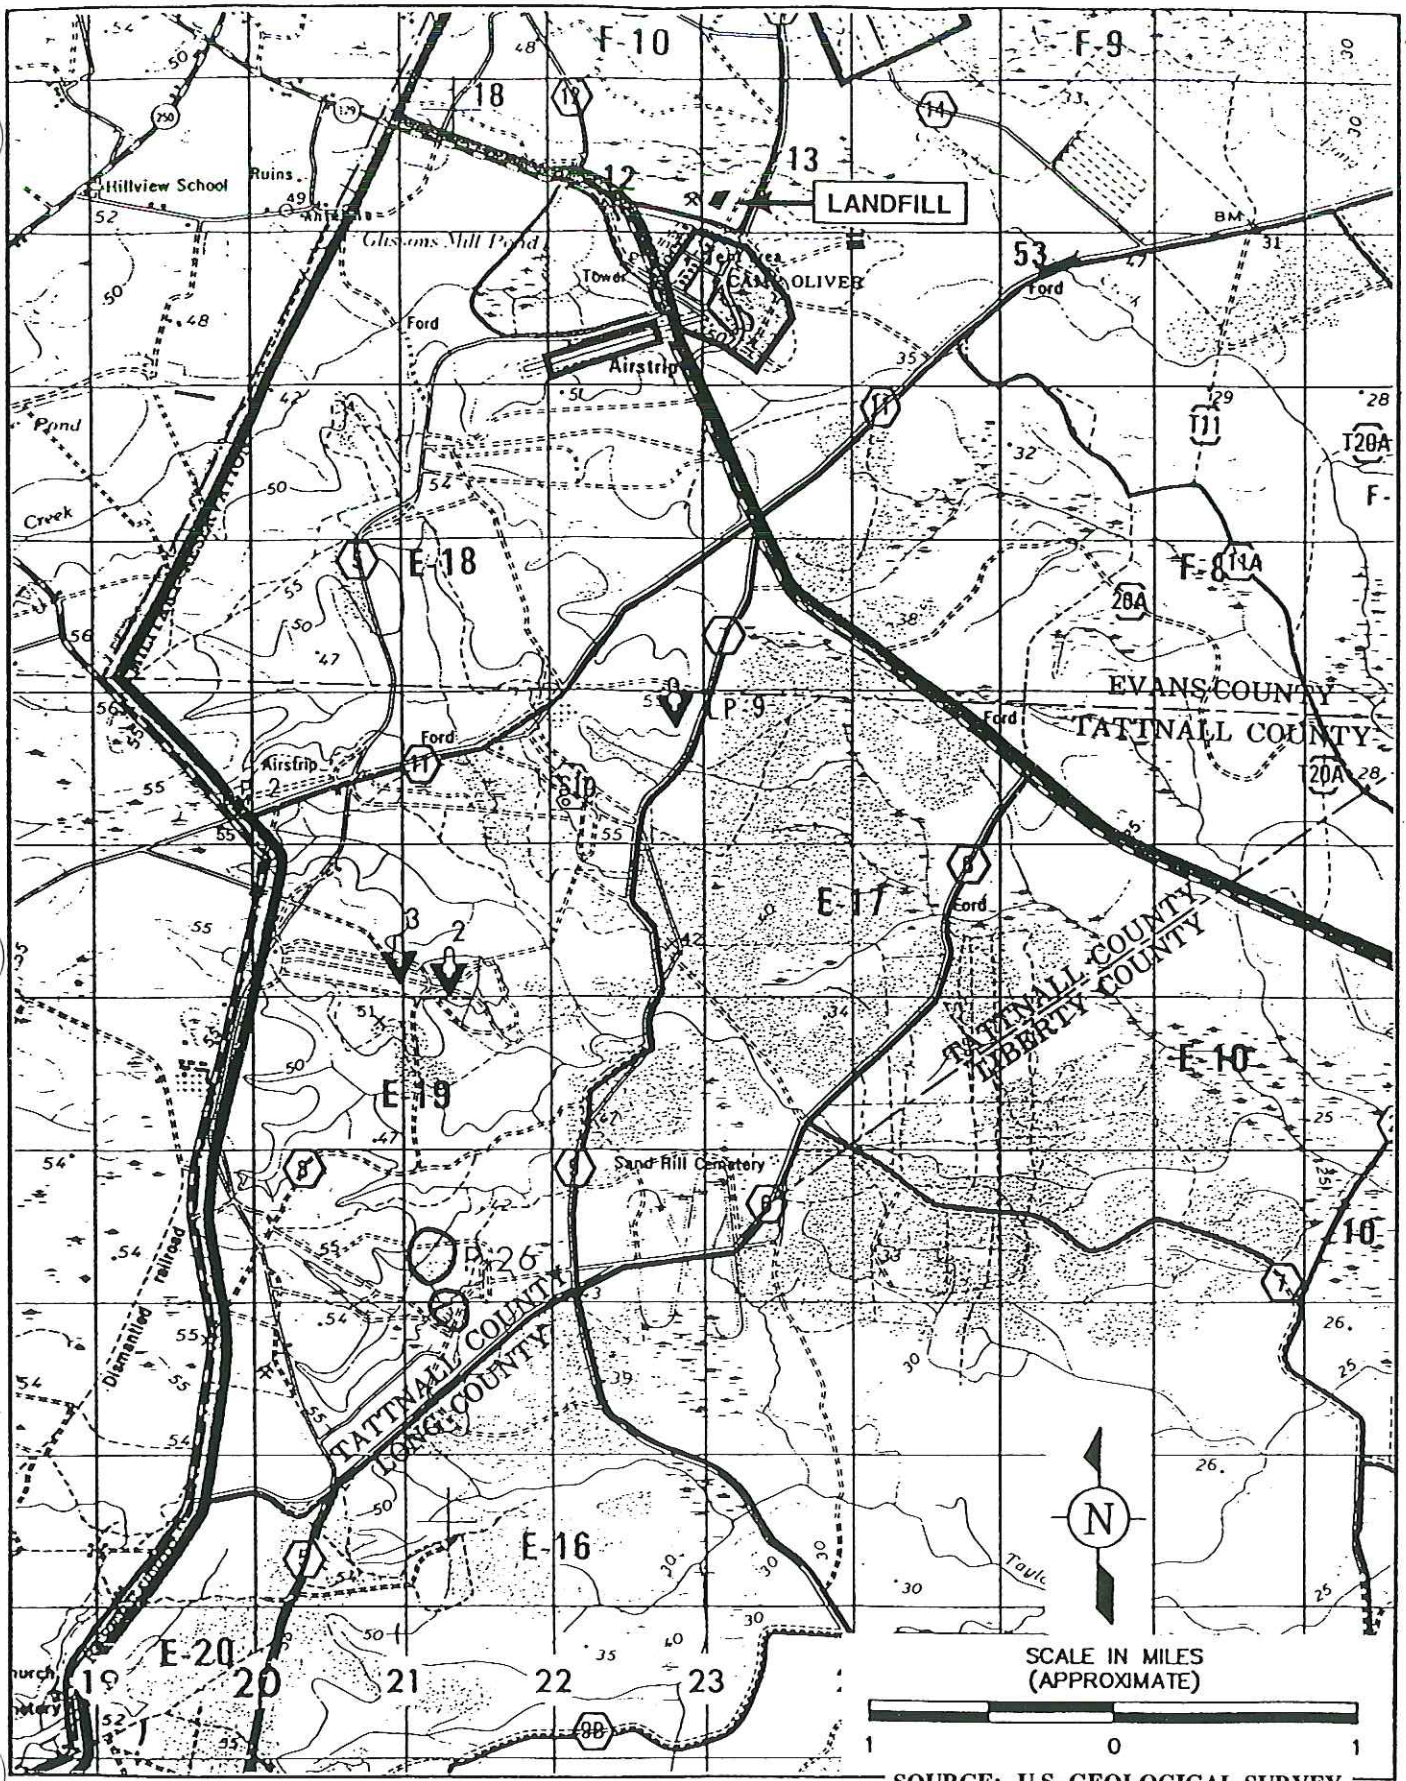
FIGURE 2.3. CAMP OLIVER LANDFILL LOCATION MAP  
FORT STEWART MILITARY RESERVATION

The northern portion of the landfill is within the floodplain of the Canoochee Creek. The soil in this area is loamy sand over a sandy subsoil and is poorly drained, which allows depressions and small drainageways to form. Due to soil conditions in this area, potential leachate release to the soil directly under the landfill is high (G&M 1991).

Regular analysis from two monitoring wells installed in 1980 has shown no contamination by any CERCLA-listed hazardous constituents. Iron (0.684 ppm to 8.750 ppm) was detected above the National Interim Primary Drinking Water Regulations (0.03 ppm). This high level of iron was attributed to high levels in the indigenous soils (G&M, 1991). Monitoring data does not indicate known releases that would impact the environment. Additional sampling is proposed under the planned RFI.

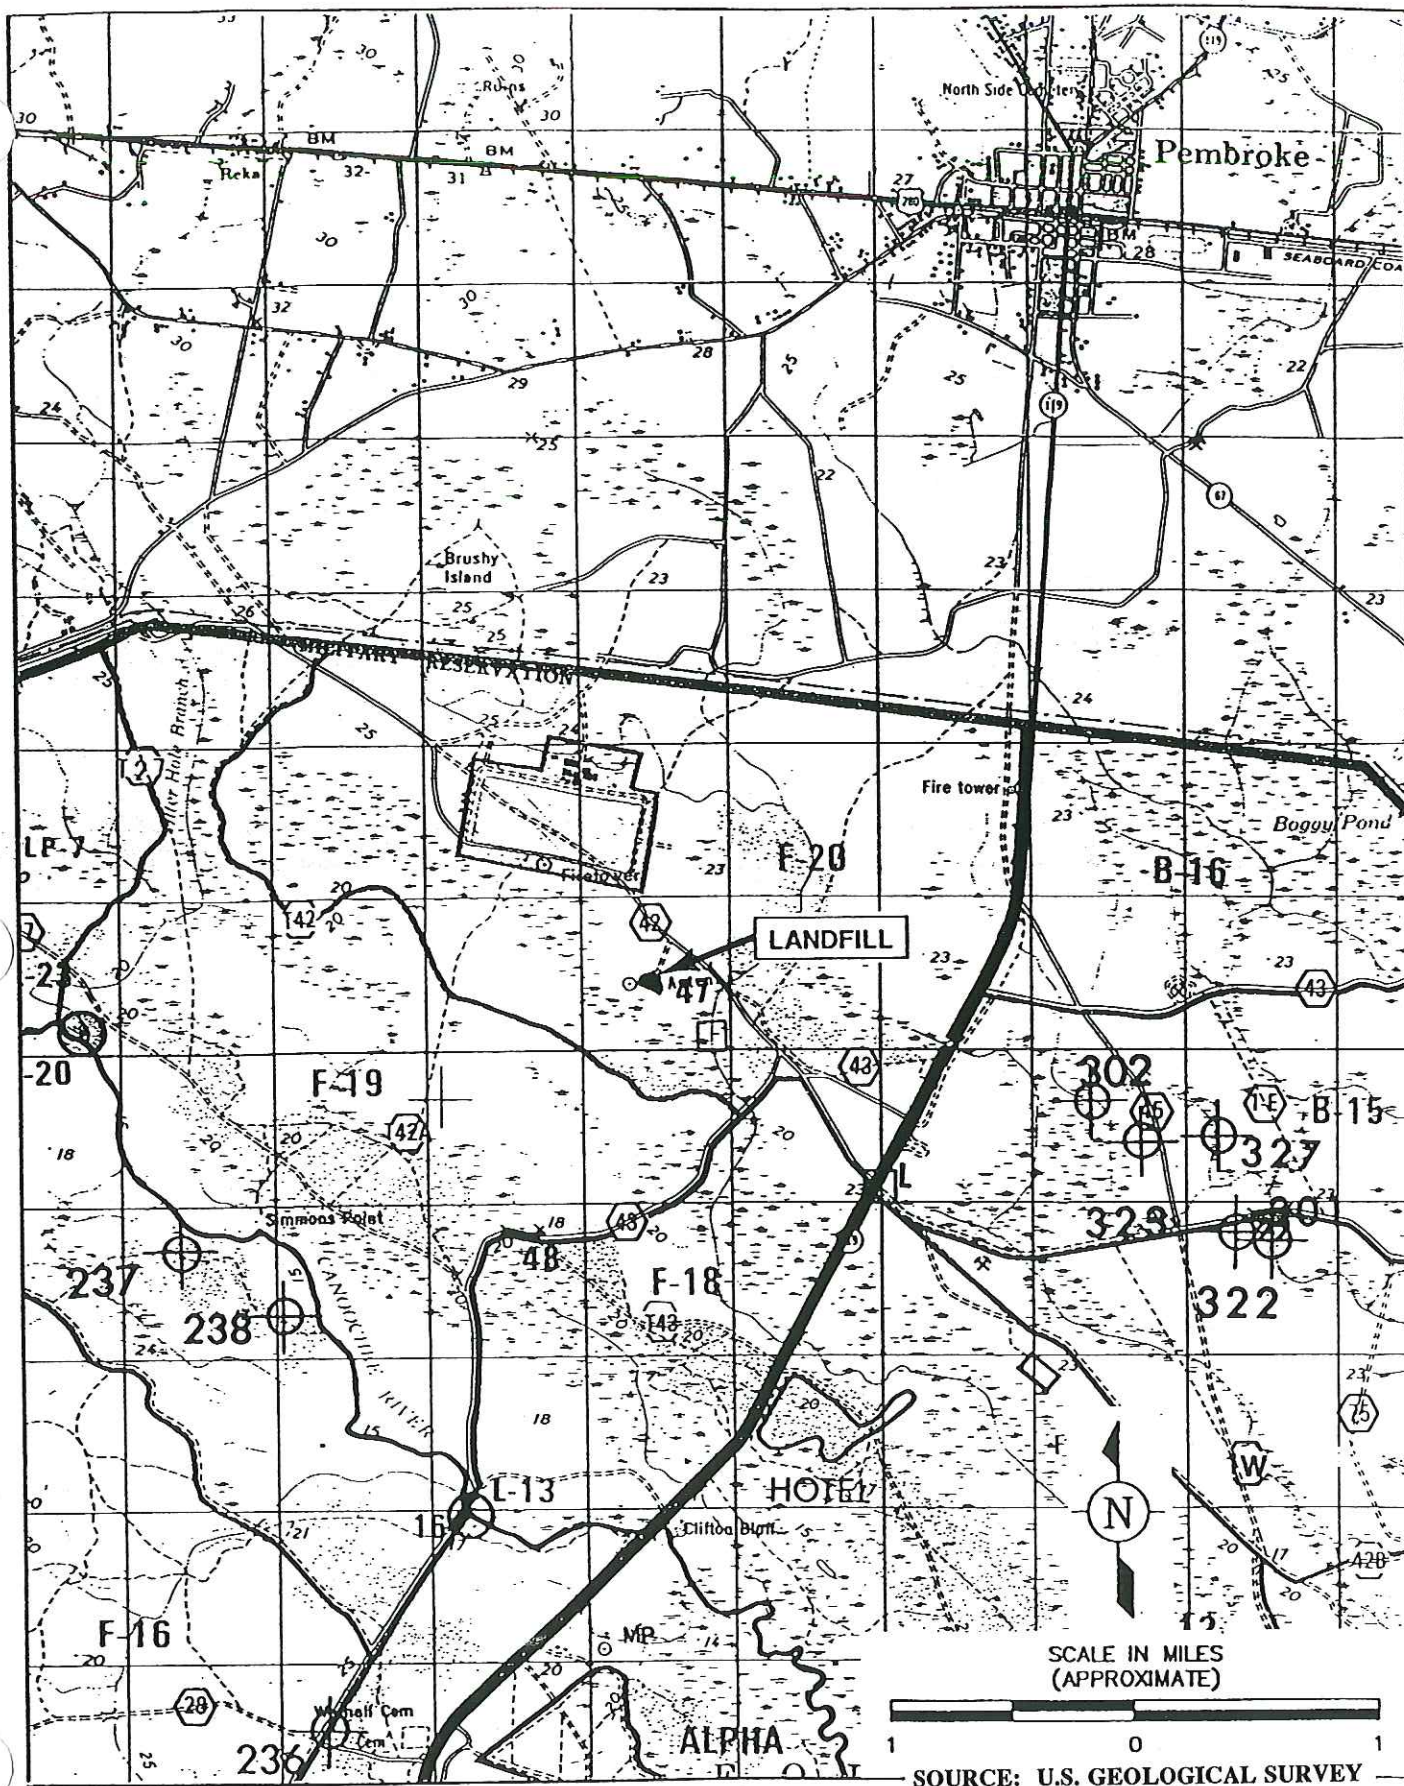
FIGURE 2.4. TAC - X LANDFILL - FORT STEWART MILITARY RESERVATION

Soils in this area are primarily sands and sand/silt mixtures. Sands in the upper 20 ft are fine-grained and become medium- to coarse-grained from 20 to 100 ft. In the southeast corner of the landfill, boring indicated small gravel pockets. Although one high-permeable area was encountered that produced groundwater at a rate of 25 gallons per minute (gpm) for approximately 15 minutes, the yield decreased to a few gpm. For the most part, the potential to release by groundwater is limited because the overall permeability of the sandy, silt soils generally restricts movement of groundwater. There is little runoff due to the flat terrain and the surface soils absorb most of the rainfall. In 1980, due to the wet season, there were active groundwater seeps that drained via trenches from the landfill toward the swampy areas located to the south of the site. There may be a potential for leachate to develop from the waste materials within the landfill and migration could occur to the local aquifer and to the wetlands located to the south of the landfill. (AEHA 1988) In 1980, leachate was observed emanating from an earthen bank at this landfill (AEHA 1987).

Regular analysis of samples collected from two monitoring wells installed in 1980 indicate no contamination of CERCLA-listed hazardous constituents to the groundwater. Iron was detected above the National Interim Primary Drinking Water Regulations, again this has been attributed primarily to the indigenous soils. (G&M 1991)

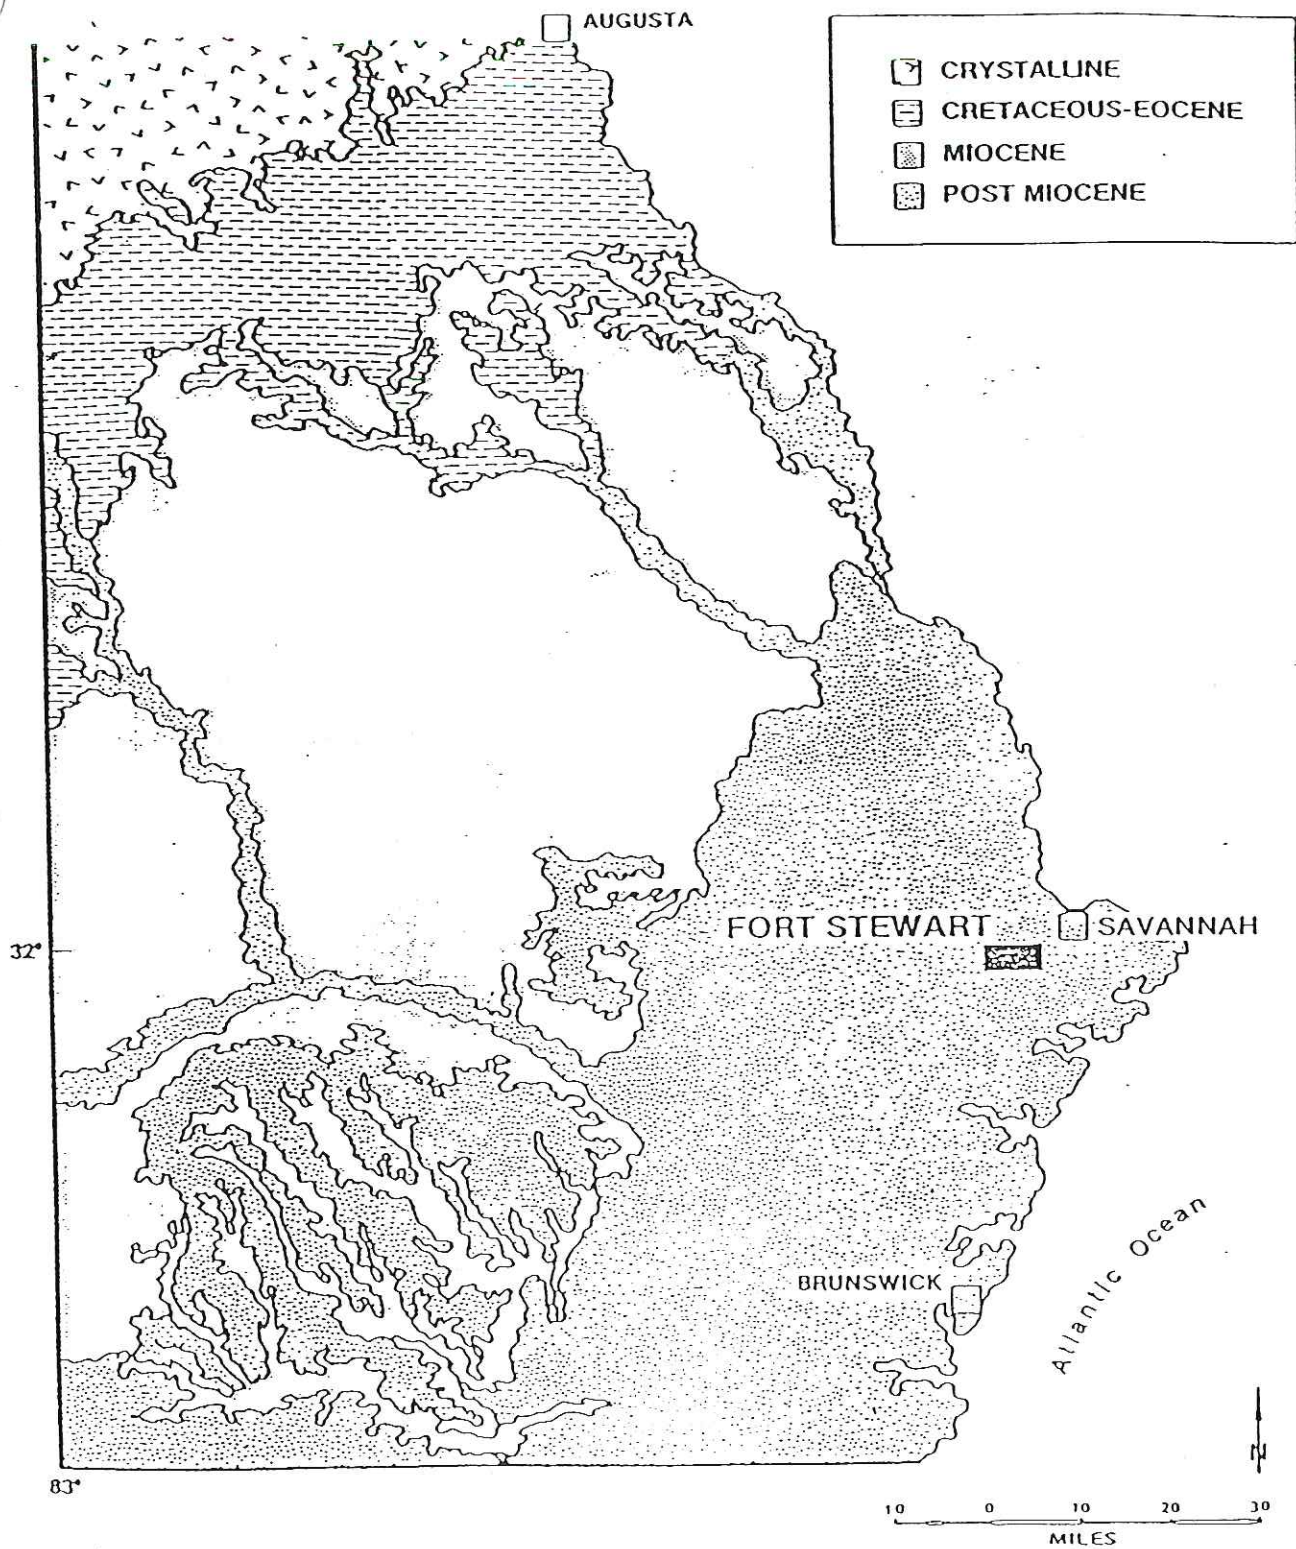
FIGURE 2.7 SEDIMENTS OF SOUTHEASTERN GEORGIA

All of the lithologic units within the study area are water bearing. Groundwater movement and storage occur in the primary intergranular porosity of the unconsolidated sediments. The recharge of groundwater is by the infiltration of precipitation through the soil. Water that is not absorbed in this manner is returned to the atmosphere by means of transpiration, evaporation, or flows as runoff to topographic lows. The discharge of groundwater is to pumping wells and to the maintenance of baseflow in streams and wetlands. (G&M 1991, Fetter 1988)

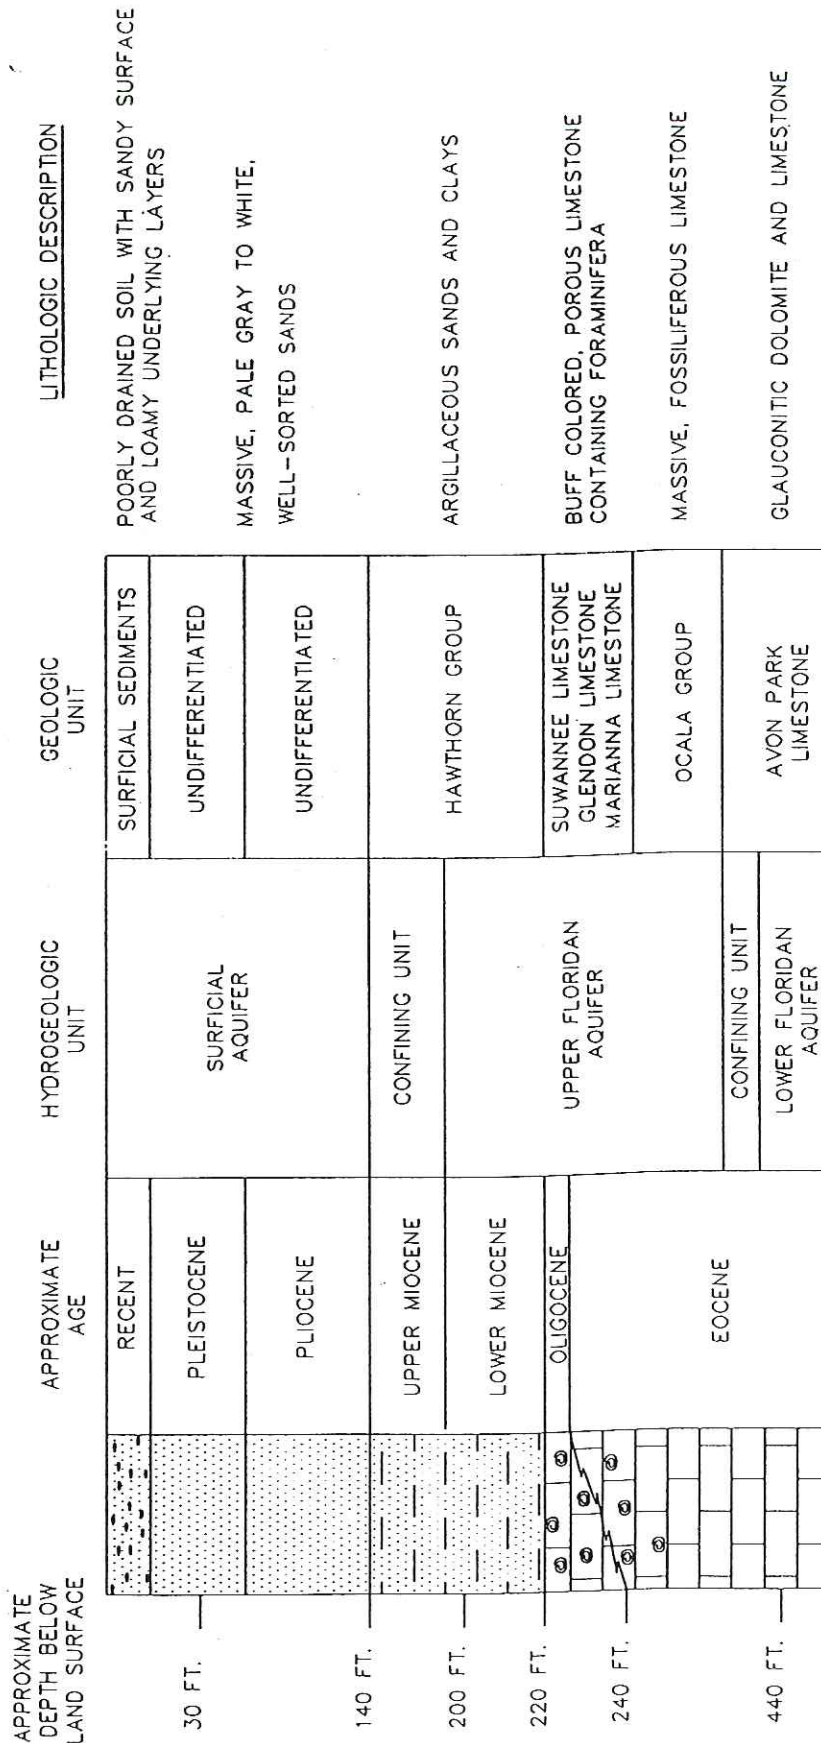
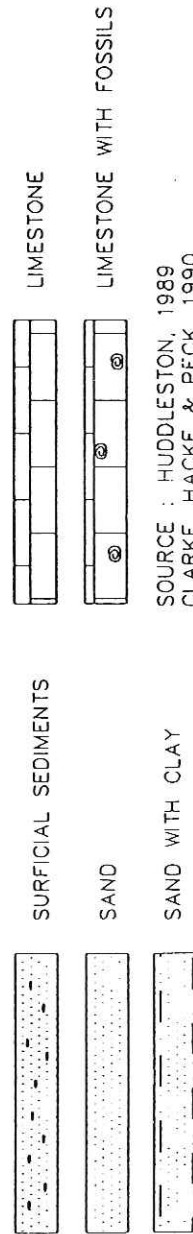
The geologic units beneath the site function as two aquifers (see Figure 2.8) that may be in hydrologic communication under certain conditions (ESE 1982). The upper aquifer or water table aquifer is present in the Recent to Pliocene age sediments. It is separated from the lower confined aquifer by the upper members of the Miocene age Hawthorn Group. The confined aquifer is the artesian Floridan aquifer. The recharge area for the Floridan aquifer is located northwest and outside of the study area. (G&M 1991)
