**CORRECTIVE ACTION PLAN - PART A REPORT
FOR
FACILITY ID #9-089115
UNDERGROUND STORAGE TANK 100
AT
BUILDING 1343
FORT STEWART, GEORGIA**

**U.S. Army Corps of Engineers - Savannah District
and
Fort Stewart Directorate of Public Works
Under Contract Number DACA21-95-D-0022
Delivery Order 0003**

May 1997

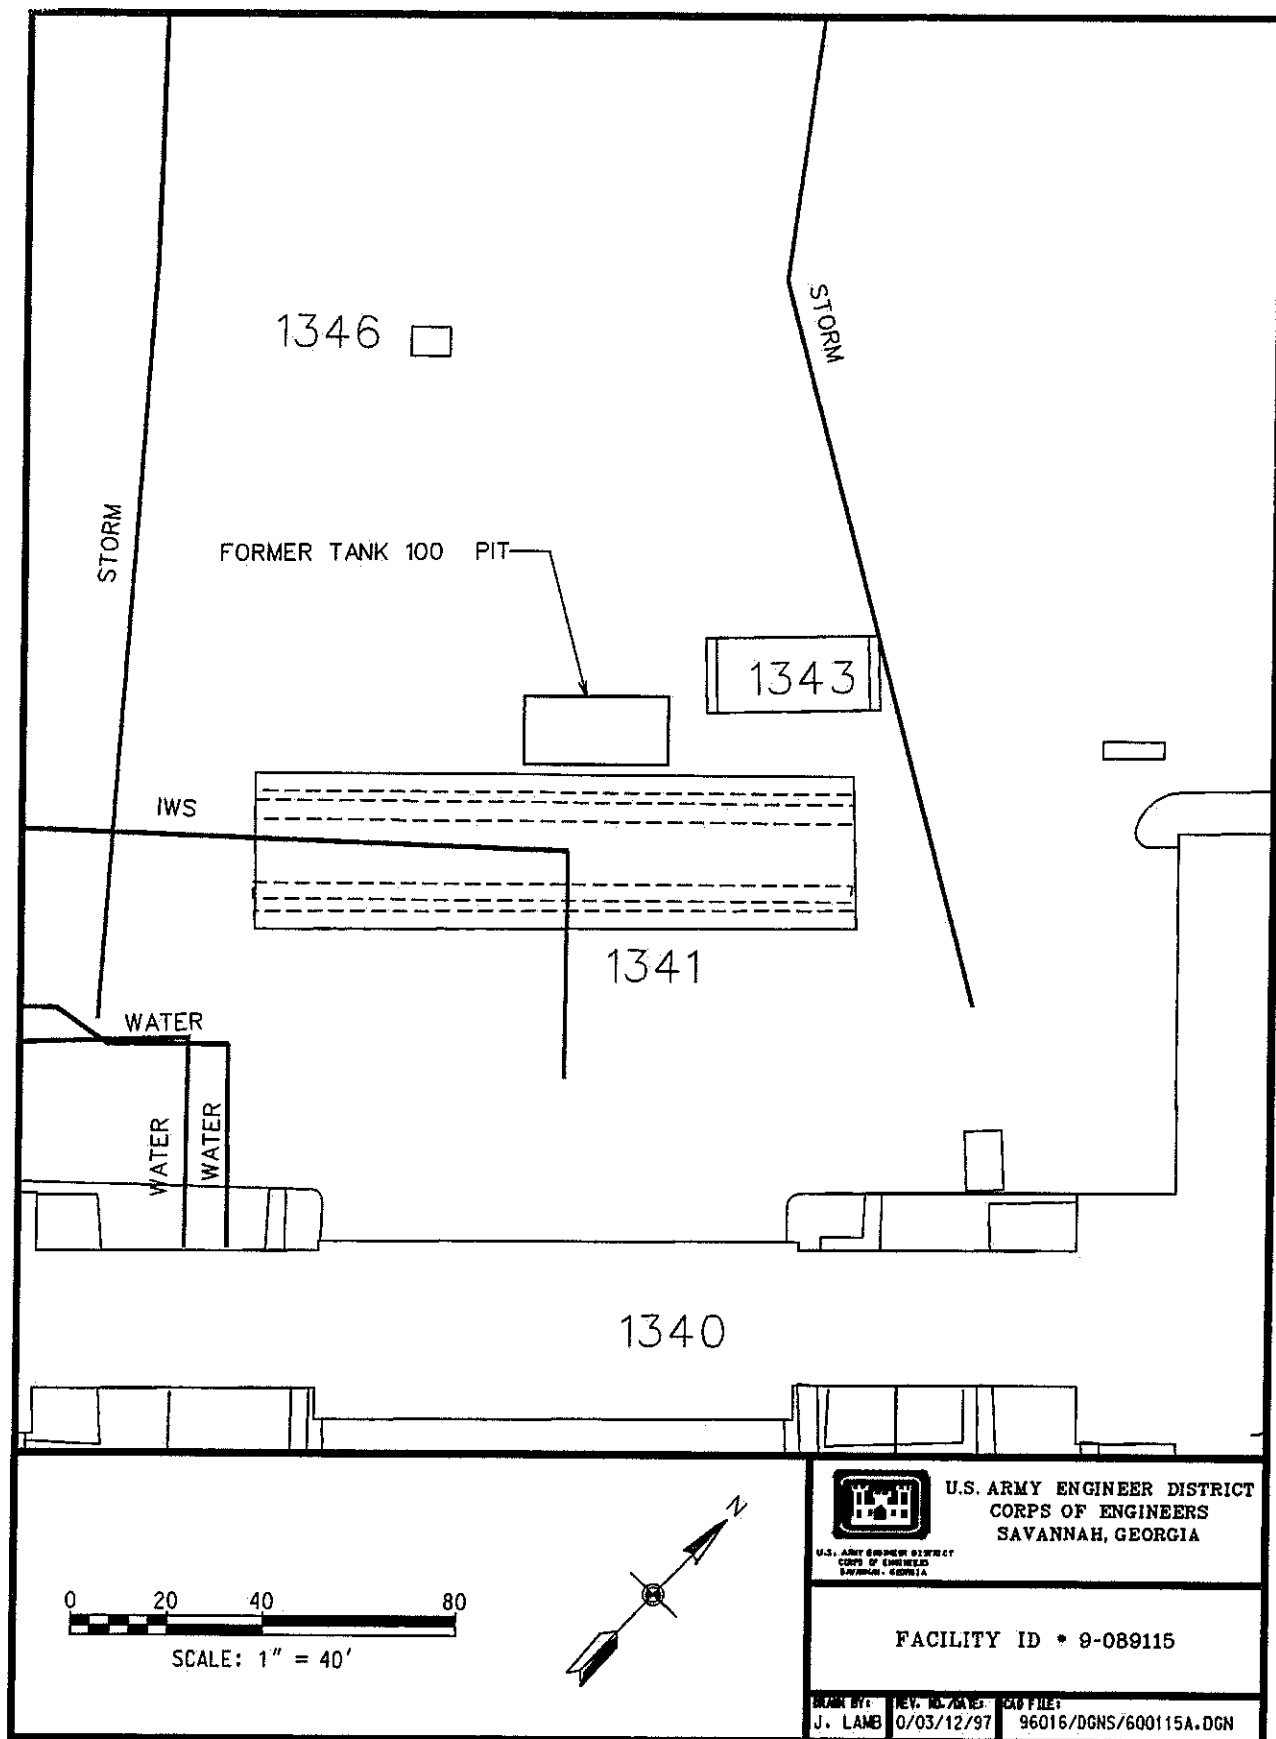
Figure II-1. Facility ID #9-089115, UST 100, Site Map

The location of former UST 100 is illustrated in Figure II-1. Detailed schematics illustrating the location of the tank and ancillary piping as configured during operation is not available. During removal activities, Fort Stewart DPW personnel observed no holes in the tank and, therefore, the source of contamination is believed to have been piping leakage and/or tank overflows. At the present time, the only remaining source of contamination at the site is contaminated soil located below the former tank pit.
