**CORRECTIVE ACTION PLAN - PART A REPORT
FOR
FACILITY ID #9-089088
UNDERGROUND STORAGE TANK 29
AT
BUILDING 1636/1643
FORT STEWART, GEORGIA**

**U.S. Army Corps of Engineers - Savannah District
and
Fort Stewart Directorate of Public Works
Under Contract Number DACA21-95-D-0022
Delivery Order 0003**

**Science Applications International Corporation
800 Oak Ridge Turnpike
Oak Ridge, Tennessee 37831**

May 1997

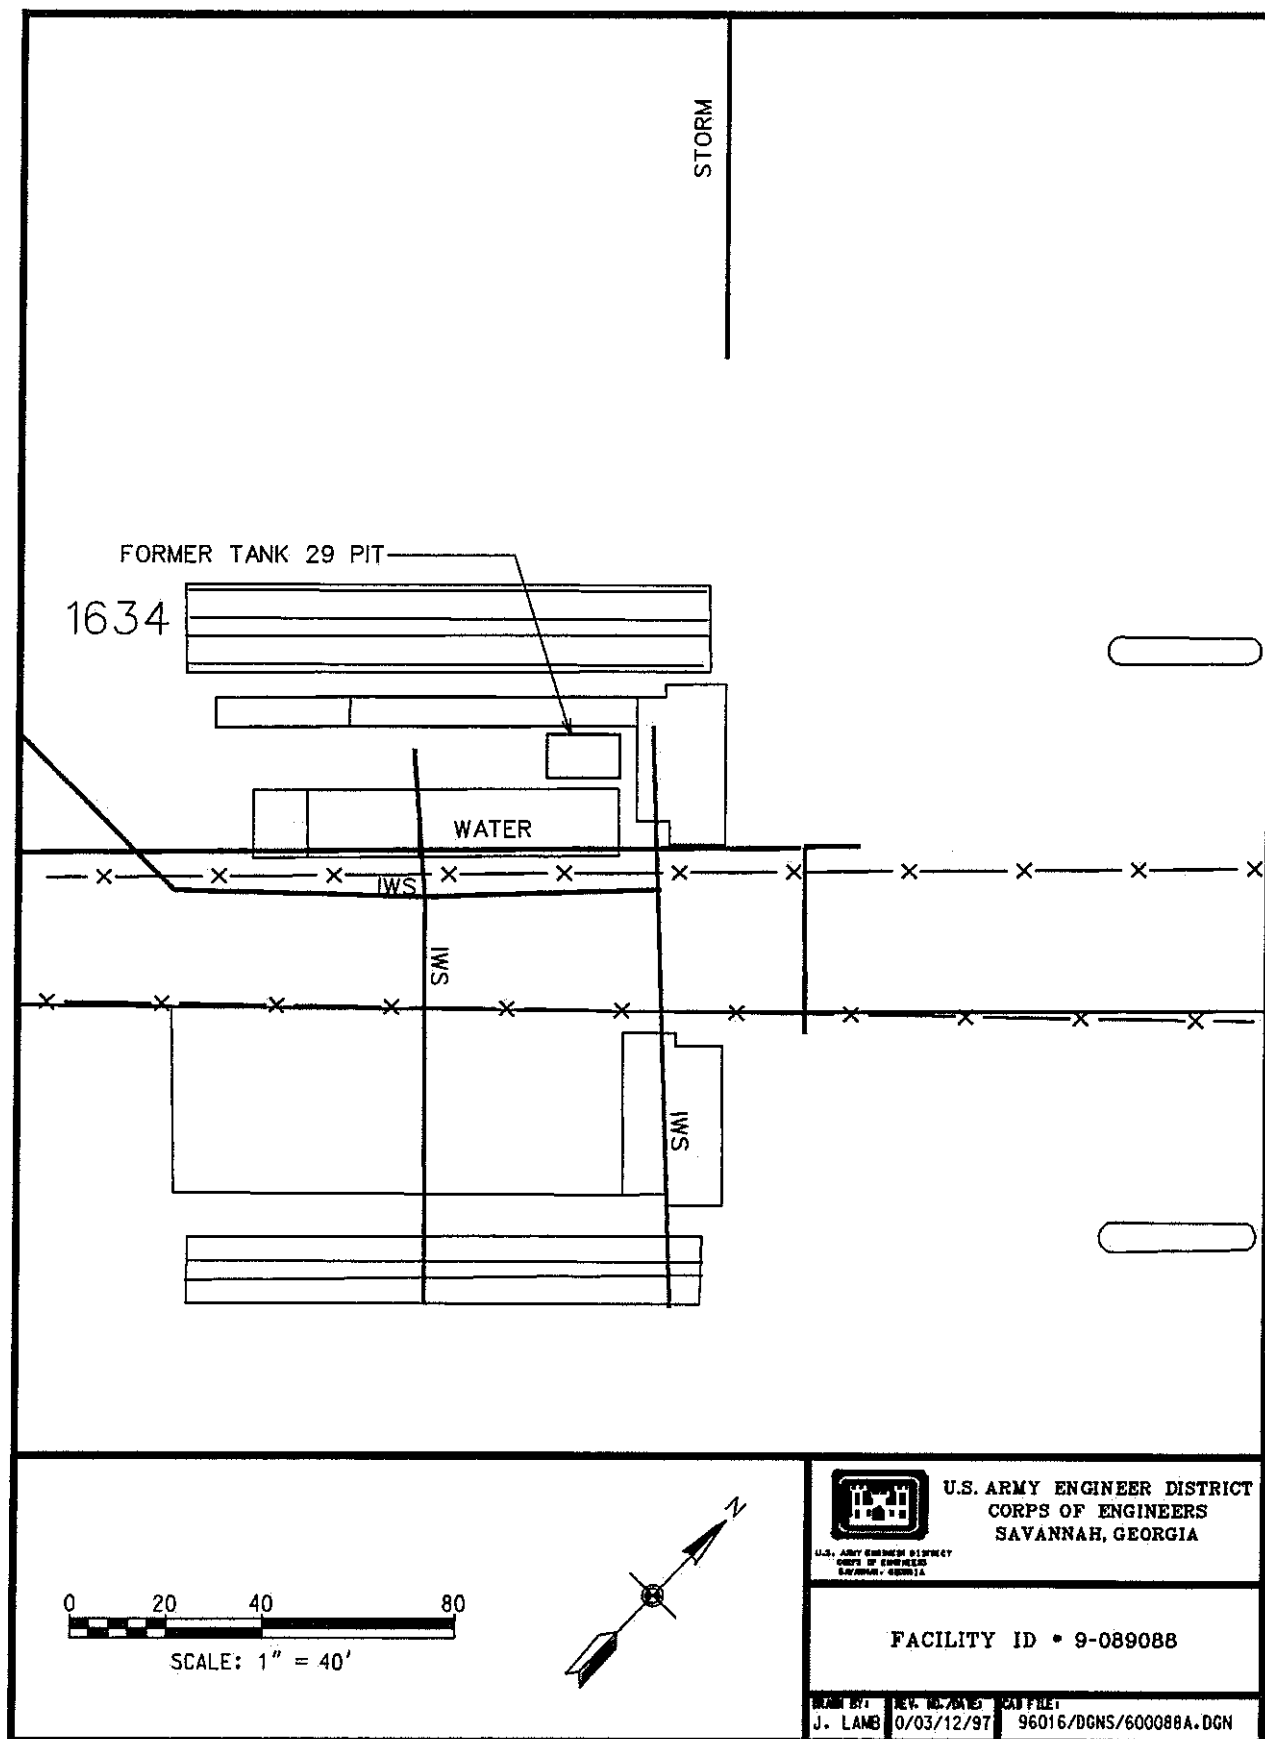
Figure II-1. Facility ID #9-089088, UST 29, Site Map

The location of former UST 29 is illustrated in Figure II-1. Detailed schematics illustrating the location of the tank and ancillary piping as configured during operation is not available. During removal activities, Fort Stewart DPW personnel observed no holes in the tank and, therefore, the source of contamination is believed to have been piping leakage and/or tank overflows. At the present time, the only remaining source of contamination at the site is contaminated soil located below the former tank pit.

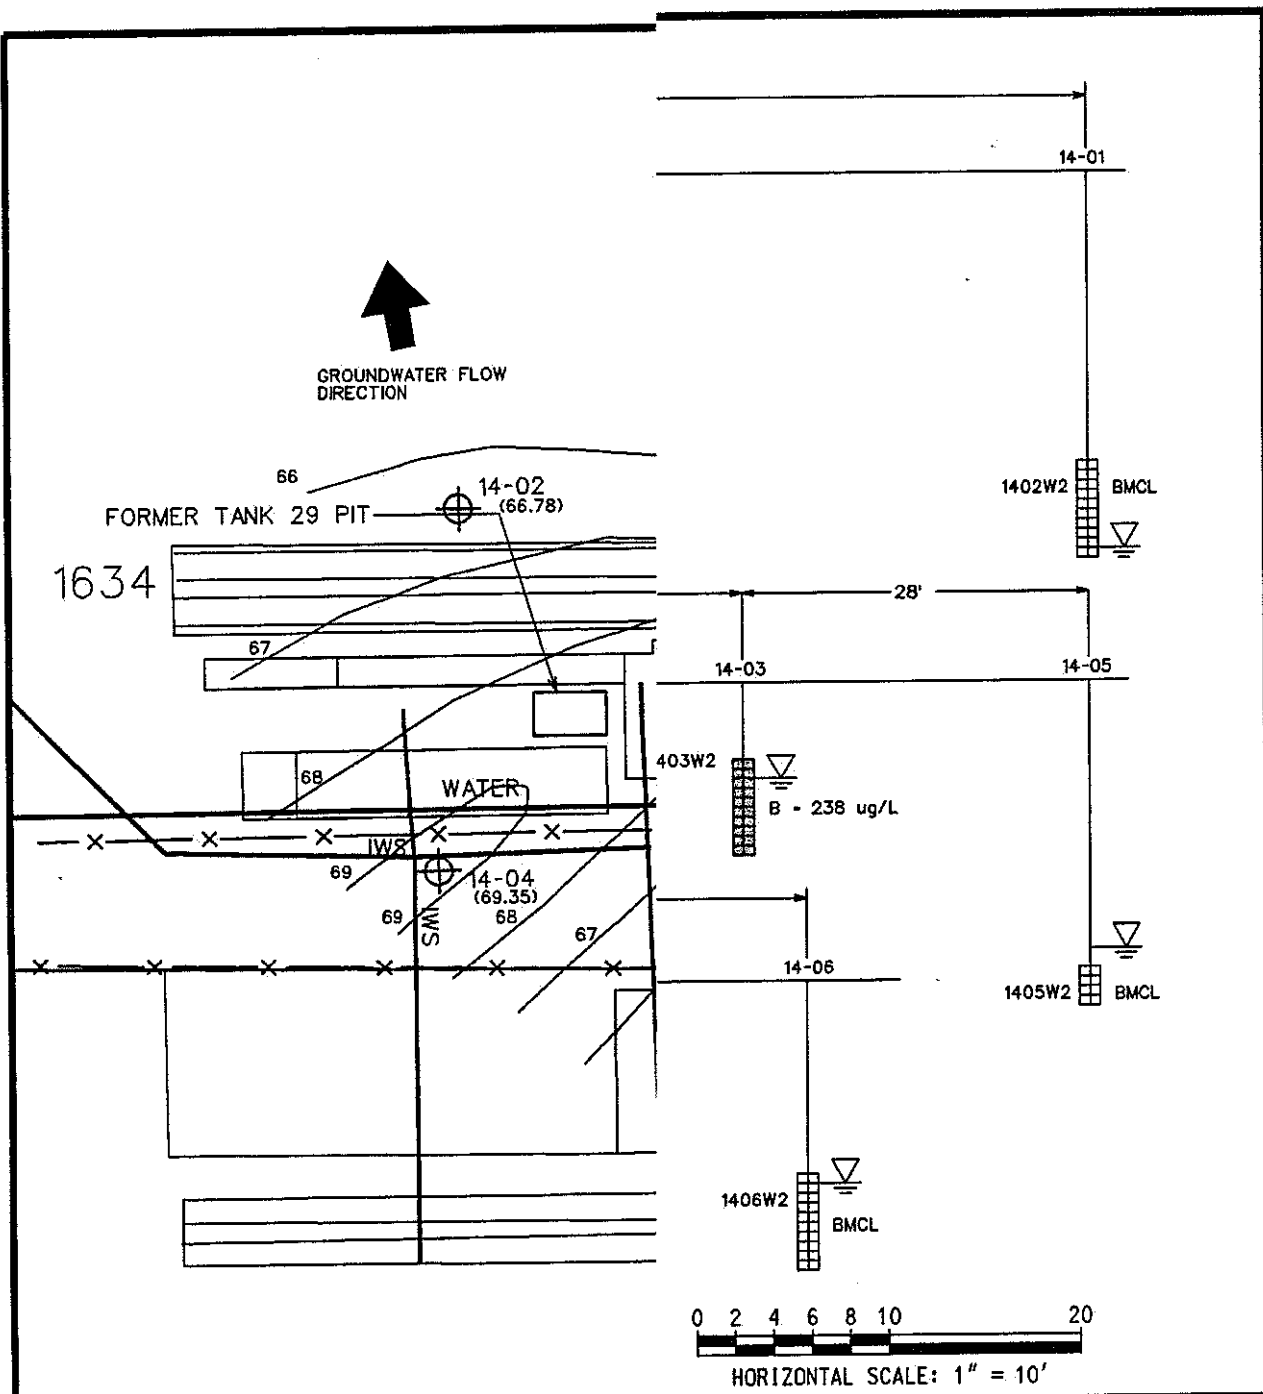
- CAP-PART A INVESTIGATION BOREHOLE
- GROUNDWATER SAMPLE LOCATION EXCEEDING MCLs
- SCREENED GROUNDWATER SAMPLE INTERVAL AND SAMPLE ID
- GROUNDWATER SAMPLE INTERVAL EXCEEDING MCLs
- ESTIMATED LIMIT OF GROUNDWATER CONTAMINATION
