PRELIMINARY SITE INSPECTION REPORT FOR FORT STEWART MILITARY RESERVATION

Site Inspection Report No. 91034

September 1992

Prepared By:
Advanced Sciences, Inc.
1250 Brass Mill Road
Belcamp, MD 21017

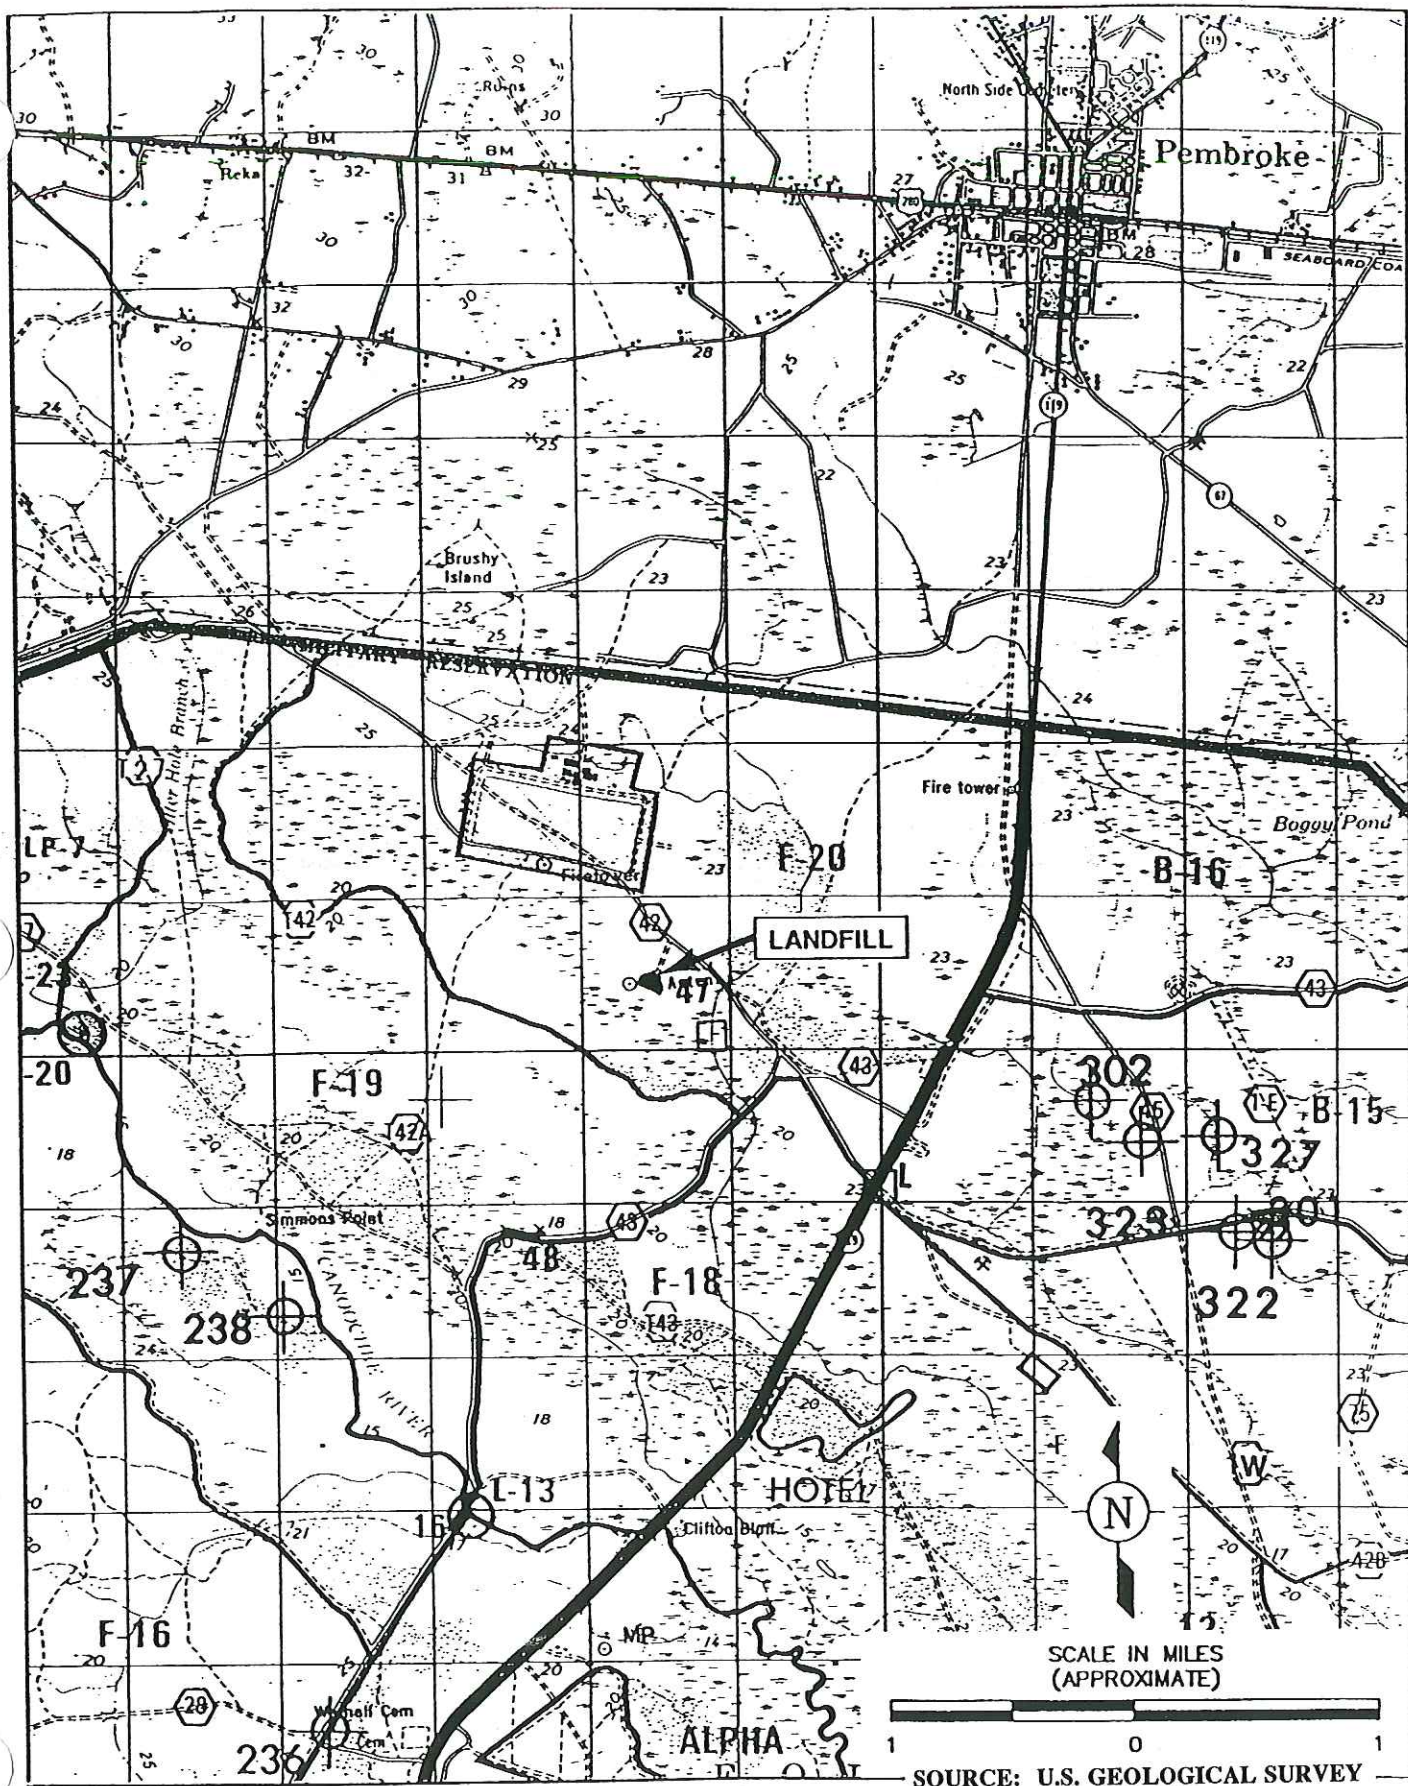
FIGURE 2.4. TAC - X LANDFILL - FORT STEWART MILITARY RESERVATION

Soils in this area are primarily sands and sand/silt mixtures. Sands in the upper 20 ft are fine-grained and become medium- to coarse-grained from 20 to 100 ft. In the southeast corner of the landfill, boring indicated small gravel pockets. Although one high-permeable area was encountered that produced groundwater at a rate of 25 gallons per minute (gpm) for approximately 15 minutes, the yield decreased to a few gpm. For the most part, the potential to release by groundwater is limited because the overall permeability of the sandy, silt soils generally restricts movement of groundwater. There is little runoff due to the flat terrain and the surface soils absorb most of the rainfall. In 1980, due to the wet season, there were active groundwater seeps that drained via trenches from the landfill toward the swampy areas located to the south of the site. There may be a potential for leachate to develop from the waste materials within the landfill and migration could occur to the local aquifer and to the wetlands located to the south of the landfill. (AEHA 1988) In 1980, leachate was observed emanating from an earthen bank at this landfill (AEHA 1987).

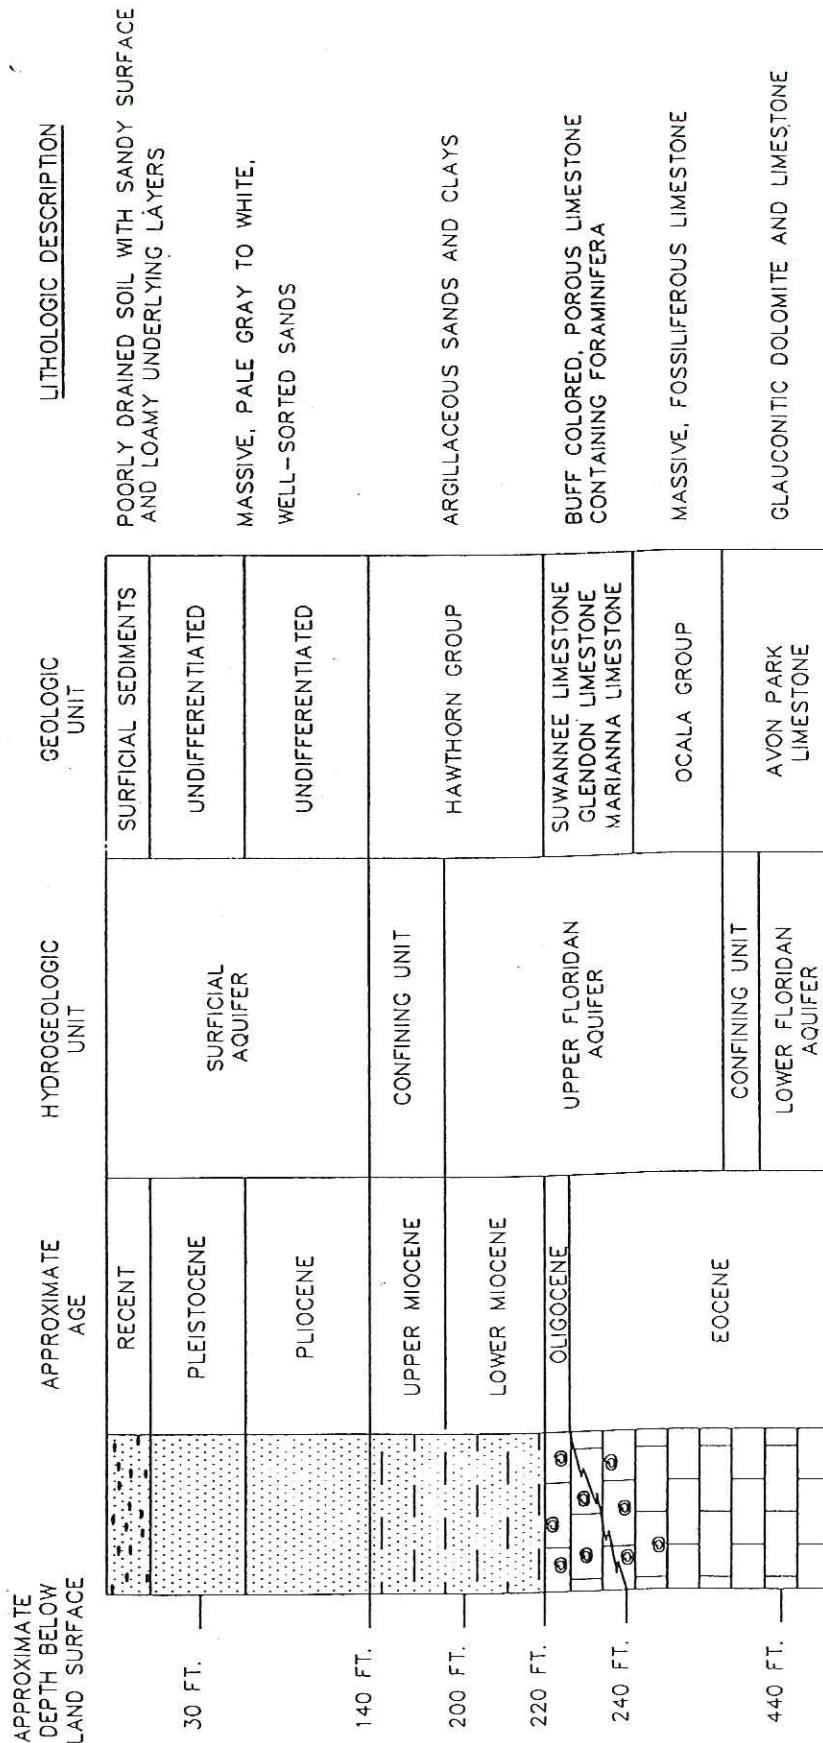
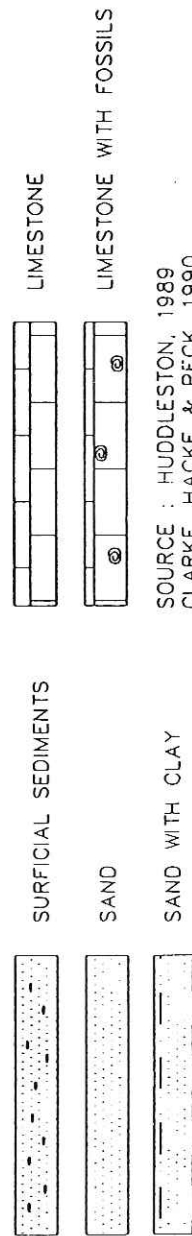
The geologic units beneath the site function as two aquifers (see Figure 2.8) that may be in hydrologic communication under certain conditions (ESE 1982). The upper aquifer or water table aquifer is present in the Recent to Pliocene age sediments. It is separated from the lower confined aquifer by the upper members of the Miocene age Hawthorn Group. The confined aquifer is the artesian Floridan aquifer. The recharge area for the Floridan aquifer is located northwest and outside of the study area. (G&M 1991)
