BUILDING #1560

# GARAGE AND MAINTENANCE BUILDING

FORT WAINWRIGHT ■ NORTH STAR BOROUGH ■ ALASKA

SURVEY NO.  
AK-36-Q

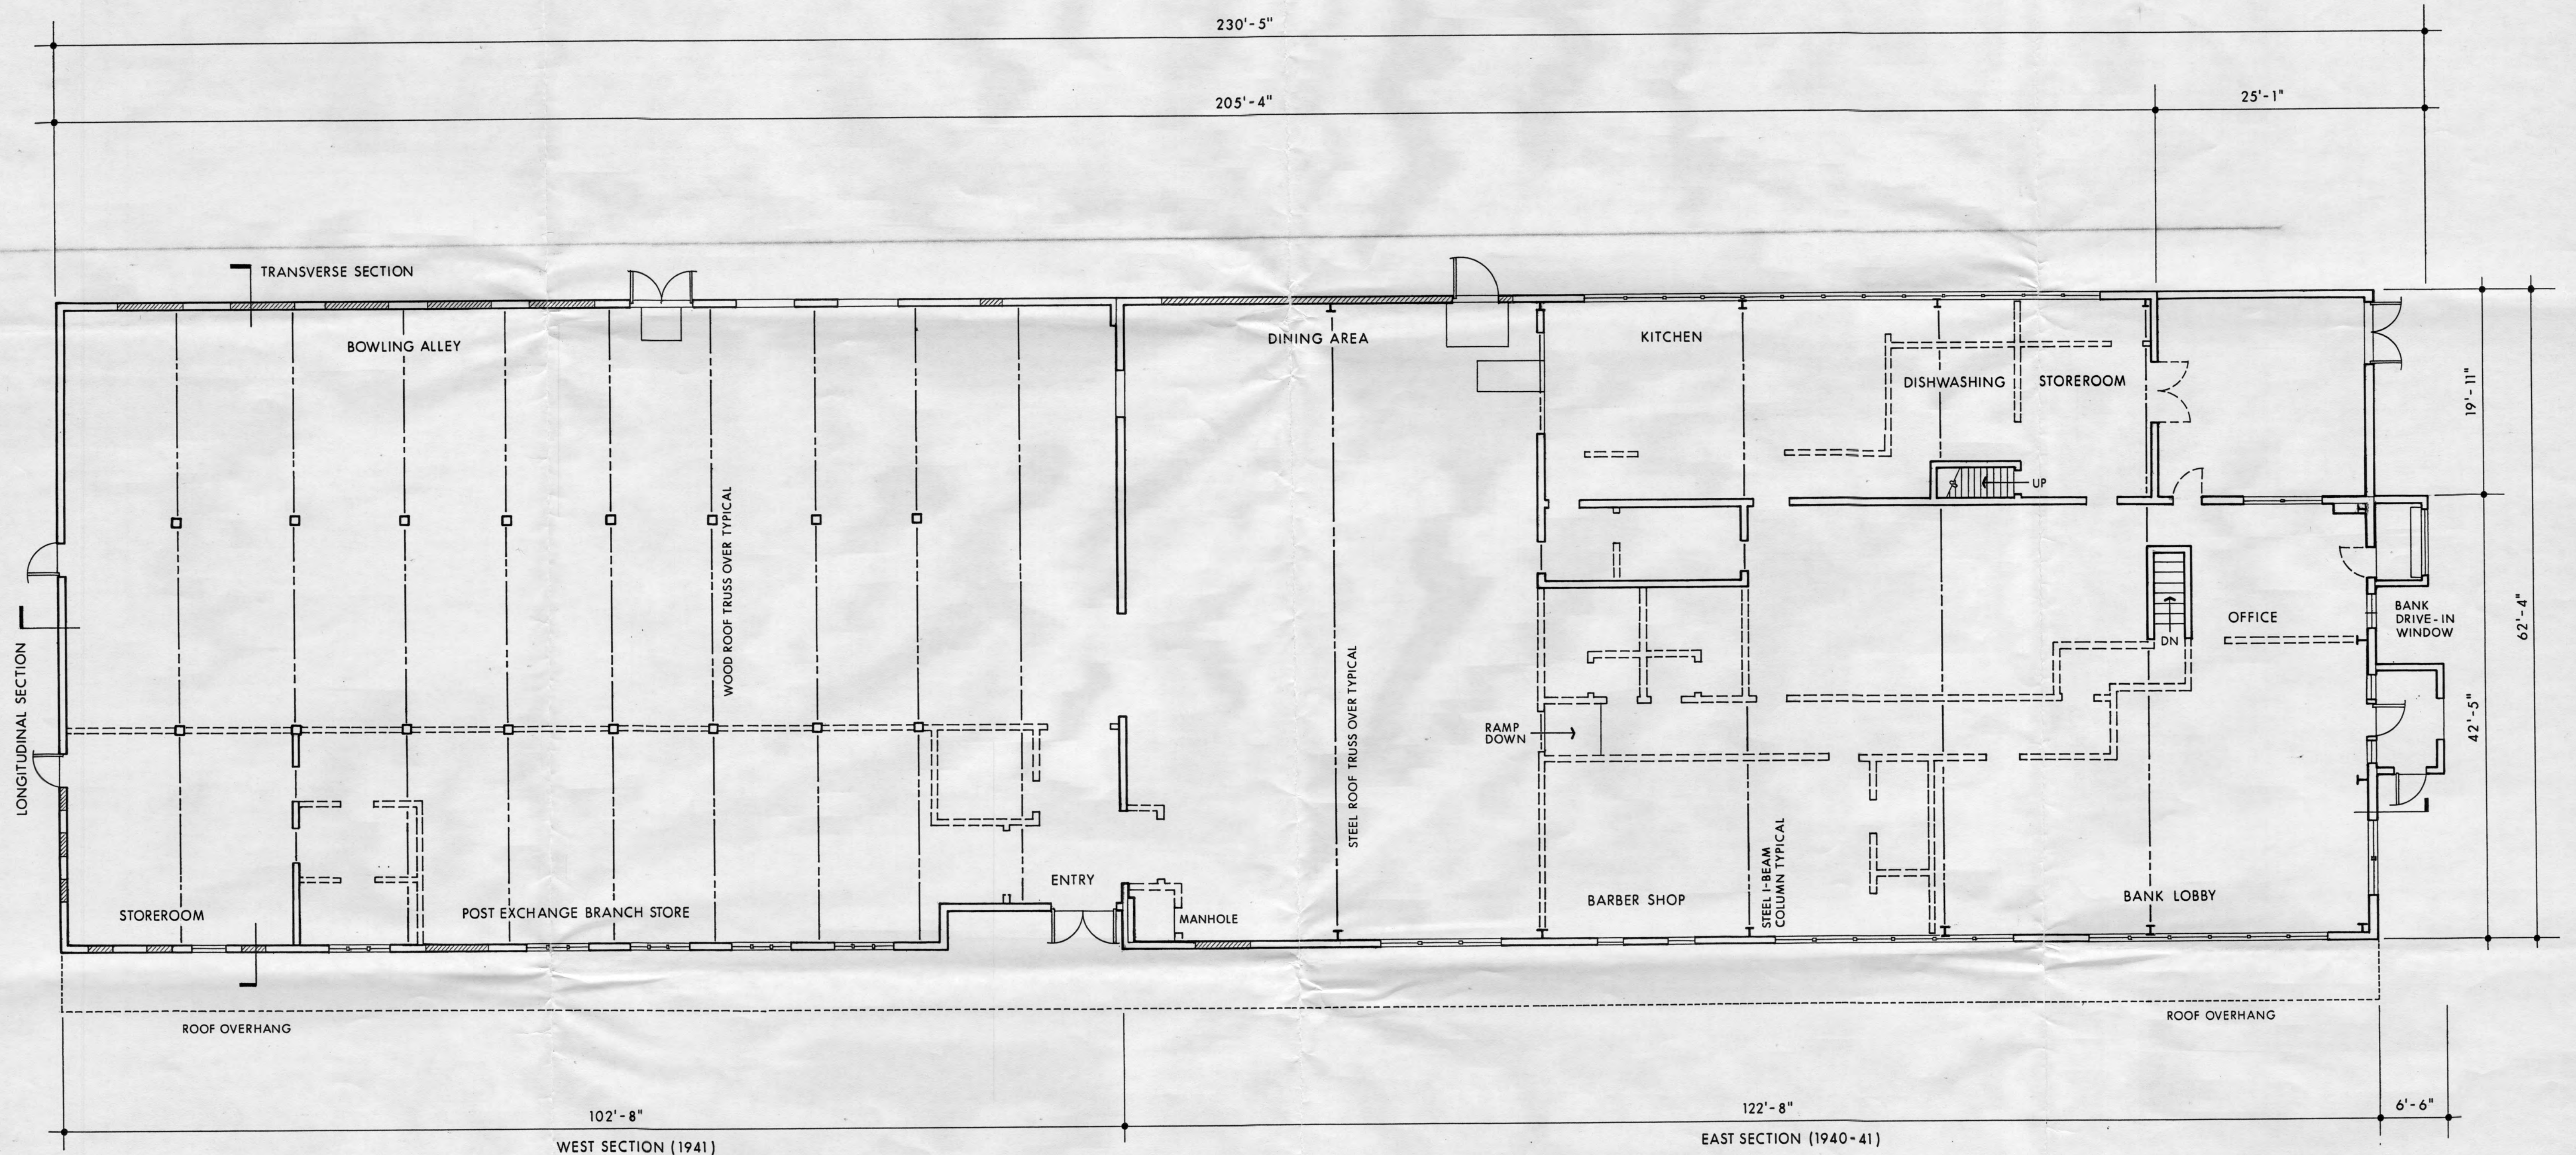
# FLOOR PLAN

NOTE: THE DRAWINGS SHOW A BUILDING THAT IS PLUMB AND TRUE, NOT REFLECTIVE OF ITS CONDITION. THE DRAWINGS ARE A GRAPHIC REPRESENTATION OF THE EXISTING BUILDING, NOT HOW IT WAS CONSTRUCTED.

STRUCTURE: CONCRETE FOUNDATIONS; WOOD FRAME WALLS; STEEL (EAST SECTION) OR WOOD (WEST SECTION) ROOF TRUSSES  
 FLOOR: CONCRETE SLAB WITH FINISH FLOORS (WOOD, CARPET AND VINYL-ASBESTOS TILE) REMOVED  
 WALLS: WOOD STUD WALLS WITH SHEETROCK SHEATHING  
 CEILINGS: REMOVED

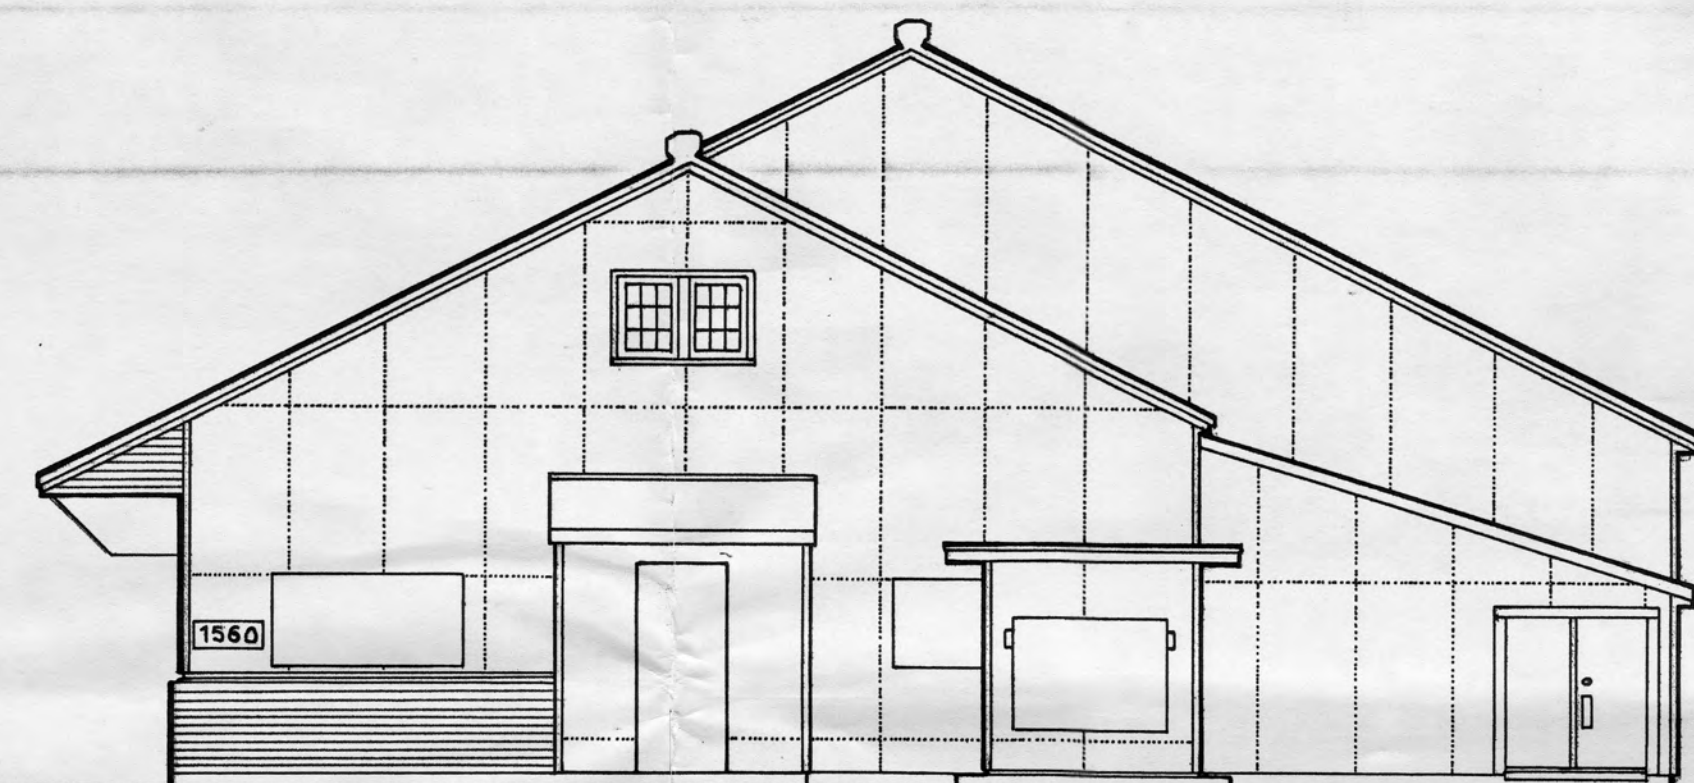
## EAST ELEVATION

TOP OF VENTILATOR  
31'-8"

ROOF EAVES  
13'-11"

MATERIALS  
WALLS: PREFINISHED ALUMINUM SIDING OVER CORRUGATED STEEL WITH ROMAN BRICK VENEER  
ROOF: RIBBED ALUMINUM ROOF OVER ORIGINAL PLYWOOD ROOF DECKING  
DOORS: PLYWOOD- OR METAL-SIDED REPLACEMENT DOORS IN WOODEN FRAMES  
WINDOWS: ORIGINAL STEEL TWO-LIGHT CASEMENTS; REPLACEMENT WOODEN ONE-LIGHT CASEMENTS

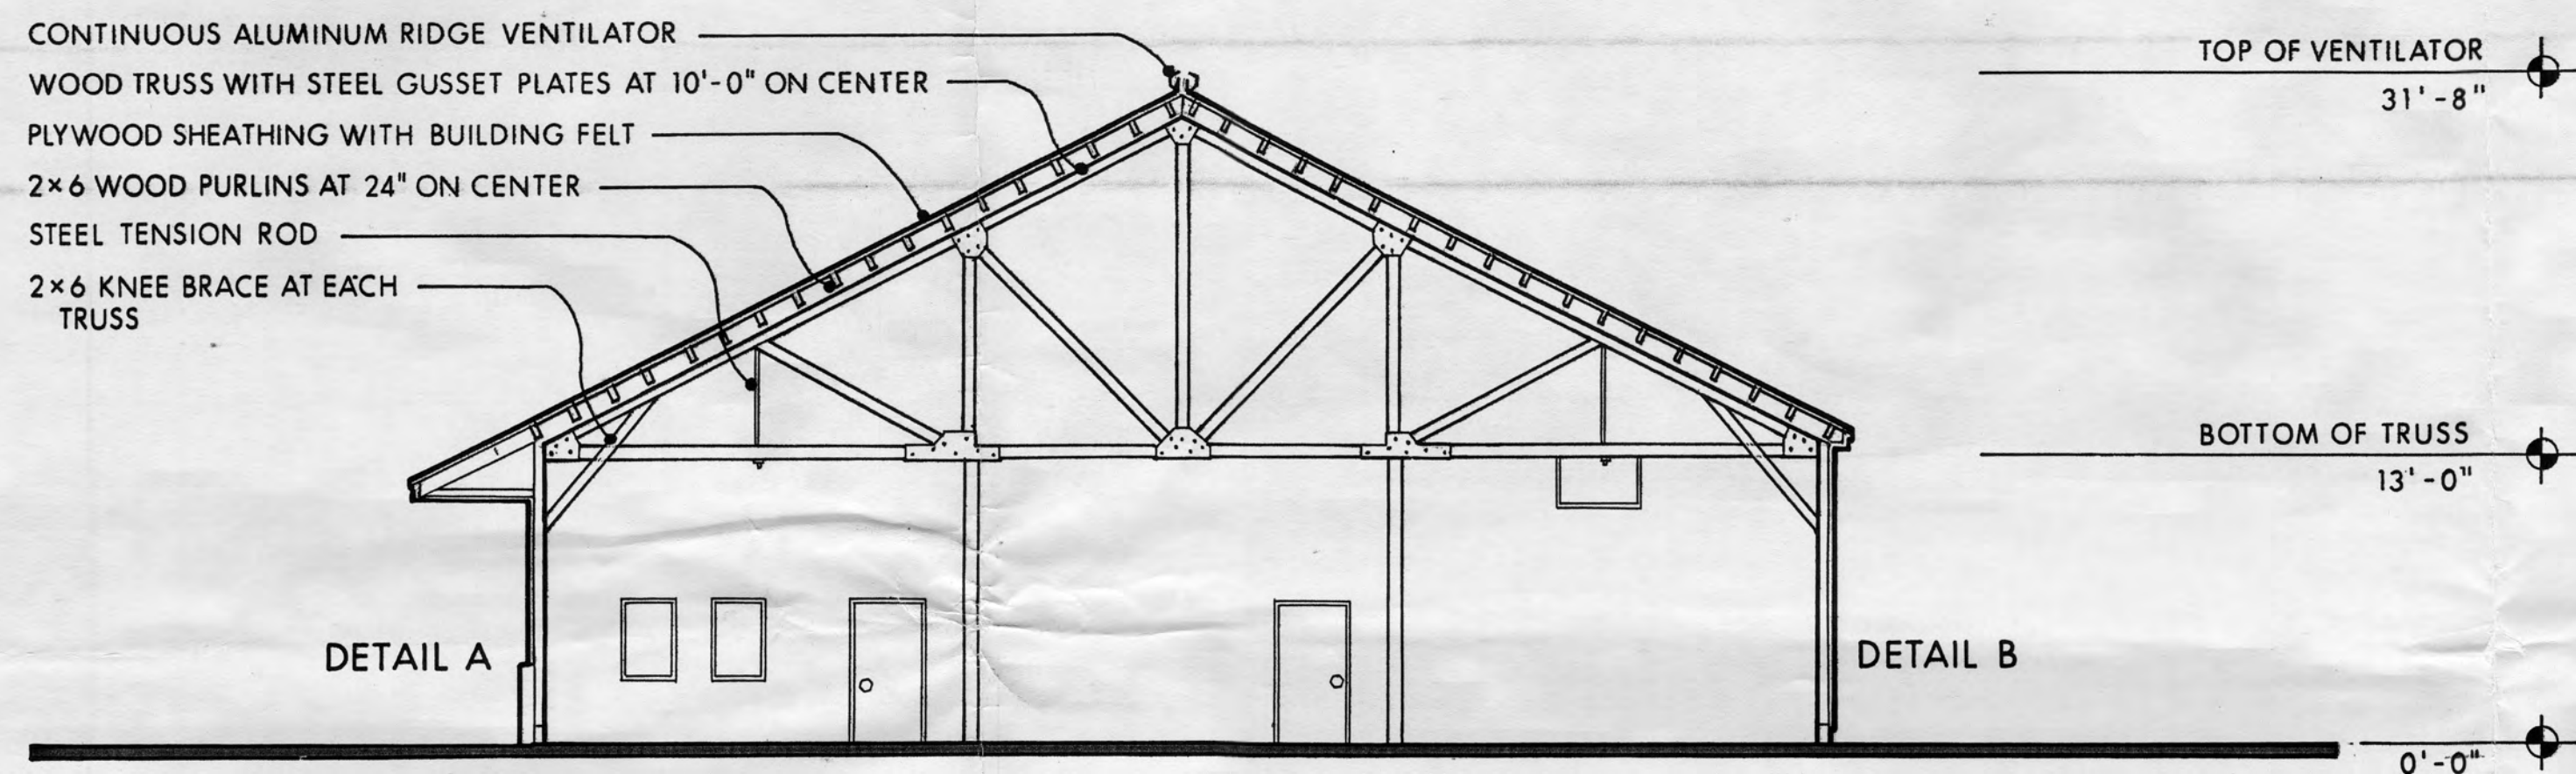
# TRANSVERSE SECTION

NOTE: INDIVIDUAL STUDS AND GIRTS IN BACKWALL NOT SHOWN FOR CLARITY

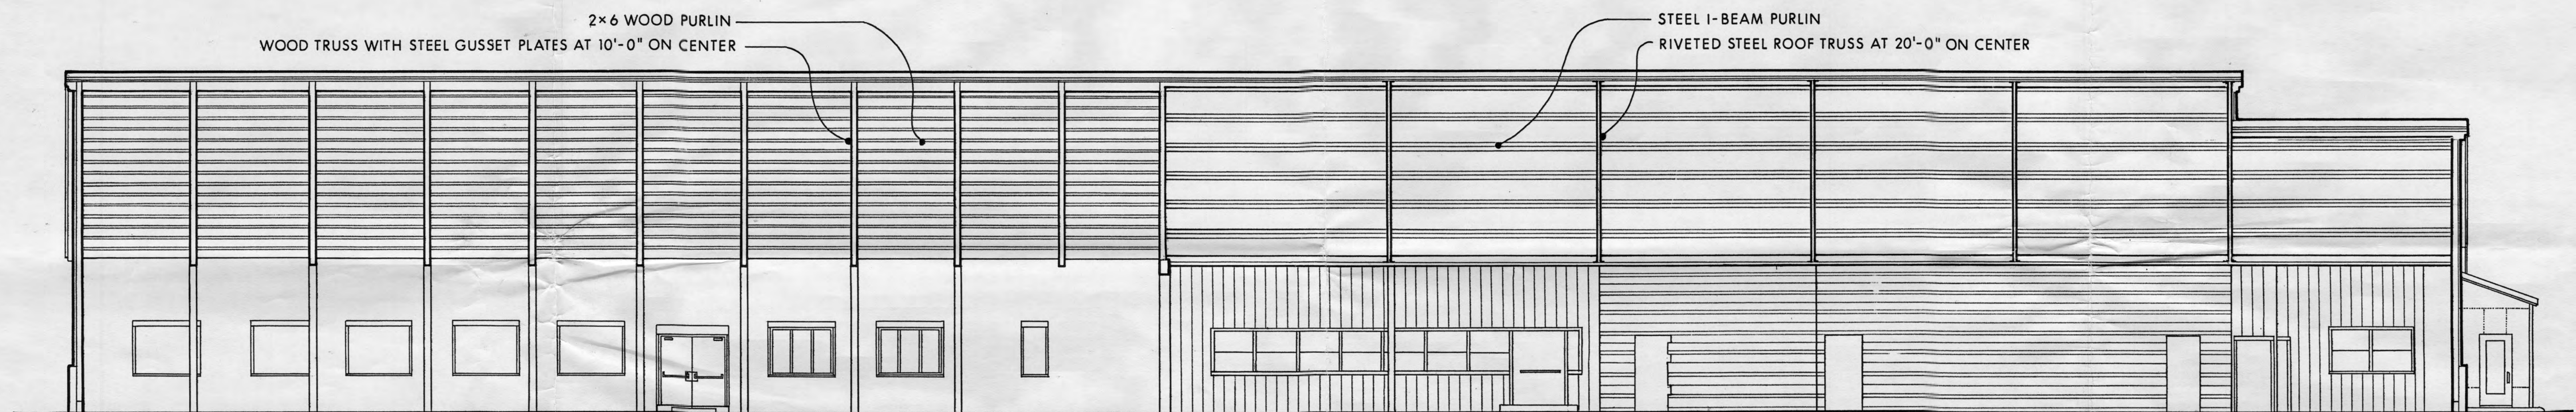
# LONGITUDINAL SECTION

NOTE: INDIVIDUAL STUDS AND GIRTS IN BACKWALL OF WEST SECTION NOT SHOWN FOR CLARITY
