APPENDIX H

Site Reconnaissance Photo Log

**APPENDIX H – SITE RECONNAISSANCE PHOTO LOG
USAEC PFAS PRELIMINARY ASSESSMENT/SITE INSPECTION**

Aberdeen Proving Ground, Maryland

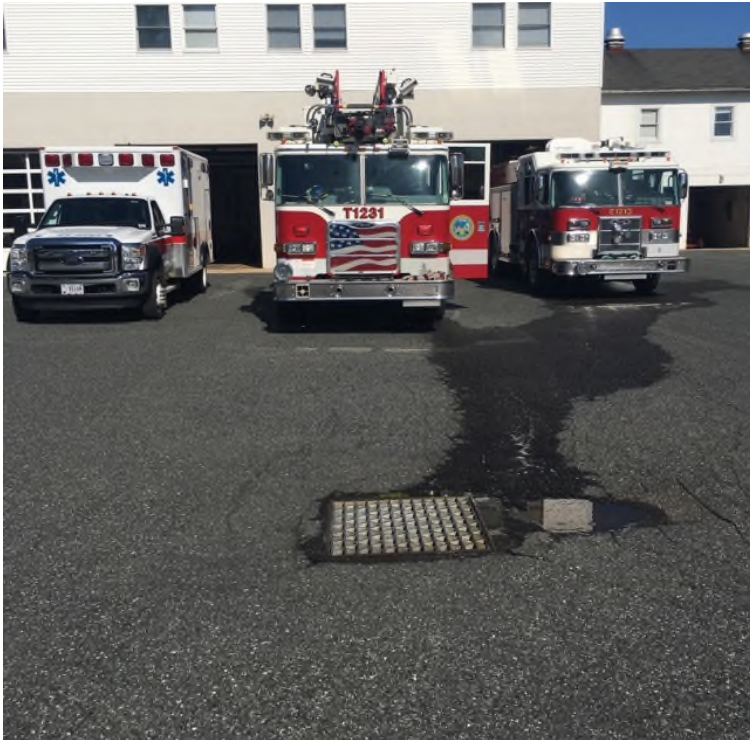
Photograph: 1

Description:
Surface water drainage
and route visible along
main fire station
driveway.

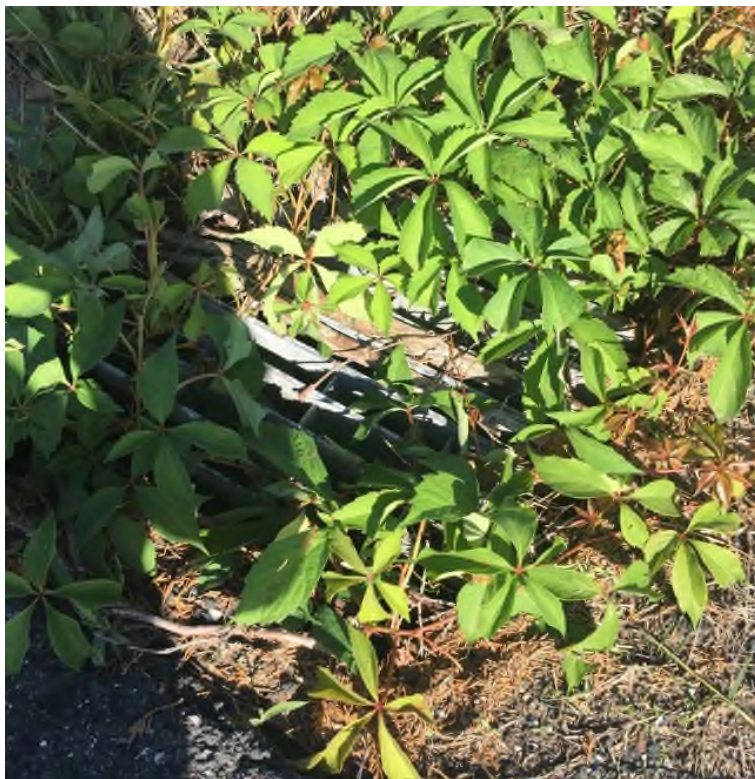
Photograph: 3

Drainage inlet
alongside Edgewood
fire station driveway.

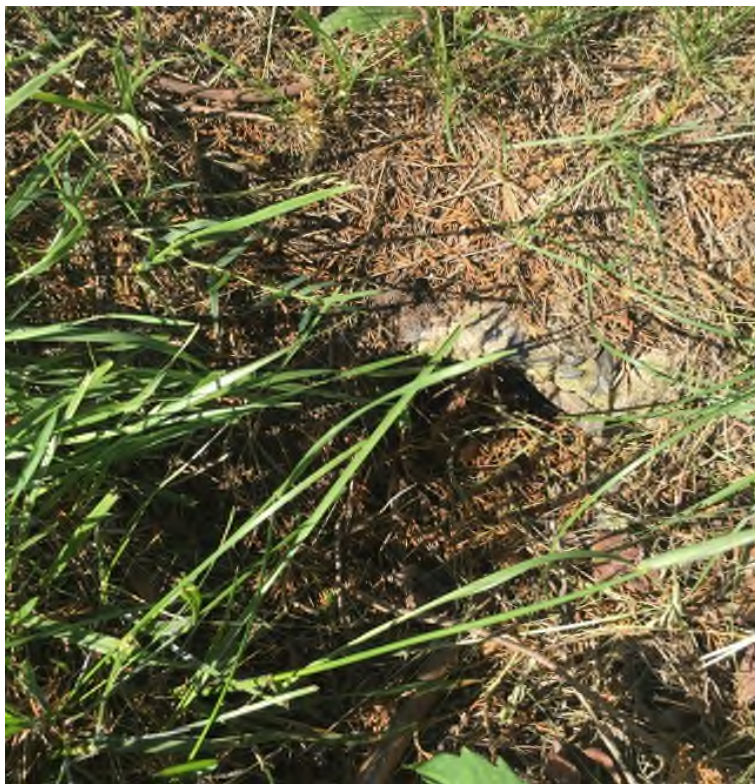
Photograph: 4

Drainage inlet
alongside Edgewood
fire station driveway.

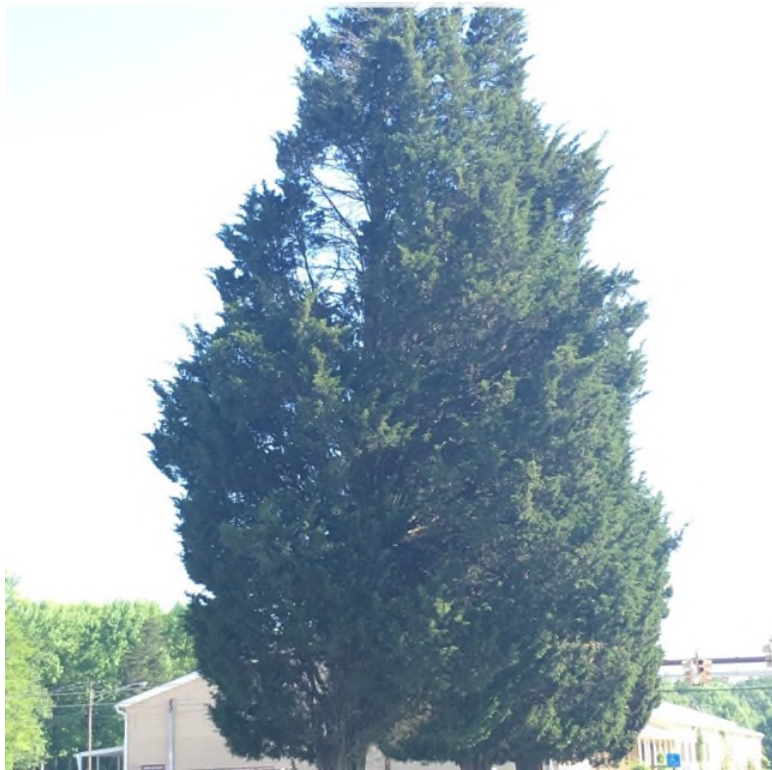
Photograph: 5

Tree located adjacent to northeast side of Edgewood fire station driveway that had historically been sprayed with AFFF.

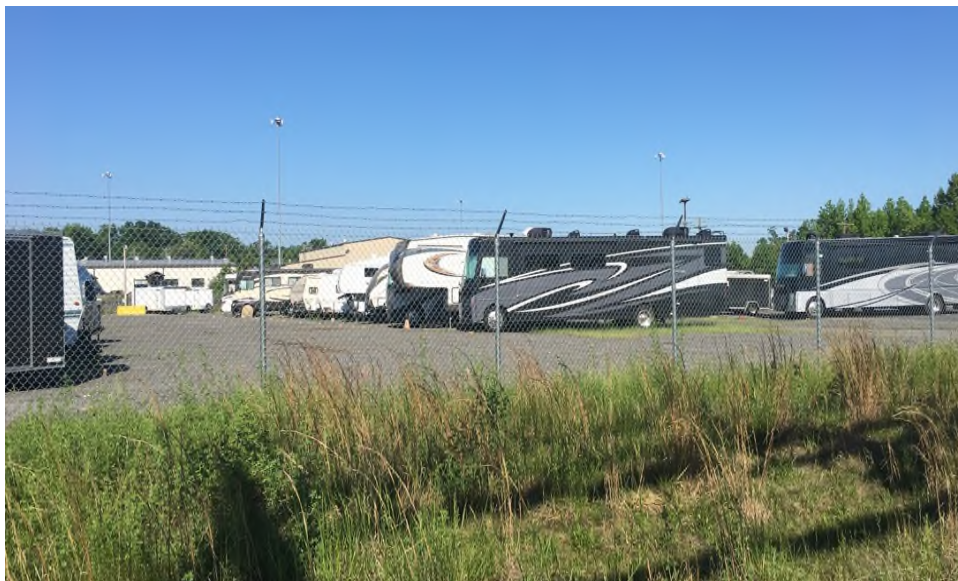
Photograph: 6

Location where AFFF was sprayed as part of chemical suppressant exercises.

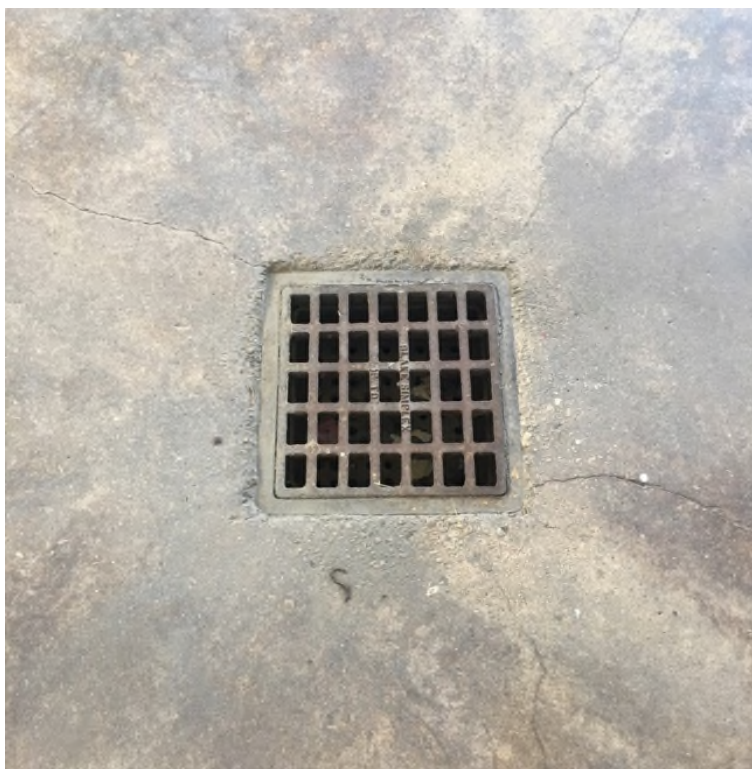
Photograph: 8

Interior drainage inlet located within Building 1059 – PAAF Station Building.

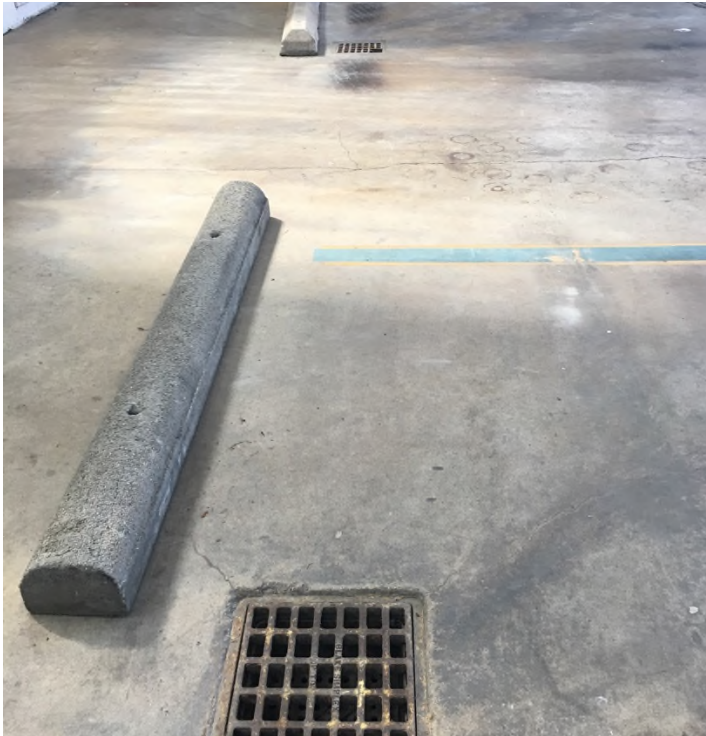
Photograph: 9

Description:
Alternate angle of
interior drainage inlet
located within Building
1059 – PAAF Station
Building.

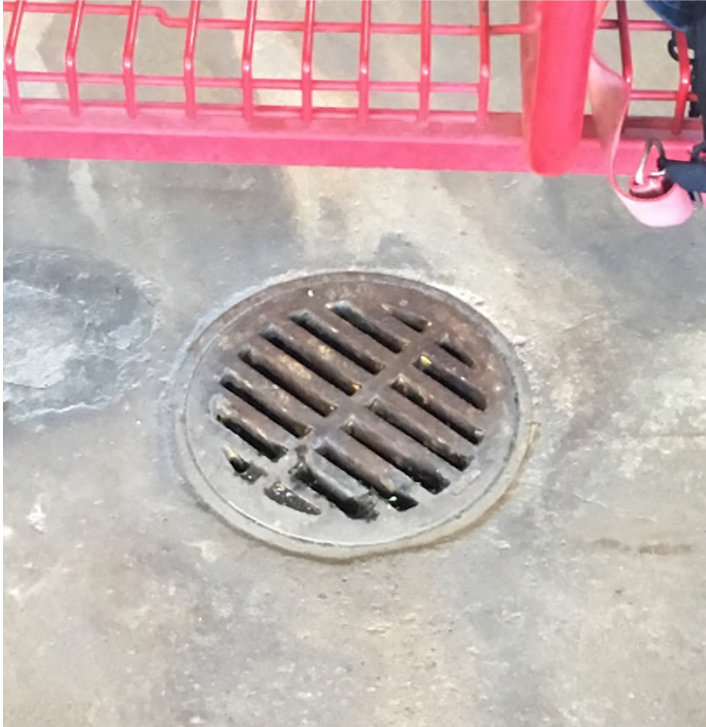
Photograph: 10

Description:
Additional interior
drainage inlet located
within Building 1059 –
PAAF Station Building.

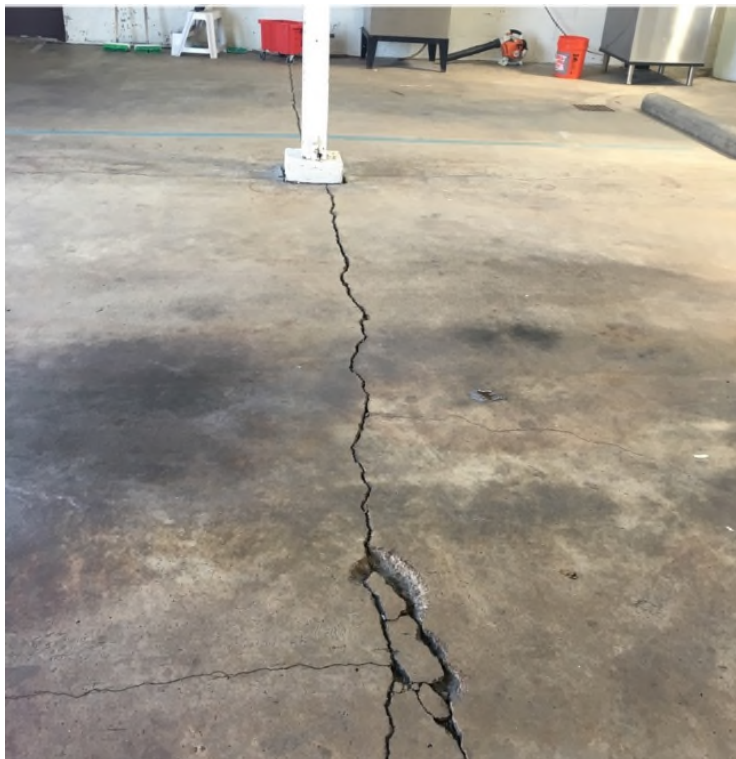
Photograph: 11

Crack in interior cement flooring of Building 1059 – PAAF Station Building.

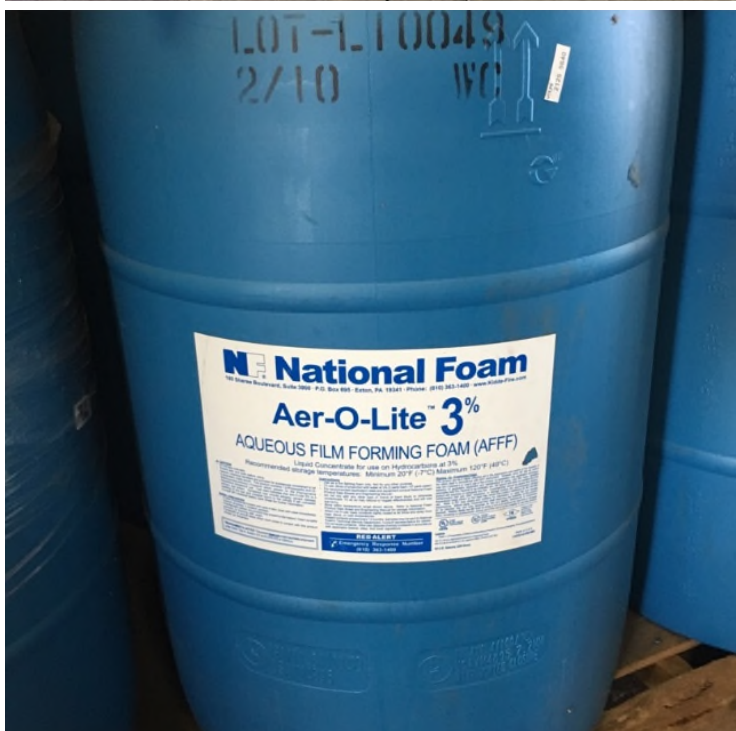
Photograph: 12

55-Gallon drum of Aer-O-Lite 3% AFFF stored within Building 1065 – Fire Department Crash Storage Bay

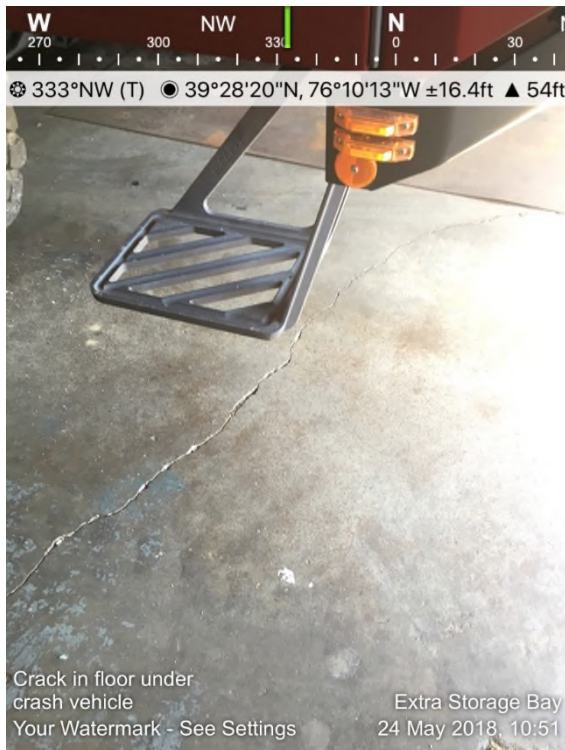
Photograph: 13

Crack in floor under vehicle parking area inside the Building 1065 – Fire Department Crash Storage Bay.

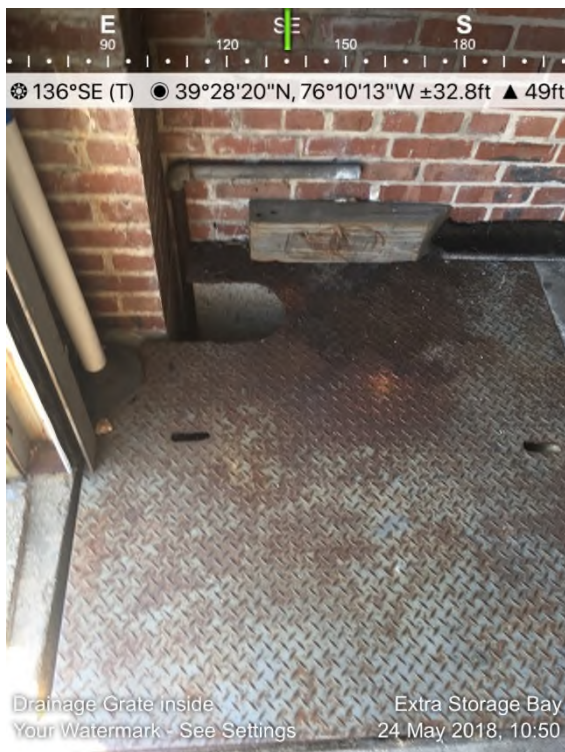
Photograph: 14

Drainage grate withing Building 1065 – Fire Department Crash Storage Bay.

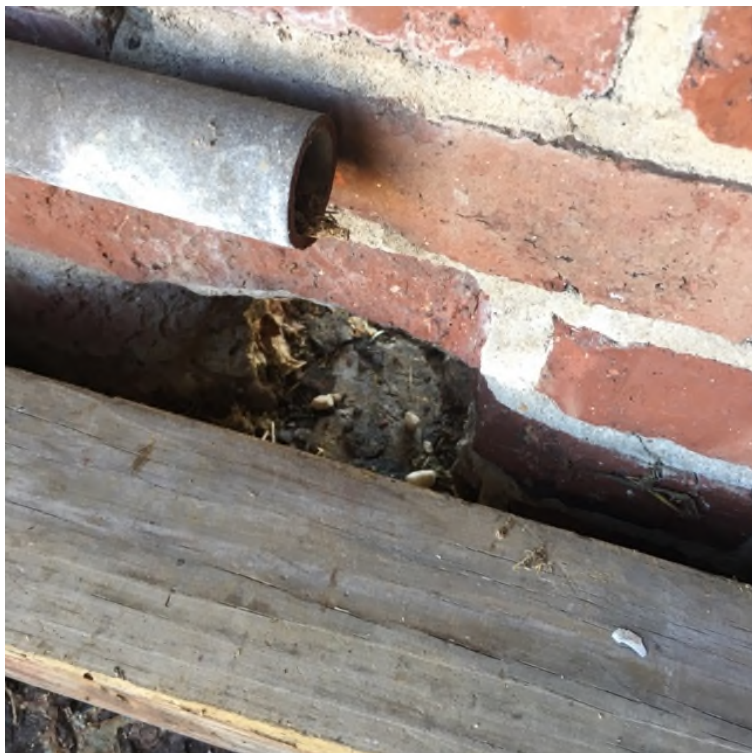
Photograph: 15

Drainage hole and piping extending outward from the Building 1065 – Fire Department Crash Storage Bay.

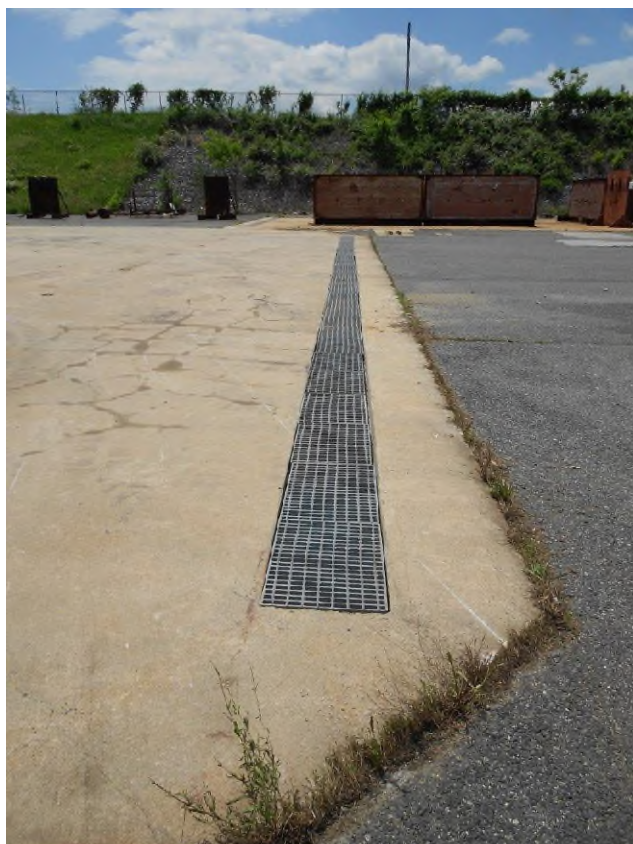
Photograph: 23

Description:
Inlet grate for environmental test pad at Air Base Range 6.

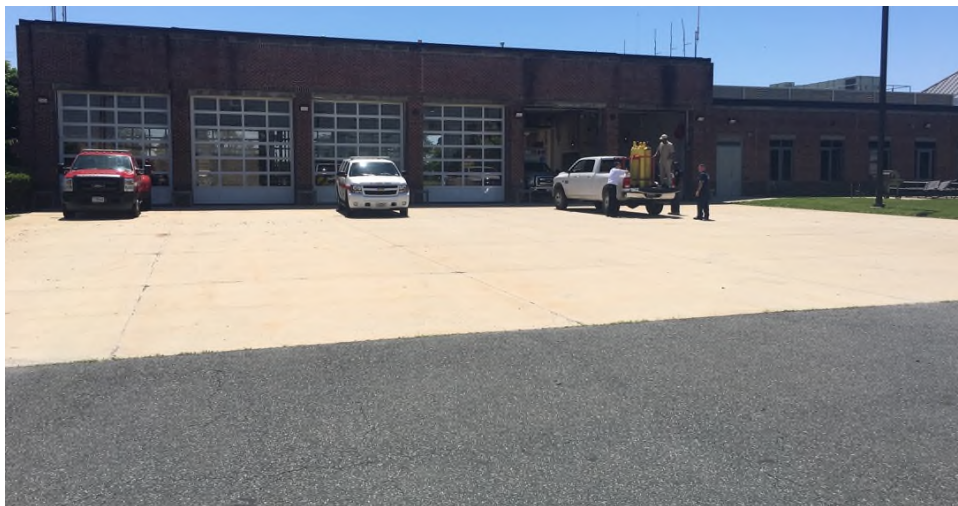
Photograph: 37

Description:
Primary driveway and
fire truck washing area
at the Building 2200 –
Aberdeen Main Fire
Station

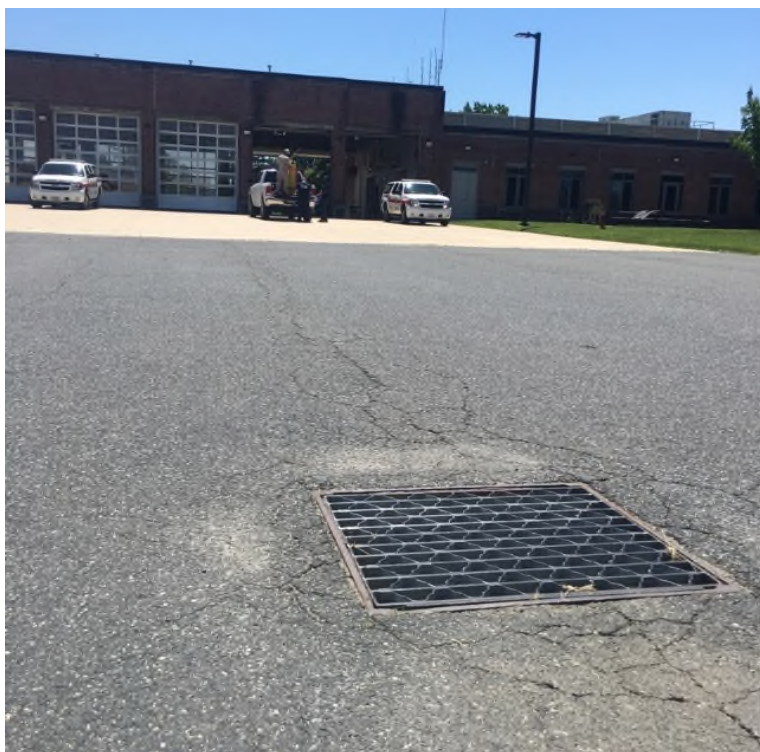
Photograph: 38

Description:
View of main storm
water drainage inlet
located along the main
Fire Station driveway.

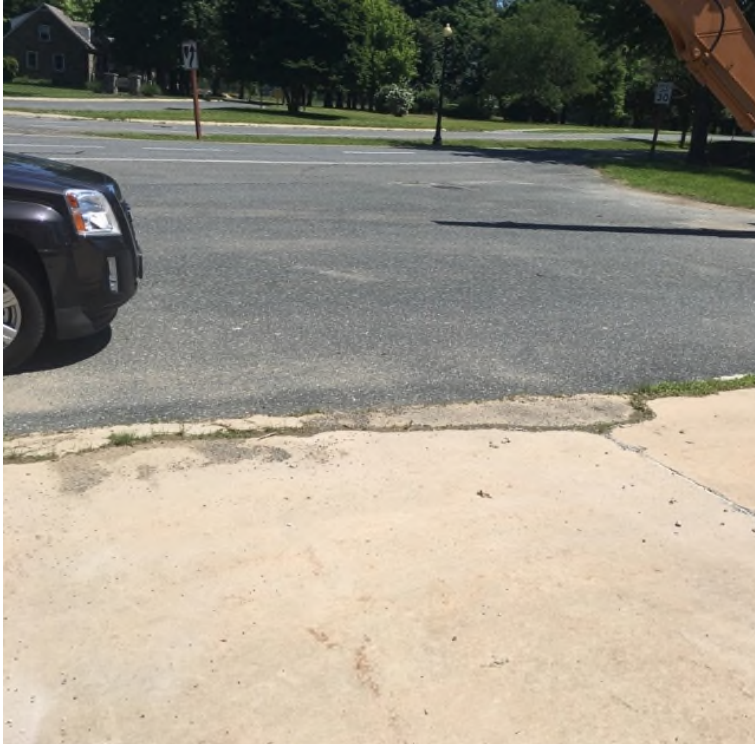
Photograph: 40

Description:
Driveway and street
adjacent to the former
Aberdeen Fire Station

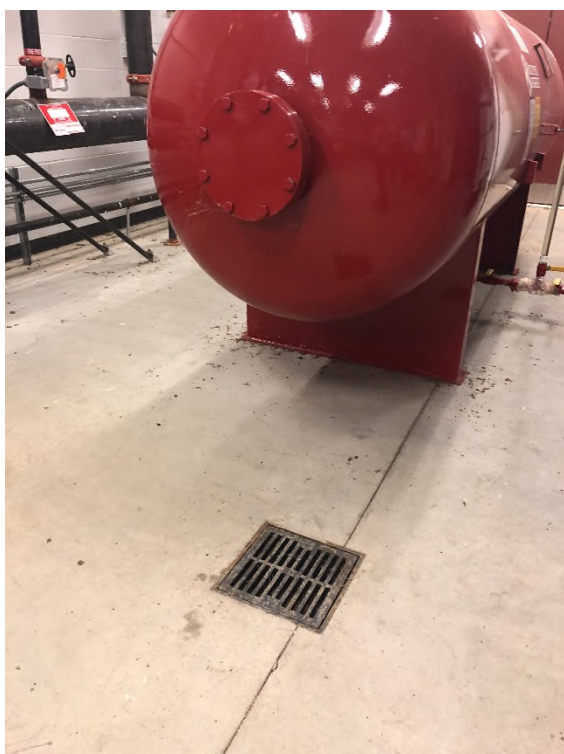
Photograph: 42

AFFF suppression tank observed inside Hangar E4081.

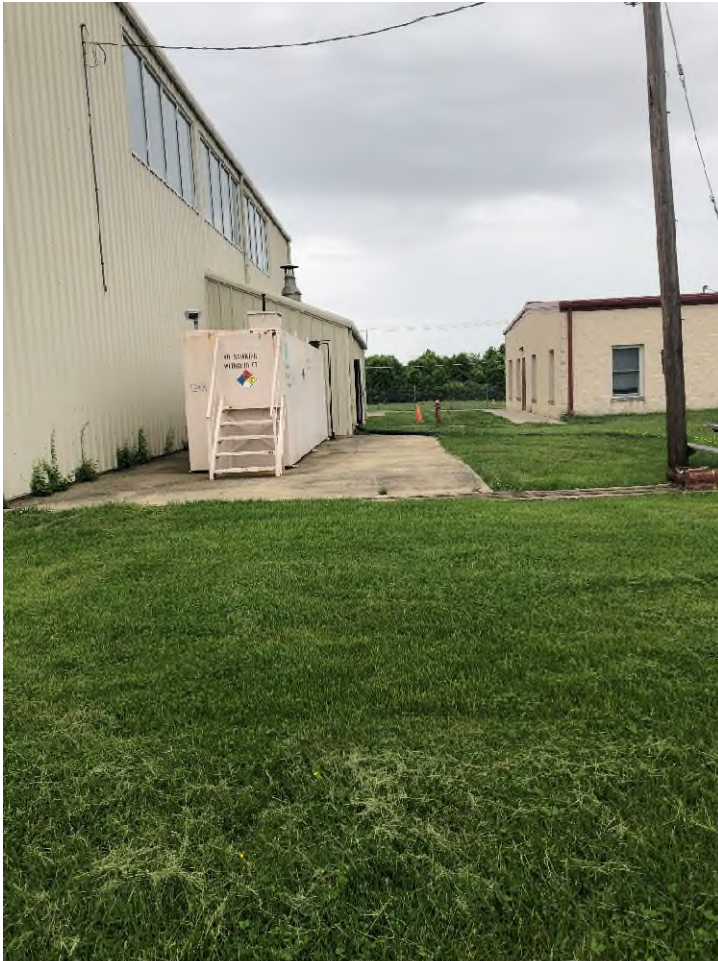
Photograph: 50

Description:
Exterior photo of
Building E4040

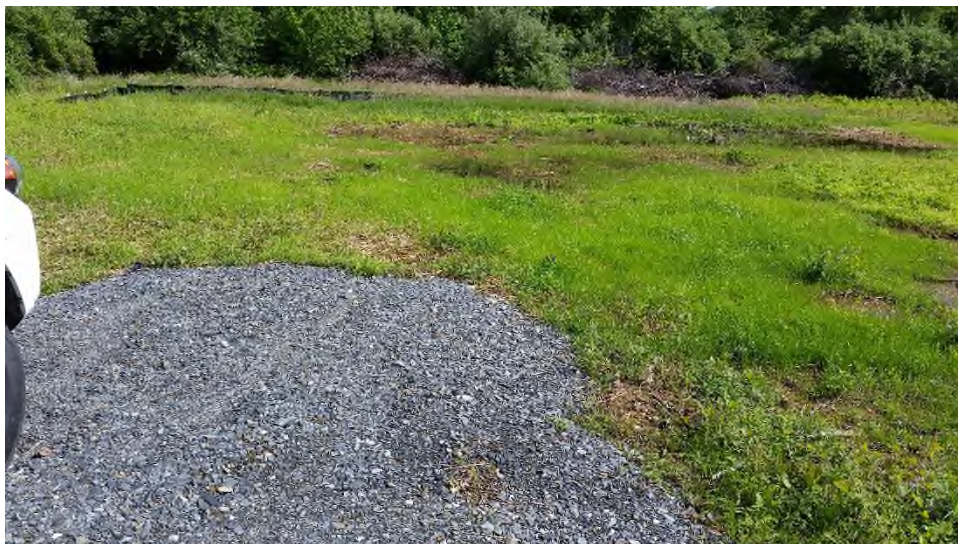
Photograph: 75

View of a second berm area used for fire training exercises at the Former Aberdeen Fire Training Area.

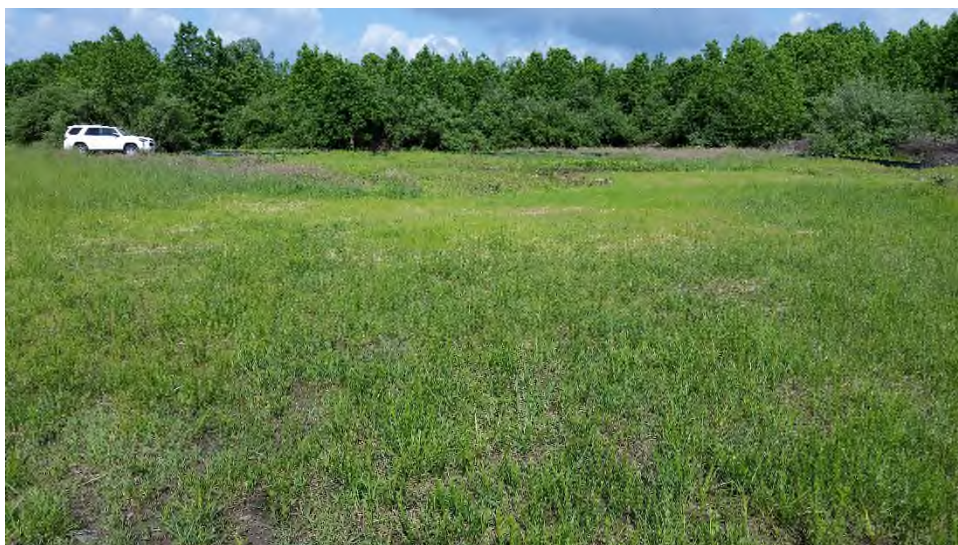
Photograph: 76

The Former Aberdeen Fire Training Area as viewed from the main access road parallel to the training area.

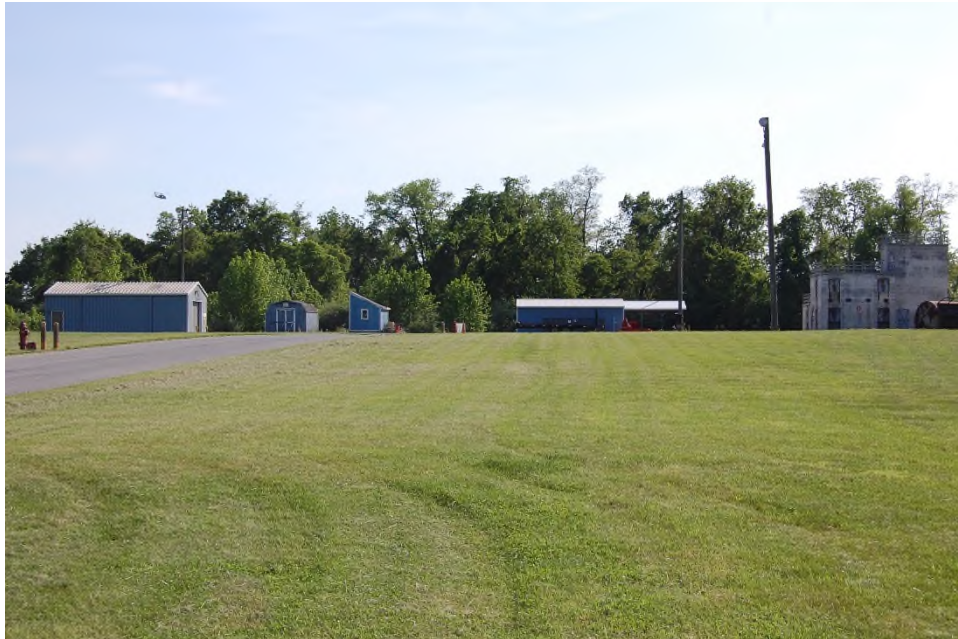
Photograph: 77

The Former Maryland Fire and Rescue Institute (MFRI) Fire Training Area as viewed from the eastern side of the training field.

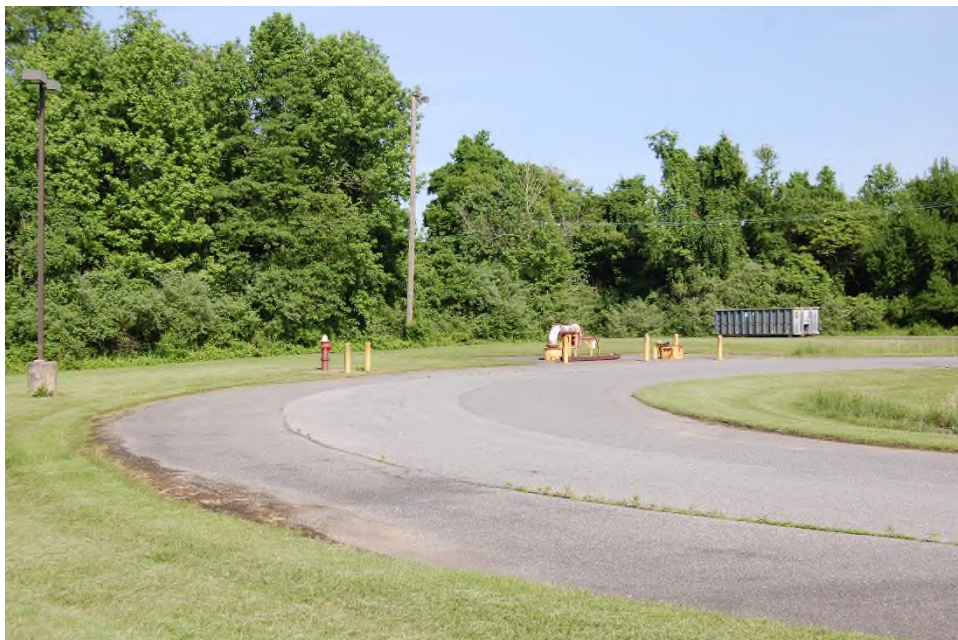
Photograph: 78

Main access road to the Former MFRI Fire Training Area.

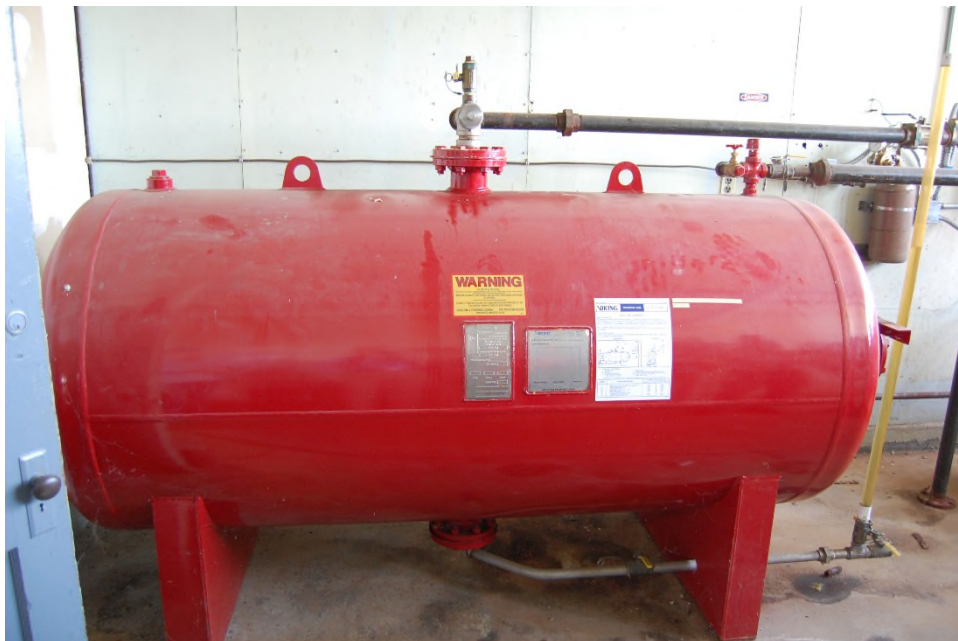
Photograph: 79

AFFF suppression system tank located within the main PAAF Hangar (Hangar 1060)

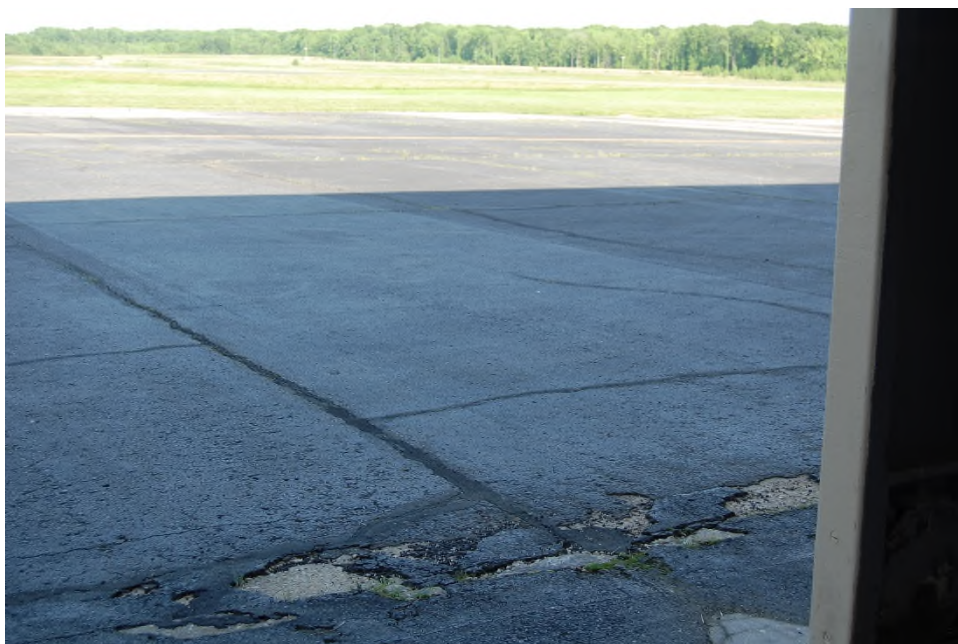
Photograph: 80

Runway directly outside of the main hangar bay doors at PAAF Hangar 1060.

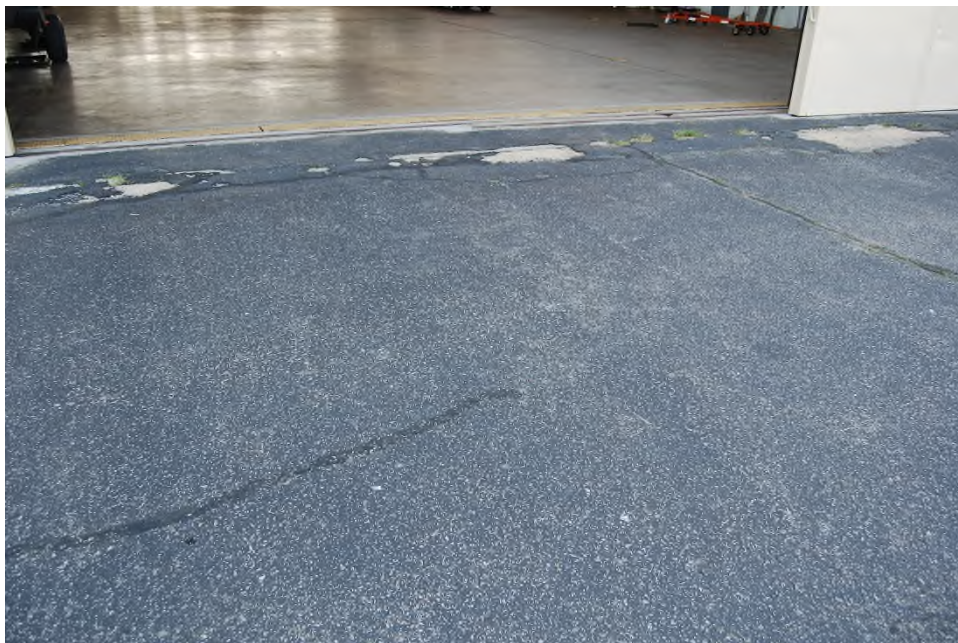
Photograph: 81

Alternative view of runway directly outside of the main hangar bay doors at PAAF Hangar 1060.

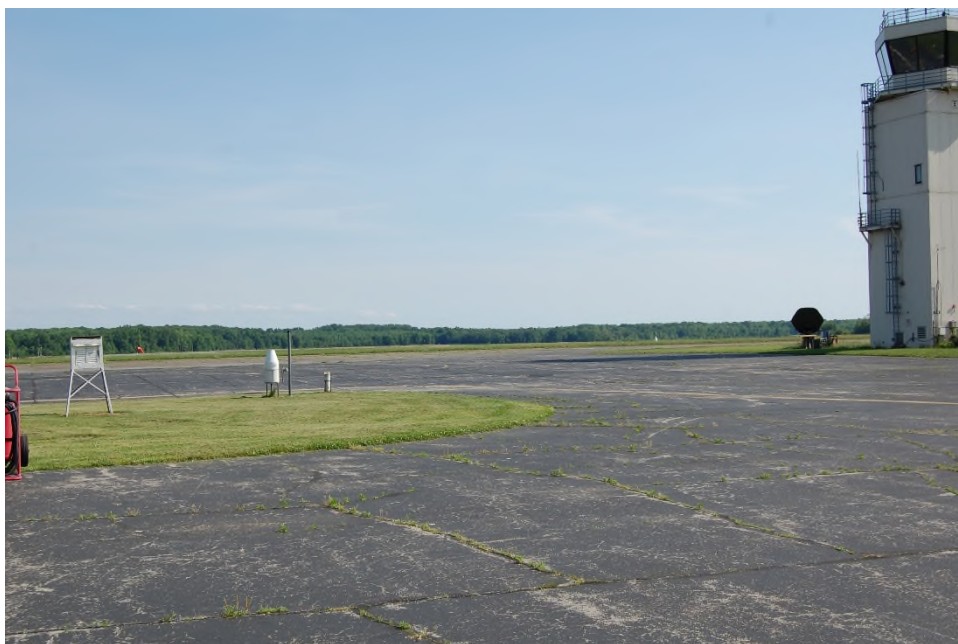
Photograph: 82

View of the PAAF runway from the main hangar bay doors of PAAF Hangar 1060

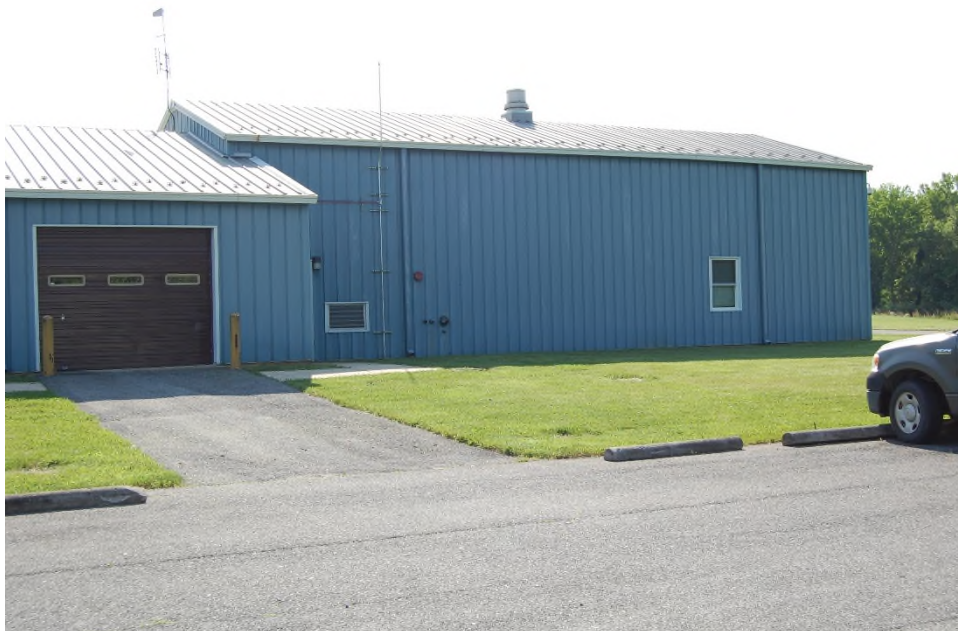
Photograph: 83

The former PAAF – Airfield Station Building 1059, demolished sometime between 2018 and 2021.

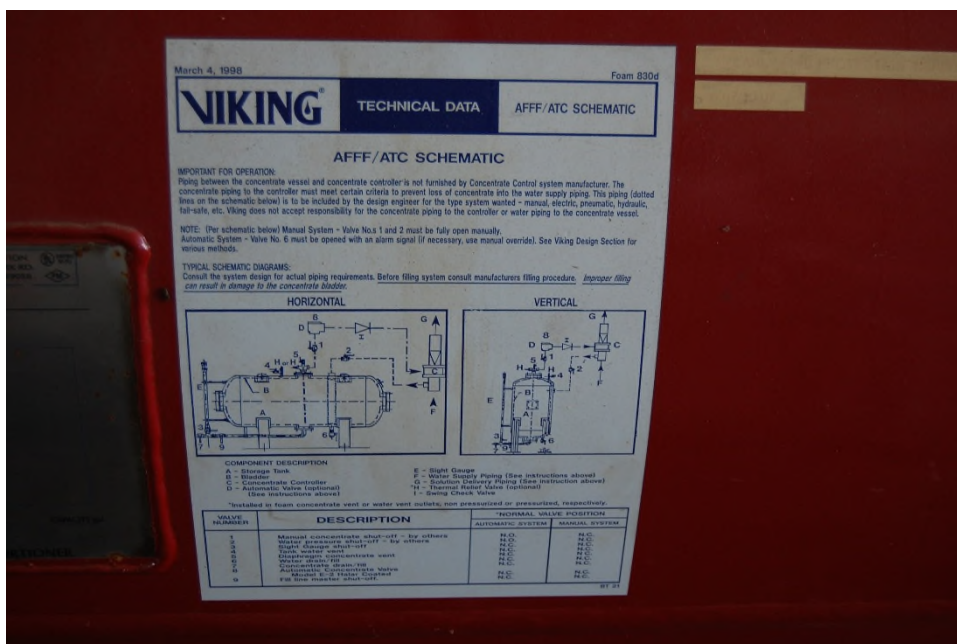
Photograph: 84

Schematic decal detailing the AFFF suppression system located within PAAF Hangar 1060.
