**Building 214, Fort Myer**  
77,310 SQFT

## **Attachment A: Photographs**

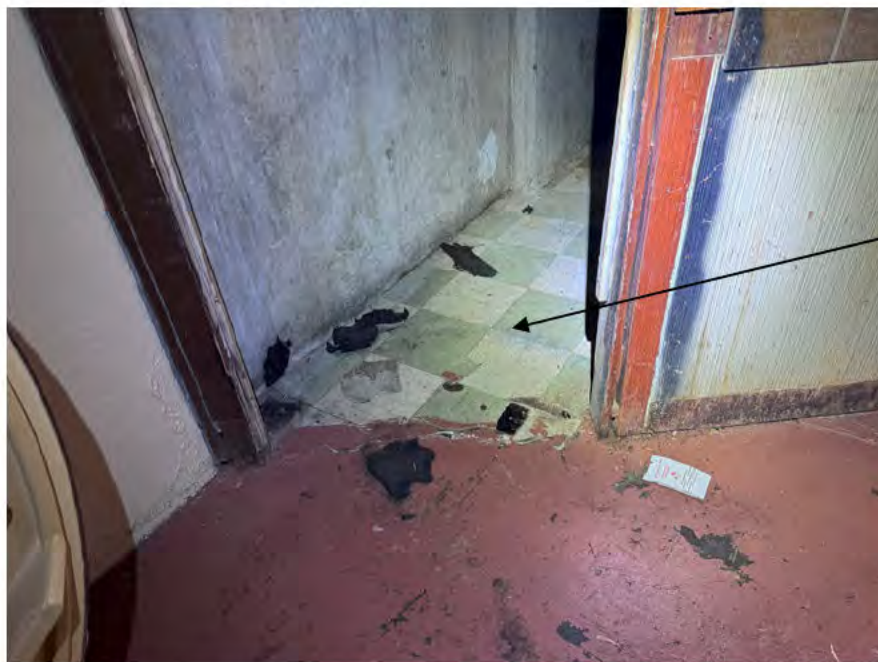
ACM  
FLOOR  
TILE

Photo 5: Two layers of ACM floor tile in Basement Room 035A (Sample #17 & 18).

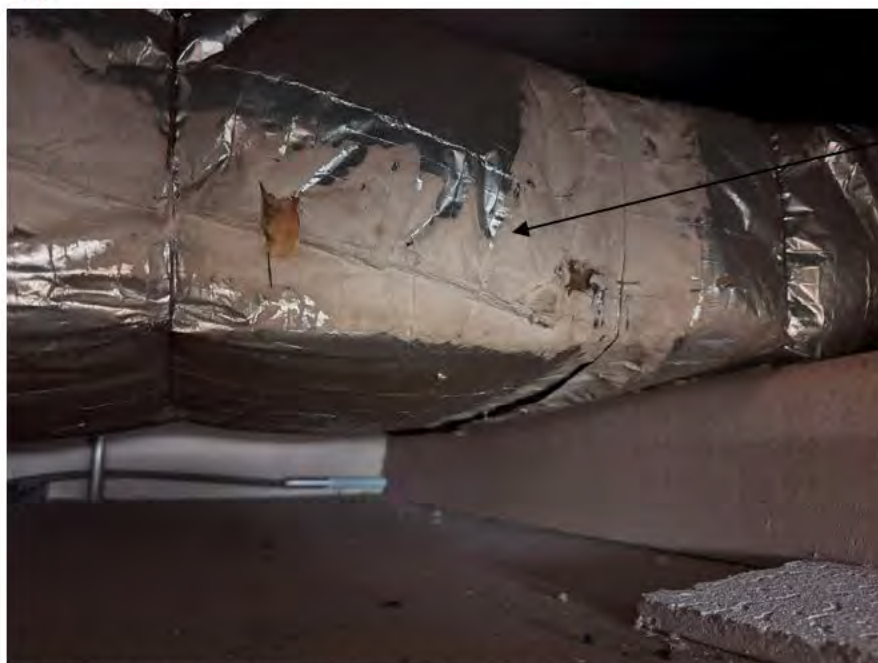
ACM  
BLACK  
MASTIC

Photo 6: Yellow mastic on fiberglass insulation on HVAC duct. The yellow mastic is ACM (Sample #40).
